The Tam Pokhari Glacier Lake outburst flood of 3 September 1998

ABSTRACT

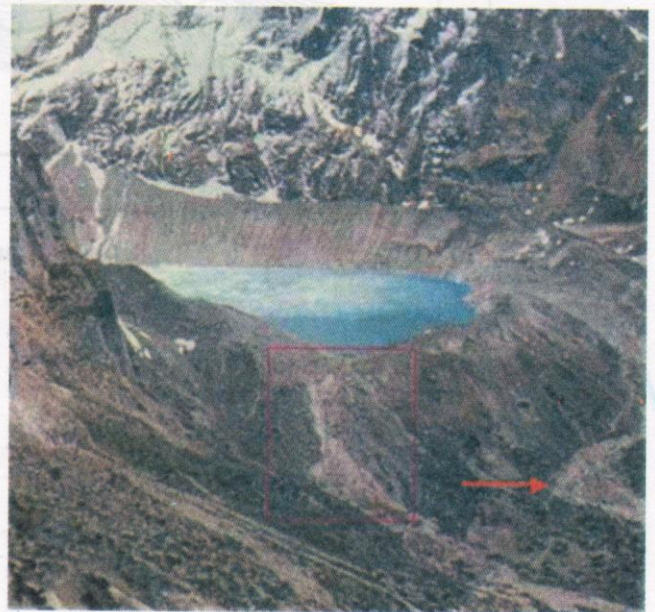
Plate 1: Scouring seen on the end moraine (indicated by the box and arrow). Photograph made available by Mrs Saskia Clark.

From the above data, it is evident that the lake area was reduced twice: i.e. between 1987 and 1990, and between 1992 and 1998. Some scouring of the end moraine can also be seen on the photographs taken around 1996 (Plate 1). Hence, it is inferred that there had already been some instances of overtopping of the end moraine before the outburst.

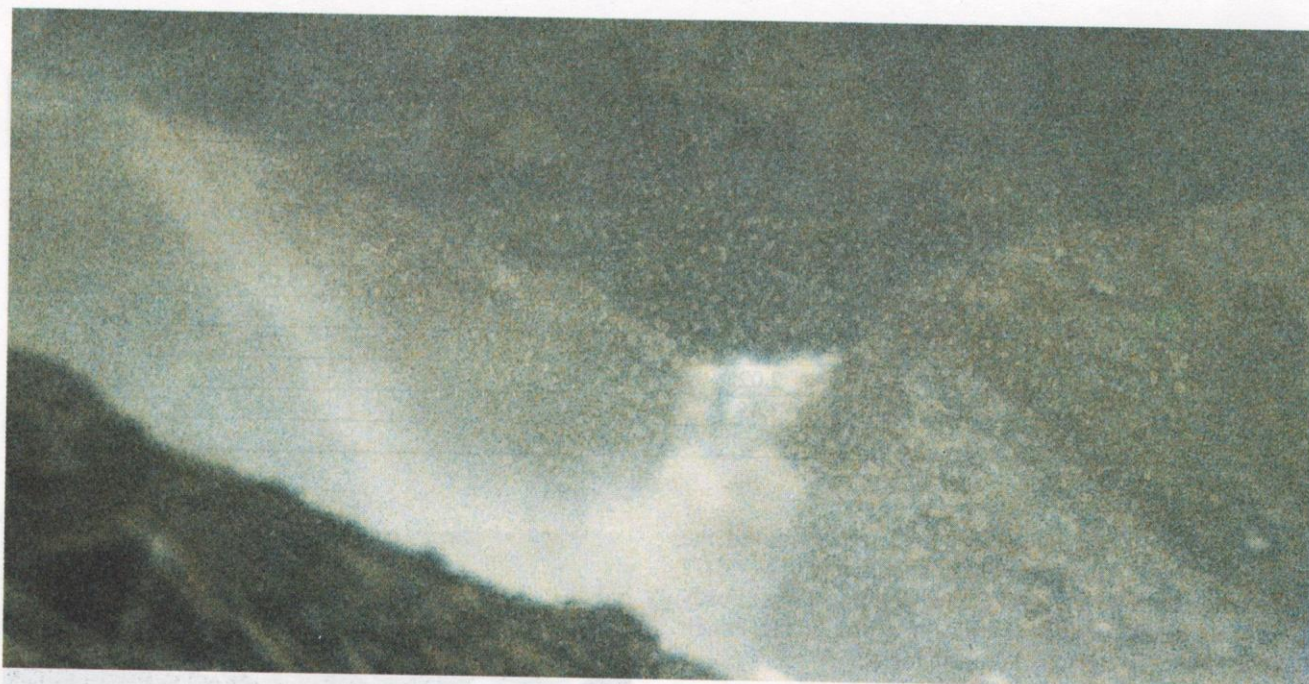
Plate 2: Breaching of the end moraine of the Tam Pokhari Glacier Lake. Photographed by Mr Lakpa Galzen Sherpa at 8 a.m. on 3 September 1998.

The people sleeping in the seasonal settlement Thagnak, which is just about 500 m downstream of the lake, were awakened by a very loud noise at 5 a.m. of 3 September 1998. It was the noise of snow avalanche from the hanging glacier into the Tam Pokhari Lake. When they came out of their houses, they saw the water of the lake rising high (about 5 m) above the end moraine of the lake, and the breaching of the moraine dam followed subsequently. Mr Lakpa Galzen Sherpa, resident of Lukla and the owner of a seasonal teashop, luckily had a loaded camera at that time and took some snaps of the breaching process of the end moraine (Plate 2). The photographs indicate that the breach did not occur at once. It appears that a large volume of ice plunged

into the lake and huge waves triggered off the breach. The surge first scoured the outer lower portion of the dam, and then the failure propagated inwards. In this process, the breached section was widened by side fall, resulting in the formation of a deep and wide channel. The people saw a huge amount of muddy water with floating large boulders and tree trunks moving rapidly downstream. Three teashops and potato fields of Thagnak were swept away by the GLOF.

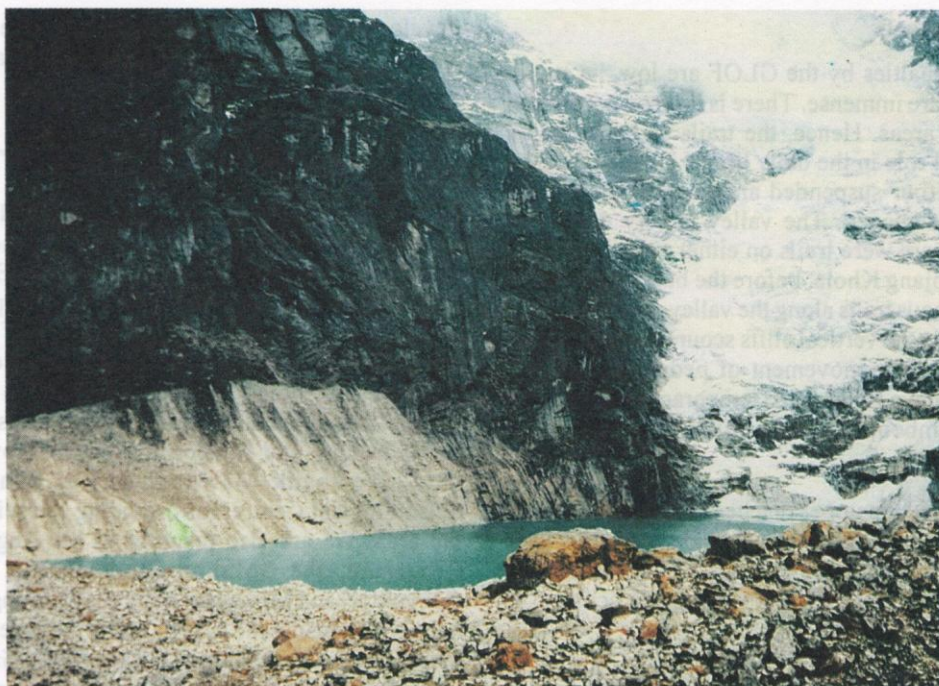
Plate 4: The hanging glacier and the lake before the outburst of 3 September 1998. Photographed by Mr Dawa Galzen Sherpa.

There was a huge mass of ice accumulated on the steep slope of the hanging glacier (Plate 4). The weight of the ice exceeded the resisting force and the resulting avalanche fell directly into the lake. The fact that frost action weakened the rock beneath the glacier cannot be ruled out. Though this was not the first time that the avalanche occurred, but it was large enough to trigger the GLOF.

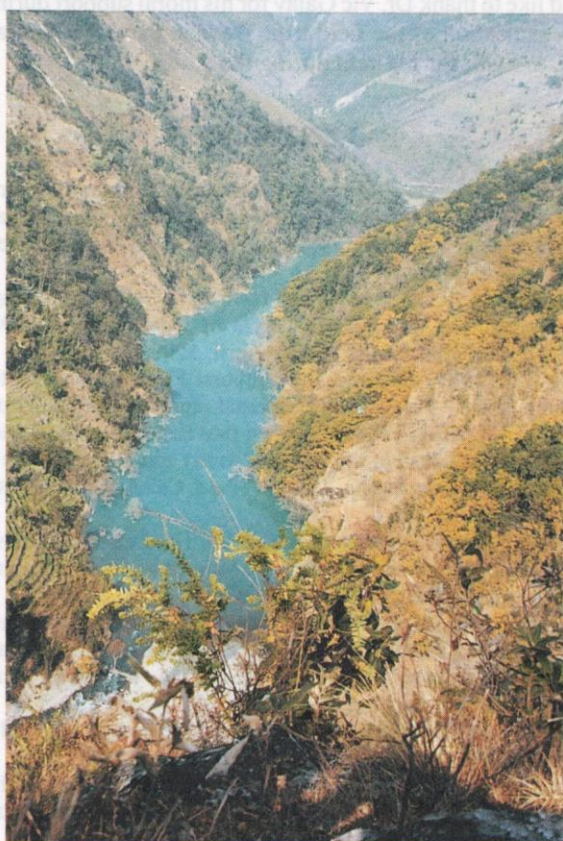
Plate 5: The temporary lake formed in the Dudh Koshi River by the GLOF of 3 September 1998. The GLOF came from the lower-right corner of the photograph.

The sediments transported by the GLOF dammed the Dudh Koshi River and inundated it up to 2 km upstream (Plate 5). About 12 m high sediment terrace was observed in the Dudh Koshi River (Plate 6). According to the inhabitants near the Dudh Koshi confluence, the river level was raised by approximately 30 m. It is reported that this temporary damming of the Dudh Koshi River was opened up during the monsoon of 1999 (i.e. in July-August 1999).
