Landslides and their mitigation in Gangtok, Sikkim

ABSTRACT

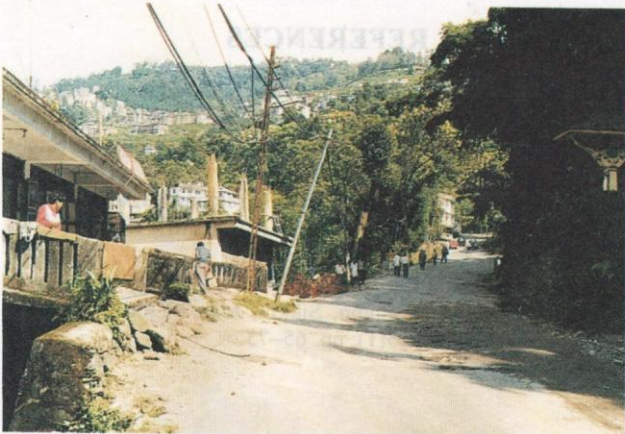
The landslide is located at a distance of six miles from the “Zero Point” (i.e. the centre of Gangtok) due south along the National Highway 31A. The landslide area was originally a rice field. A ravine has formed in this area after repeated sliding in 1980s. The area consists of phyllite with soapstone and residual soil. The bedrock is exposed in the ravine where a considerable amount of water is flowing. The highway is

sinking and the buildings around it are seriously damaged (Plate 3).

Plate 3: The sinking part of the National Highway 31A at “Six Miles” Landslide, Tadong

It is necessary to monitor the rate of settlement in various parts of the landslide area including the installation of a few piezometers to evaluate the pore pressure fluctuations. The stability analysis of the landslide should be carried out based on the above data as well as the laboratory study of soil samples. Drainage systems and retaining walls are necessary for the stability of the road.

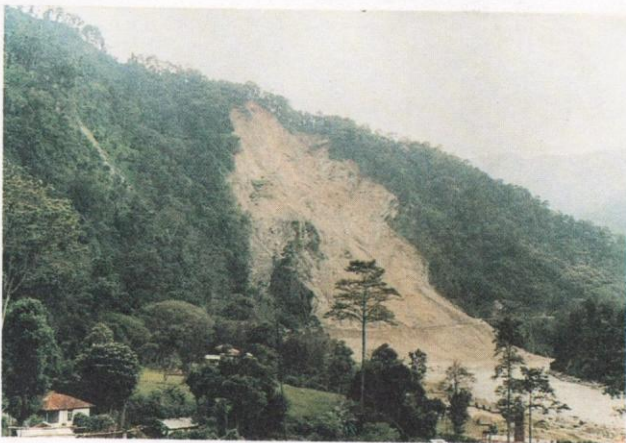
Like the Chanmari Landslide, the Burdang Landslide (Plate 4) was also triggered by the rainstorm of 8 June 1997. It has a volume of 100,000–200,000 m³. Because of the slide, the National Highway 31A (the main connection between West Bengal and Sikkim) was disrupted for a long time, as an enormous mass of debris blocked about 250 m of the road length. Later, a new track was opened temporarily through the slide with bulldozers. But, as the debris and the scarp above were unstable, the road is frequently blocked in the rainy season.

The landslide occurs on a northwest-facing hillslope made up of phyllite and extends between 600 and 725 m. The slope has an average gradient of 36° between the upper scarp and the toe, which is being actively undercut by the river Tista. The slide presumably occurred along the steeply dipping foliation plane of phyllite. These fractures were probably saturated and had lost their shear strength due to

Plate 4: View of the Burdang Landslide by the Tista River

high infiltration of water during the rainstorm. The slip surface is undulating and rough (it has the amplitude of 20–50 mm within the length of 1–2 m).

Similar to the Chanmari Landslide, it is also a reactivated old slide, which occurred for the first time in 1960s, when it failed at a lower level but with approximately the same width. At that time, some catch drains of concrete were constructed above the scarp to protect the area from new slides. Later, these drains cracked due to soil creep. Inadequate maintenance of drains caused leakage, which could have been the main triggering factor of the 1997 landslide.

As the landslide of 1997 has already involved the slope all the way up to the crest, it is least probable that a new large landslide occurs in the near future. The unstable debris cone (which is eroded by the river) and the surface water from above are the two main problems. It is recommended to remove the whole debris cone and rebuild the road by stabilising the slope above the road and controlling the toe

erosion. Another alternative is to construct a 300 m long tunnel through the mountain and avoid the landslide zone.
