Stress Induced Deformation in Phyllite Rock in Mahadevtar Tunnel of KTFT Road Project

Abstract

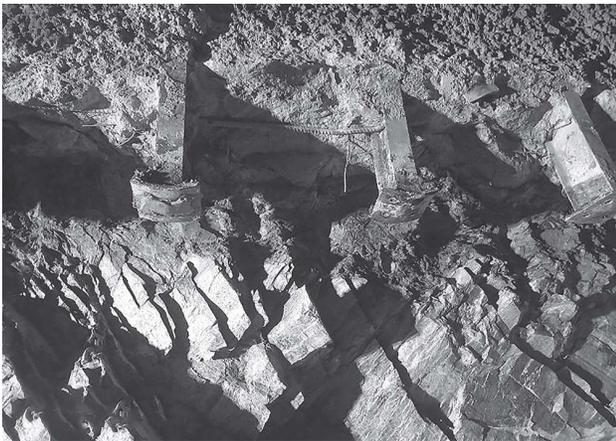
Figure 7 shows punching of the footplate of steel rib of top heading part indicating significant vertical stress.

Figure 7: Foot plate of steel rib heading part found punched while excavation of bench

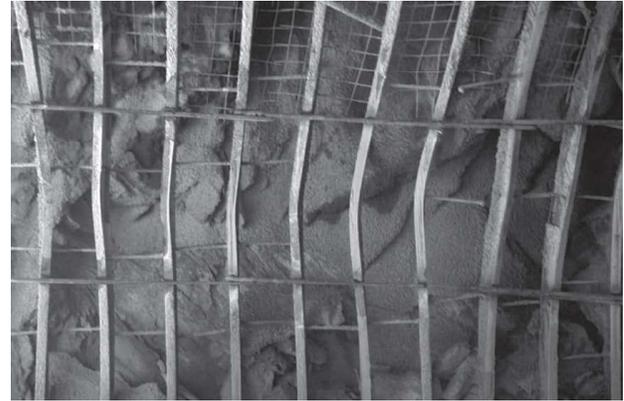
At the tunnel side walls, windows need to be maintained for the embedded parts as well as openings for various components like cross tunnel. In such an area, steel ribs were installed without shotcrete. Such steel ribs were found buckled in some locations (Figure 8). This phenomenon also indicated significant stress conditions of the steel ribs.

Figure 8: Buckling of steel ribs without shotcrete

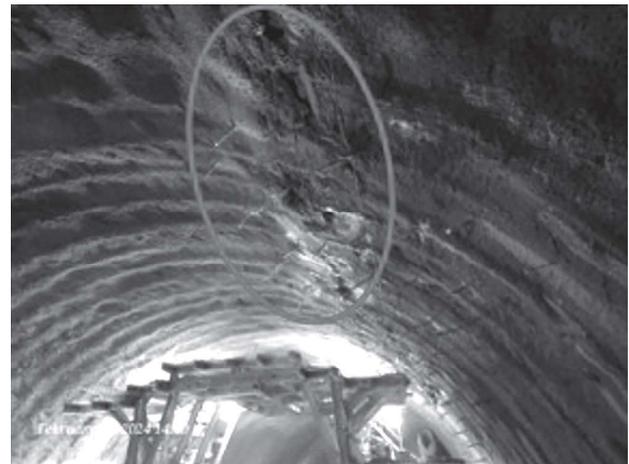
In about 20m long section, significant deformation (10-12cm) is noticed along the right crown part of the tunnel as presented in Figure 9.

Figure 9: deformation at right crown part

Once the deformation is converged, the deformed tunnel profile (as shown in Figure 9) was corrected. For this shotcrete as well as steel ribs of the bulged section were removed and replaced locally.

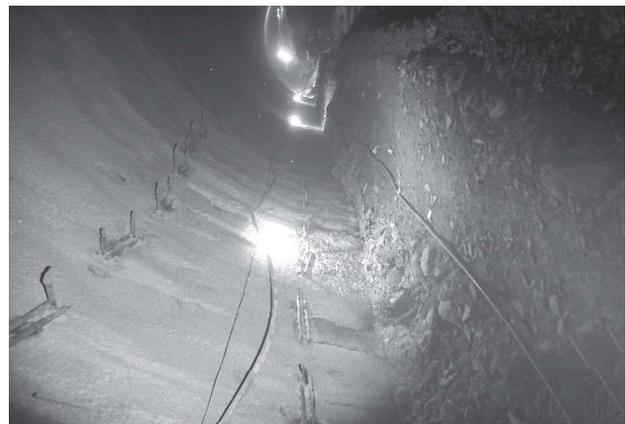
Figure 11: Foot locks for the steel ribs strengthening

For the section with increased deformation, grouted foot locks (perforated hollow steel pipes dia. 42mm and length 4 m) were installed at both sides of the steel ribs and connected to the steel ribs as shown in Figure 12.

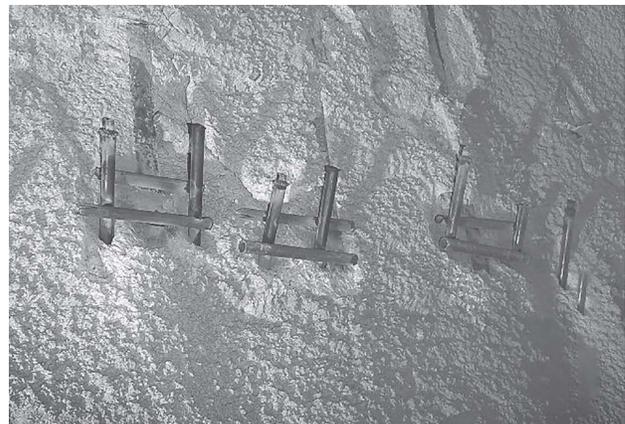
Figure 12: Foot locks for the steel ribs strengthening- a close view

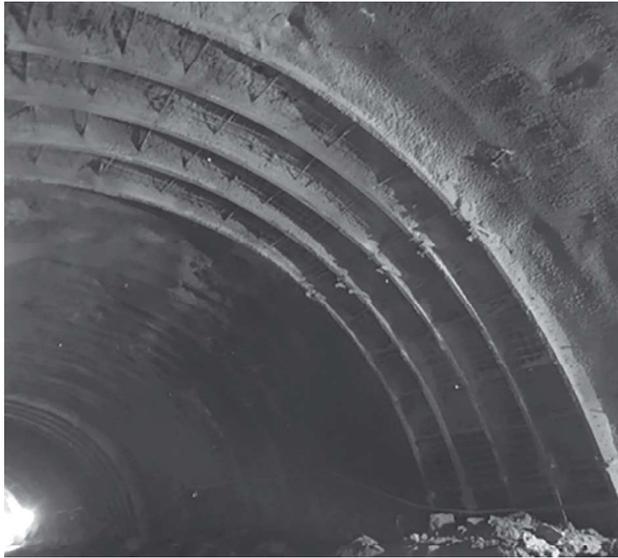
Figure 13: Additional steel ribs installed inside the twisted steel ribs

Additionally, to ensure the stability of the tunnel, additional steel ribs were installed at the inner profile of the existing twisted steel ribs.

For the section where double steel ribs are installed, the full profile of the steel ribs is replaced with larger steel ribs i.e. 2xMB175 is replaced with single MB200 steel ribs. Taking out the installed support is a very challenging and risky job and needs fine judgment and supervision of highly experienced engineers. Even a minor mistake may lead to the collapse of the tunnel.

The reason behind the replacement is that, twisted inner rib is theoretically not taking any load and the inner added ribs lie in the profile of the secondary lining i.e. the thickness of secondary lining shall be otherwise compromised.

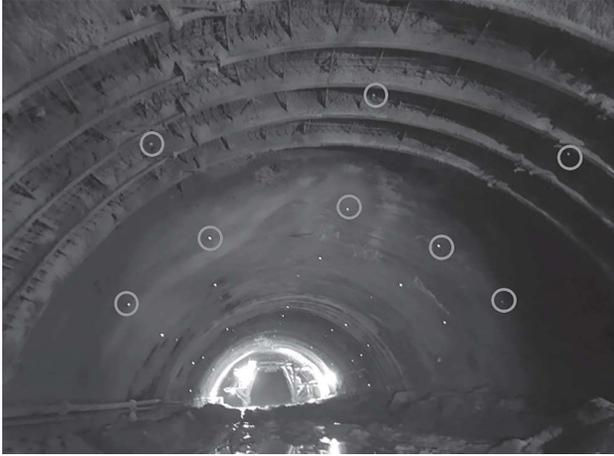
Figure 14: Optical Targets for Convergence Monitoring of the Tunnel

In the NATM tunneling, the measured deformation result play vital role to confirm the adequacy of the installed support as well as to adapt the support measure as per encountered site condition. The tunnel can only be stable, once the deformation is mostly converged prior to construction of secondary lining.

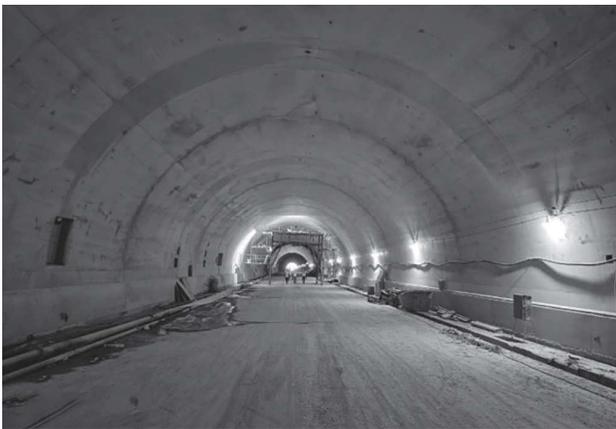
4. In order to avoid water pressure on the concrete lining, a layer of geotextile along with circumferential perforated pipe as well as waterproof membrane will be laid between the primary and secondary lining. A photograph of the section with secondary lining is shown in Figure 17.

Figure 17: Secondary Lining

2. Reinforced Concrete Secondary Lining: The severely impacted stretches with multiple twisted steel ribs are upgraded to reinforced concrete lining for the additional safety. In Right tunnel about 140 m and in left tunnel about 80 m long section will be upgraded to reinforced concrete.
