SEISMIC PERFORMANCE OF TRADITIONAL UNREINFORCED MASONRY BUILDING IN NEPAL

Shyam Sundar Khadka

Department of Civil & Geomatics Engineering, Kathmandu University

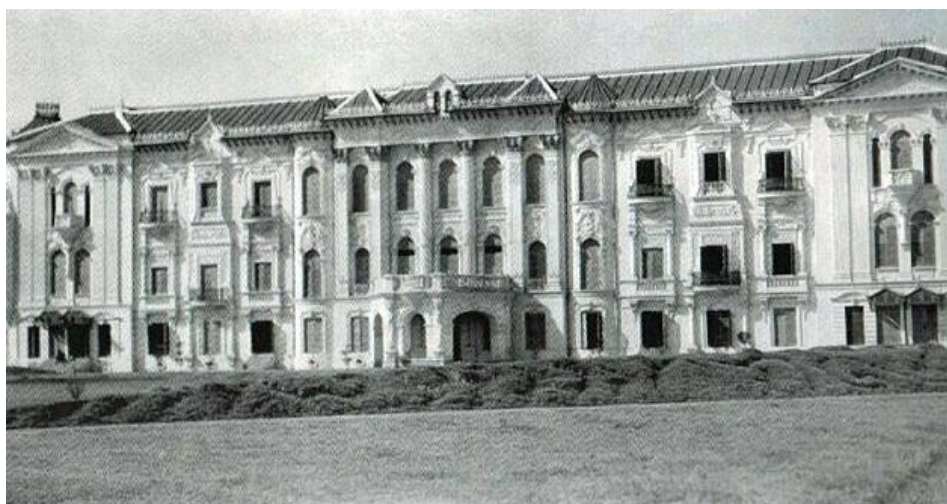
Figure 1 Shital Nivas before 1934 AD earthquake

Nepal experienced a new scenario in construction of buildings during the middle of the Nineteenth century. After returning from the Europe tour the first Rana Prime Minister Janga Bhaduar Rana built the palaces for him with inspiration of the European style. Construction of such neo-classical building introduced 1850 AD continued to take place during over 100 years of ruling by Rana family. These palaces of neo-classical type are scattered all over the Kathmandu valley. It is to be noted that these places were used for residential purpose in general, and the construction was different from that of other civil residential buildings in terms of quality and grandiose. These palaces are usually three storied and cover large area with huge compounds. In general, the palaces are built in courtyard system, sometimes with a number of courtyards. The large wings of the buildings are of gallery type with long corridors with spacious rooms of different sizes. Singha durbar one of the largest palaces, for instance, covers a large area with many courtyards and a large compound. All important government offices include Ministries of Government and National Planning Commission are accommodated in the buildings. In 1970 AD it was badly affected by fire and renovated using traditional technology. Another palace, Sital Nivas, which at present accommodates House of President, was re-built after the damage in 1934 AD earthquake. The original old Sital Nivas was built in 1923 AD as shown in figure 1. In 1934 AD earthquake, it was extensively damaged and again reconstructed on the same ground immediately after earthquake. The present condition of Sital Nivas palace is shown in figure 2. Hasty re-construction of palaces after the devastating earthquake with no seismic consideration these structures more vulnerable, indicating further need of seismic risk assessment. The building plan of the North wing of Sital Nivas palace presented in figure 3 to illustrate the typical structural plan of the palaces.

The old Shital Nivas was constructed in 1923 AD and it was extensively damaged in 1934 AD earthquake and hasty constructed after earthquake without consideration of seismic effect on the same ground. This building is in courtyard type. It has two courtyards of different types as shown in the figure 5.1. The sizes of the Courtyard I and Courtyard II are 44 m by 37 m and 26 m by 25 m respectively. The building is long in length and narrow in width, the aspect ratio is more than five. Ground floor covers the area of 3346 square meter. The Ground, First and Second floor plan of the building are shown in figure 5.2, 5.3 and 5.4 respectively.

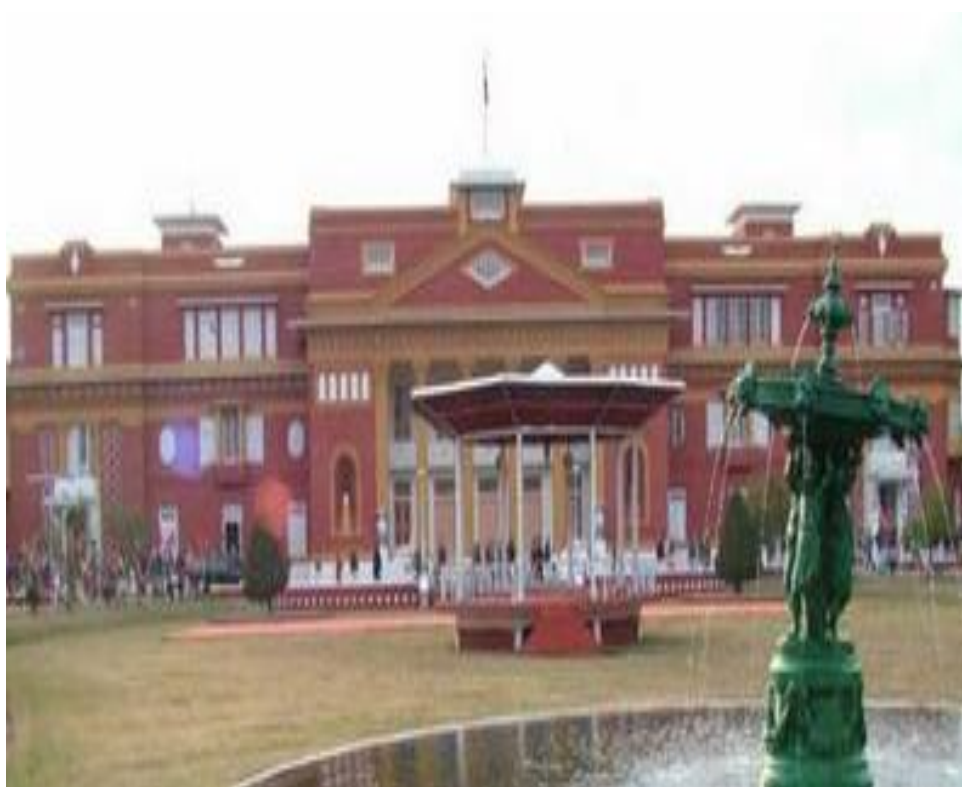
Figure 2 Present condition of Shital Nivas

number of opening in their façade and have slope roofs. The buildings constitutes of long walls with rectangular or square shaped court-yards. The main structural system for lateral load resisting is thick un-reinforced masonry wall with about one meter thickness in the ground floor, reduced thickness in the upper floors but with 0.6 meter as a minimum thickness. The walls are made of high class burnt clay brick with good quality of lime surkhi mortar. Thick timber floors are used with timber joists provided normal to the front façade wall, and with planks. Depending upon the spans of the room sometimes rolled steel I-sections are employed to support the joists of the flooring with decorative steel plates. There are clusters of openings in the wall for adequate lightning and also for architectural aesthetic. Sizes of opening are same in all floors and placed in symmetrical position. Strip brick masonry foundations of the buildings are rigid. The plinth level is considerably high above the ground level with a provision for ventilation in the suspended timber ground floor. All the palaces have sloped roof normally covered with GI sheets or clay tiles with timber truss and rafters.

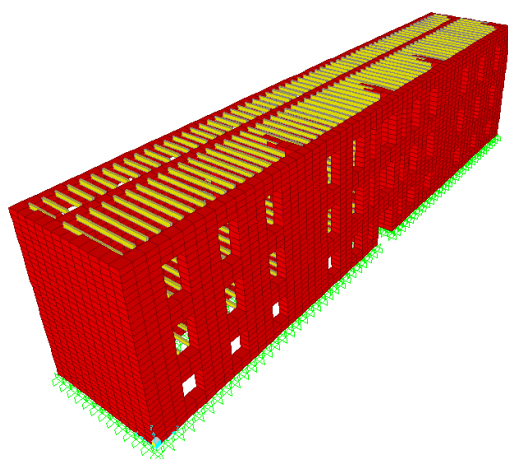
Figure 4 3D Finite element model of the studied building

The internal composite walls, the timber roofs and others architectural parts associated with the building are not considered in the modeling. However, the loads associates with these elements were included in the analysis. The foundation of building was fully restrained. The whole building is not taken for modeling, for simplicity one wing of the building is modeled. The 3-D homogenous solid element model of the modeled building having the timber floor is shown in figure 4. For modeling the timber floor, a three dimensional linear beam element is

used to model the timber joist. The connection of the timber floor/roof with the masonry wall is neglected and assuming that it is simply rest on the wall by considering the fact that the timber nails or iron ties, if present, were heavily deteriorated or damaged over the long years. So, simply supported connection is used for the modeling the joint between the timber joist and masonry wall.

The model is analyzed by the Seismic Coefficient method, in which seismic effect, that is, a horizontal force is considered as the percentage of the total weight of the building. In this method, dynamic forces, which act on the structure during the excitation, are converted into equivalent horizontal force. In this research work the seismic coefficient method is used as described by the IS 1893 (Part I): 2002. The distribution of lateral load is different for different floor system of unreinforced masonry building. The commonly adopted inverse triangular force distribution is not applicable to the flexible floor diaphragm. Because, the in-plane stiffness of the thick shear wall is relatively larger than the floor and the magnitude of lateral force at all level were nearly equal or same. Therefore, uniform pattern of loading was used for the analysis of the loosely connected timber floor. For simulations of the numerical model a commercial program SAP2000 is used.

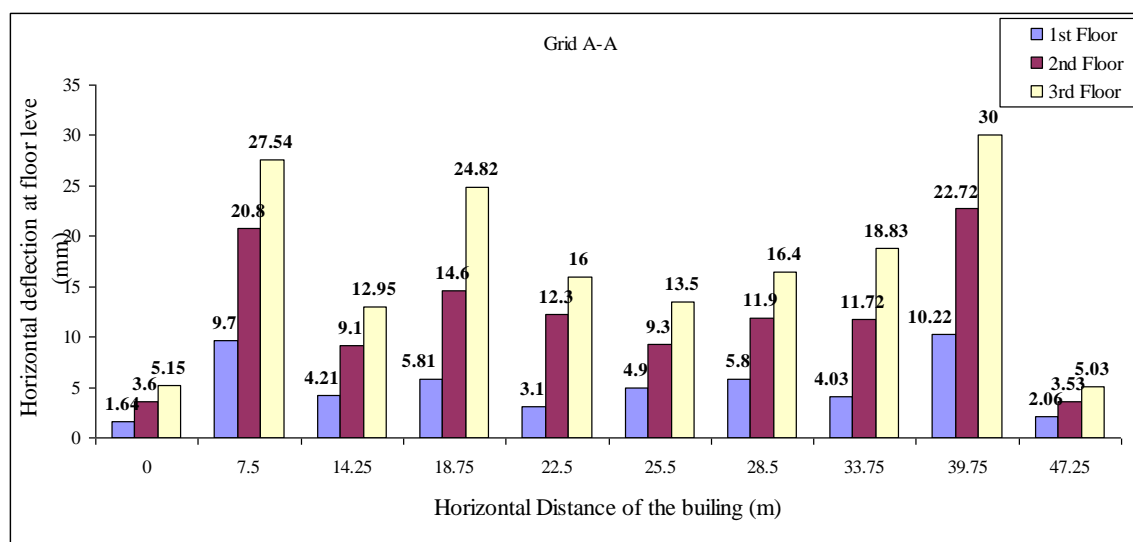
So, due to the less number of the cross wall and large sizes of rooms, the horizontal displacement of the building at the floor level is not same. The out-of-plane displacement at the floor level is different in each span of the wall, along the longitudinal direction. There is maximum displacement at distance of 7.5 m and 39.75 m, from the left of the building plan, along the x-axis, shown in figure 3. The out-of-plane displacement is drastically reduced near the cross wall, that is, at 14.25 m, 22.5 m 25.5 m and 33.75 m, at Grid 2-2, Grid 3-3, Grid 4-4 and Grid 5-5 respectively. The out-of-plane displacement of the longitudinal wall of the building has more significant effect from 0 to 14.25 m and from 33.75 m to 47.25 m, that is, Room A and Room D in compare to Room B and Room C, due to the long span of the wall. In case of the first floor level, for longitudinal wall along the Grid A-A, at a distance of 7.5 m from the left of the building plan shown in figure 3, the top displacement of the building is 9.7 mm and it reduced to 4.21 mm at a distance of 14.25 m and reached 5.81 mm at 18.75 m. And it is again decreased to 3.1 mm at 22.5 m and increased to 4.9 mm to 5.8 mm at 25.5 m and 28.5 m respectively and it decreases to 4.03 mm at 33.75 m. From 33.75 m to 39.75 m the displacement value is increased from 4.03 mm to maximum of 10.22 mm and then again decreased to 2.06 mm at 47.25 mm distance from the left, that is, next end of the building. The above displacement pattern is described in figure 5.

Figure 5 Horizontal displacements (out-of- plane) of the longitudinal wall along the Grid A-A at the floor level of the three dimensional building having the timber floor.

The horizontal displacement of the building, at the floor level, due to walls along the Grid A-A, Grid B-B and Grid C-C, follow the same pattern as described in figure 5 to 7. But, at Grid 2-2, 3-3 and 5-5, that is, at distance 14.25 m, 22.5 m and 33.75 m along the longitudinal direction of the building, at the first floor level, the displacement value by these three walls are little bit different. The displacement values are shown in figure 5 to 7. In that location longitudinal wall along the Grid C-C deflects more in compare with Grid A-A and Grid B-B. This is due to that the Grid A-A and Grid B-B are connected with cross walls while there are no cross walls in between Grid B-B and Grid C-C, as already mentioned above.

In case of the second floor level, the displacement pattern of all longitudinal walls are in same pattern, as above, as shown in figure 5 to 7. As the Grid C-C does not connect with the cross wall, as Grid A-A and Grid B-B, there is no significant different in the displacement pattern at the location of the cross wall. But the longitudinal wall along the Grid C-C has little bit more displacements value, but which is not significant. The internal wall, that is, Grid B-B, behaves differently in the first floor and top floor level. In the first floor level, the displacement pattern of the Grid B-B is out-of-phase with rest of two walls from 33.75 m to 47.25 m and in the top floor it is out of phase from 0 to 24.75 m.

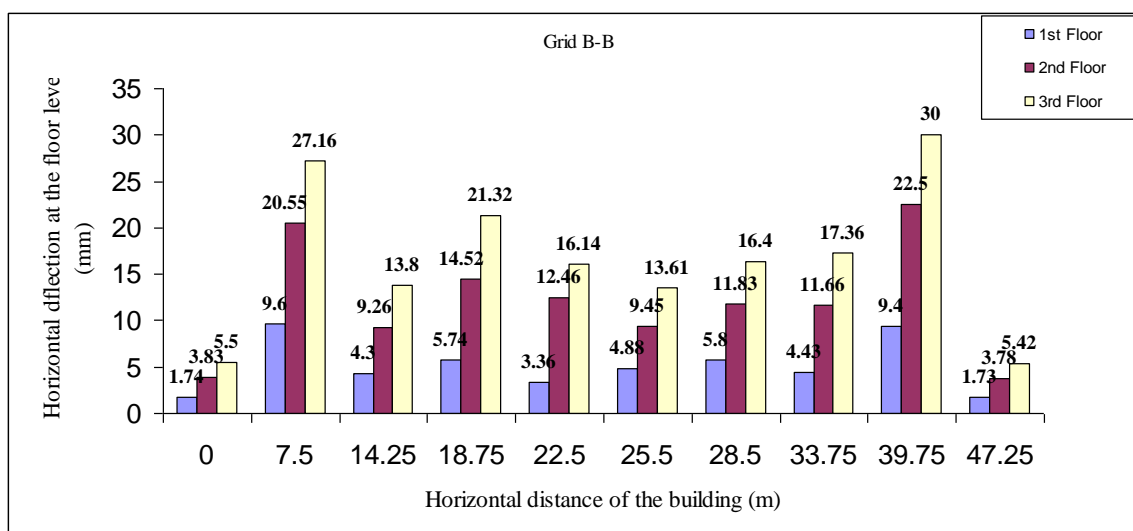
Figure 6 Horizontal displacements (out-of- plane) of the longitudinal wall along the Grid B-B at the floor level of the three dimensional building having the timber floor.

It is clear that, the presence of the cross wall the out-of-plane displacement of the building is drastically reduced. Due to loosely, that is, inadequate, connection of the existing timber joist to the masonry walls, the floor cannot act as a rigid diaphragm and allow for the differential movement and cantilever plate action between walls, leading to collapse of the walls. And also due to larger sizes of the room which separated the cross wall apart greatly, making the walls more vulnerable to overturning during the earthquake. Due to the insufficient transverse connection to the longitudinal walls and the longitudinal direction of the building is more than five times larger than the transverse direction, the whole building cannot acts as a single unit and the longitudinal and transverse walls behaves independently and leads to failure during the earthquake.

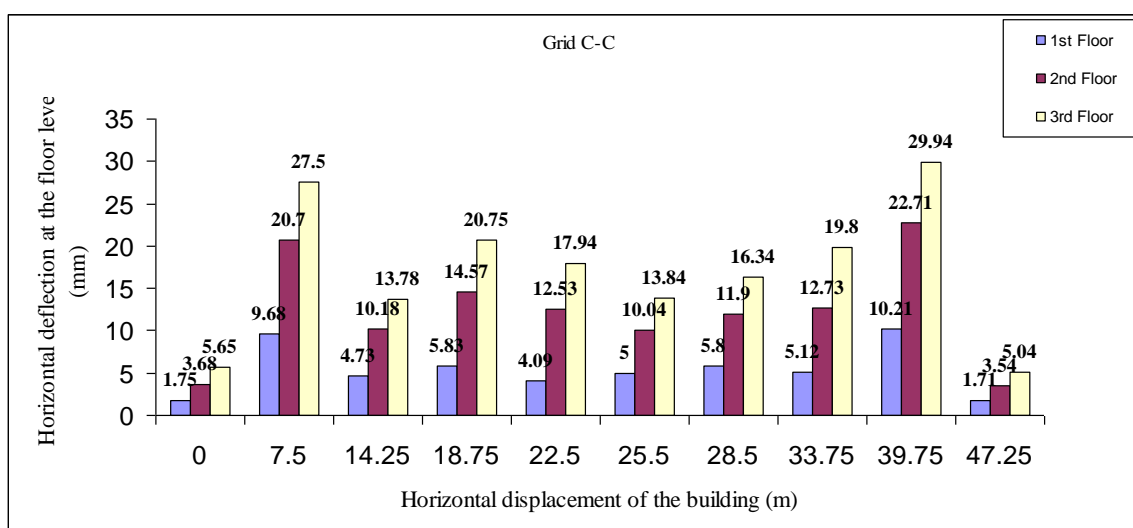
Figure 7 Horizontal displacement (out-of- plane) of the longitudinal wall along the Grid C-C at the floor level of the three dimensional building having the timber floor.

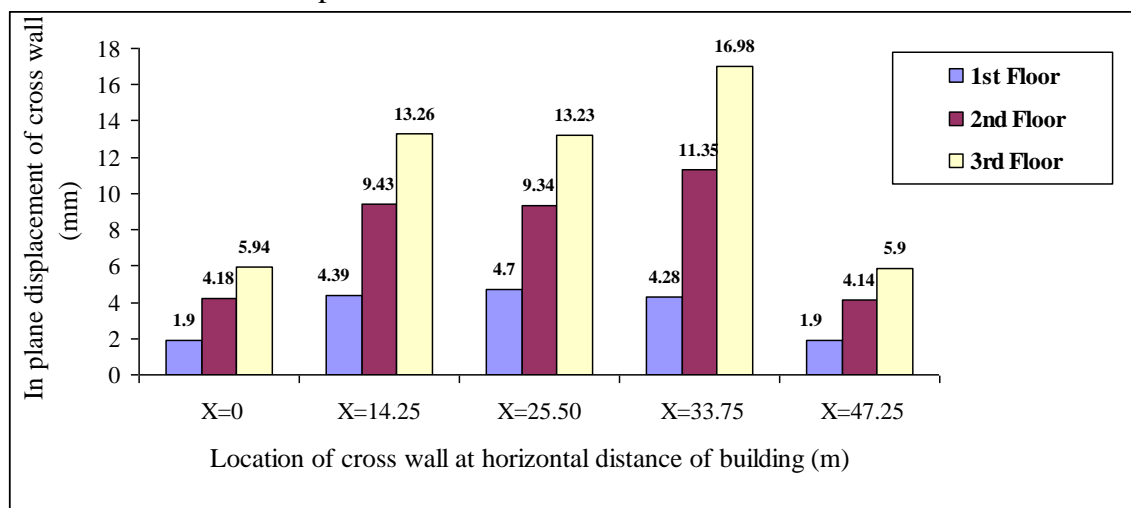
The in-plane displacement of the building due to the cross walls and end walls is also studied. The story level displacement due to the transverse wall, parallel to the seismic excitation, that is, at Grid 1-1 and 6-6, the end walls at distance 0 m and 47.25 m and cross walls, Grid 2-2, 3-3 and 5-5 at distance 14.25 m, 25.5 m and 33.75 m respectively, presented in figure 8. The displacement patterns of the end walls are similar and the top floor level displacement is 5.94 mm which is nearly six times smaller than the maximum out-of-plane displacement. Similarly, cross wall at distance of 14.5 m and 25.5 m, along Room B, have the similar displacement pattern. The top floor level displacement value is 13.23 mm, which is more than two times less than the maximum out-of-plane displacement of the building.

But, transverse wall at Grid 5-5, distance of 33.75 m, which separate the Room C and Room D, the displacement pattern is same at the Ground floor level. For the First and Second floor the displacement pattern is different than other two cross walls and end walls of the building. The maximum value of the top floor level displacement is 16.98 mm as shown in figure 8.

Figure 8 In-plane displacement of the transverse wall at the story level of the three dimensional building having the timber floor at different location of the horizontal distance, shown in figure 5.5 to 5.7. Earthquake force applied along the y-direction

Therefore, the in-plane displacement of the cross walls are more than that of the end walls of the building. And also the displacement pattern of the cross walls are not same, along the height of the building. In Ground floor, there are four number of the cross walls at distance of 14.25 m, 22.5 m, 25.5 m and 33.75 m respectively; but in the First and Second floor the cross wall at a distance of 22.5 m is not exists. Due to this fact the displacement pattern of the cross walls are different.

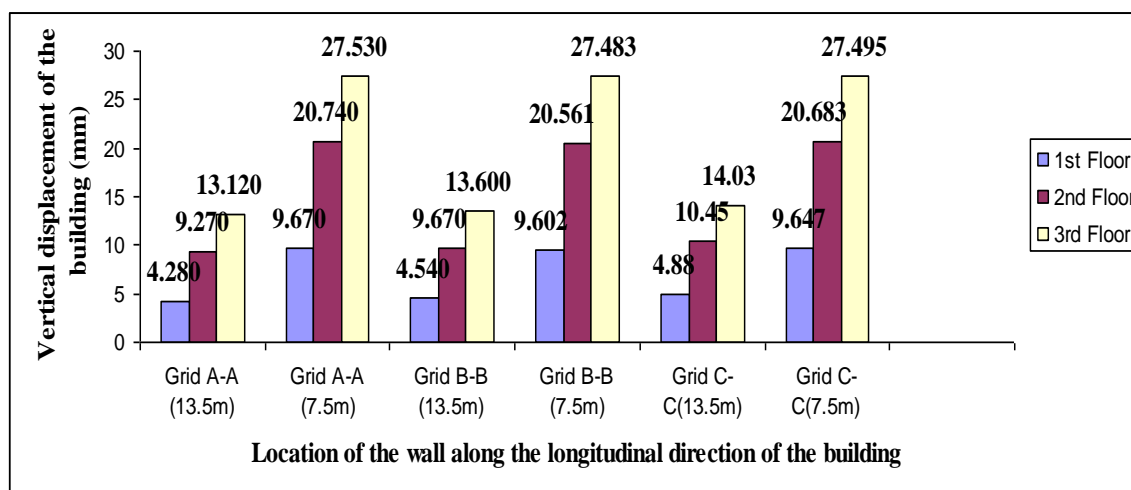
Figure 9 Vertical deflection of the building due to longitudinal wall along Grid A-A at different location shown in legend, along the X-direction of the building, at the story level of the three dimensional building having the timber floor. Earthquake force applied along the y-direction.

Figure 9 and 10 describes the vertical displacement pattern, at the story level, of the building of the longitudinal walls, Grid A-A, Grid B-B and Grid C-C respectively, at different location, where the maximum and minimum out-of- plane displacement are observed respectively. It shows that the vertical displacement pattern is different in these locations with respect to each floor. The vertical displacement near or at the cross wall is nearly half than the maximum value. And also it has different displacement value at the distance of 7.5 m and 39.75 m, along the Grid A-A, of 27.53 mm and 30.9 mm respectively. Therefore along the longitudinal direction, Grid A-A, Grid B-B, and Grid C-C, the vertical displacement pattern is different, that is, different value. The inter-story displacement with respect to floor is also different. At 7.5 m, where maximum out-of- plane displacement is expected, along the Grid A-A, the inter-story displacement difference with respect to the second floor to the first level is 11, while the difference between the top floor and the second floor is 6.8. At 39.75 m, where maximum out-of- plane displacement is expected, the difference of the storey level displacement between the second floor and the first floor level is 12.5 and it is 8.2 in between the top and the second floor level.

Since the existing floor does not have sufficient rigidity, therefore the inter-storey displacement of the building, along the height of the building is different. The inter-storey displacement between the first floor level and the second floor level is different with the second floor level and top floor level.

Due to the presence of the timber floor, the longitudinal wall along the Grid C-C, this is not connected with the Grid B-B through cross wall, behaves like Grid A-A and Grid B-B. Therefore, the failure of such old traditional building is collapsed by the unequal vertical deformations of the outer walls and cross walls.

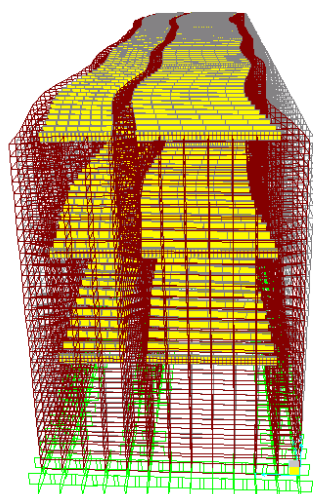
Figure 11 Deformed shape of the three dimensional unreinforced masonry building, North wing of the Shital Nivas, with timber floor subjected to seismic loading.

3. The North wing of the old traditional building, is collapsed with the excessive deformation of the outer wall.
4. For such building, having long in length and narrow in width, the number of the existing cross walls are not sufficient form the seismic consideration.

5. The large sizes of the rooms without cross walls are the main draw backs of the building.
6. The in-plane wall, which is parallel to the seismic excitation, of the building resists the out-of-plane failure. Figure 5.18 shows the deformed shape of the building.
