# Roadmap for Re-establishment of Geospatial Relationship of the Control Points and Features in Nepal due to Gorkha Earthquake 2015

Rabin K. Sharma

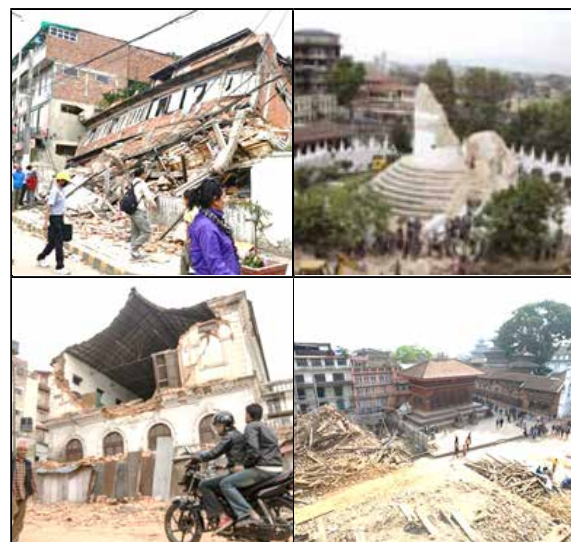
Photo 1: Clockwise from top left Destroyed building, Monument (Dharahara), School (Durbar High School) and Basantapur Durbar Square

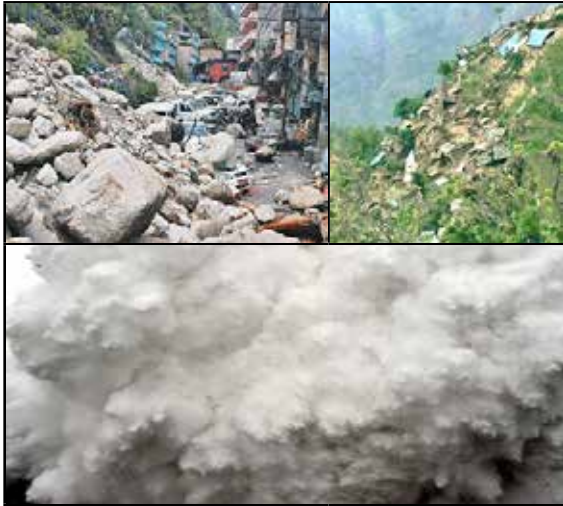
Photo 2: Clockwise from top left Rock fall at Bhotang Village of Kavre, Landslide at Arniko highway and Avalanche at Sagarmatha base camp

After occurrence of the Earthquake, additional damages were made due to other natural phenomenon such as landslides, debris flow, avalanches, *et cetera*. Due to shaking of ground by the earthquake, the land especially in the mountainous region and Himalayan region became very unstable and loosen its grip, therefore, at number of places, there were landslides, debris flowing down the slopes containing soil and rocks and avalanches depend upon the nature of the ground. These natural phenomenons damaged and destroyed large number of settlement areas. The consequence of disasters was loss of lives including human and animals. For example, in Langtang valley, a huge avalanche came which swept away the total settlement of the area and around 350 people were missing. Similarly, immediately after the major earthquake on 25<sup>th</sup> April 2015, there was a huge avalanche at Sagarmatha base camp. The avalanche swept away mountain climbers who were on the way to atop the Sagarmatha. Later, it was declared that 10 Nepalese porters including some guides and 5 foreign mountain climbers were dead and 61 were injured by the avalanche.

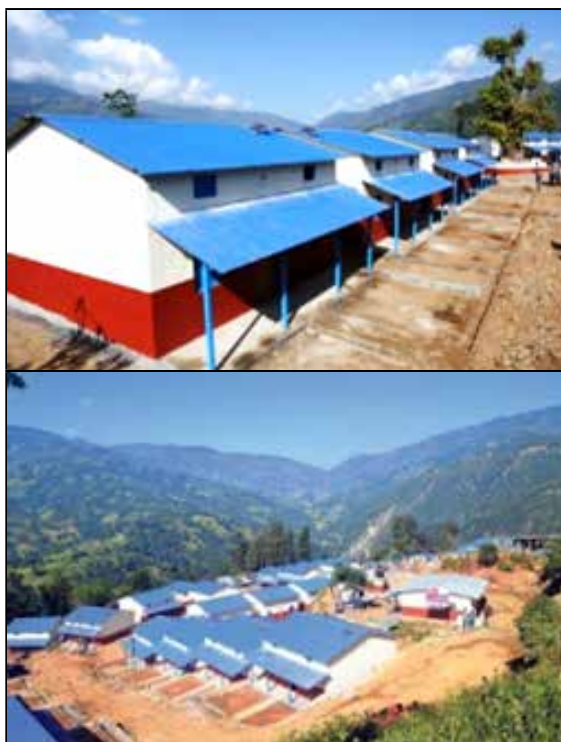
Photo 3: Houses of the Giranchaur integrated settlement for quake survivors, built by the Dhurmus Suntali Foundation, in Melamchi of Sindhupalchok district

In order to do this, teams should be deputed to monitor the reconstruction at heritage sites and newly constructed settlement areas. As soon as the reconstruction of the site or area is completed, the database can be updated by collection of data applying appropriate technology which could be either ground survey method using Total Station Theodolite or remote sensing method by flying Drones. One of the examples of completion of reconstruction site was houses of the Giranchaur integrated settlement for quake survivors, built by the **Dhurmus Suntali Foundation**, in Melamchi of Sindhupalchok district as shown in the photo 3. The newly built settlement was inaugurated, on Friday, October 28, 2016 by the Honourable President Bidya Devi Bhandari and handed over to the locals.
