Management of Separated Endodontic Instrument and a Blocked Canal - A Case Report

ABSTRACT

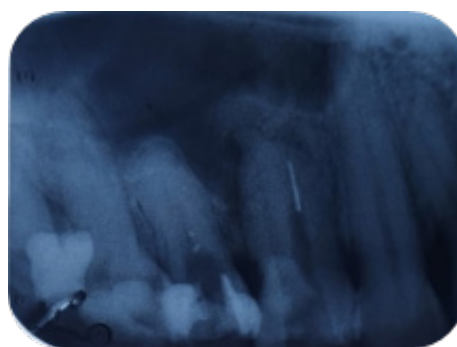
of Dental Surgery, BPKIHS, with pain in her upper left back region of the jaw for the management of previously initiated 24 and 25 with symptomatic apical periodontitis. She was undergoing endodontic treatment on 24 and 25 when the NiTi rotary instrument (*HyFlex*TMCM of #20, 0.4% taper) was separated in the buccal canal of 24, and 25 had an instrumentation-related blockage. Attempt to bypass file and retrieval of the fragment with hollow-tube based extractor was tried for 24 and gaining patency for 25 was attempted but was unsuccessful. The medical history of the patient was non-contributory. Diagnostic radiography revealed that the separated instrument extended along the root canal from the middle third to the apical third (Figure 1).

Figure 1. Preoperative radiograph showing separated instrument in 24.

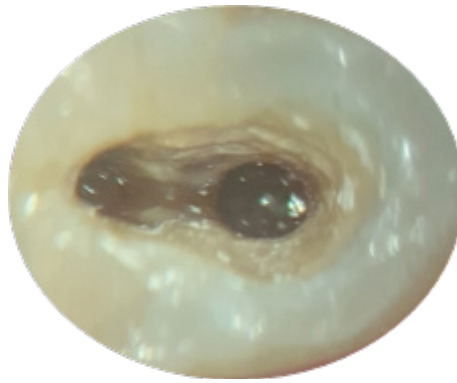
Figure 2. Separated file under microscope.

After flaring, the tip of the separated endodontic file (SEF) was visible under magnification and peripheral dentin was removed around the file tip in a counter-clockwise motion (Figure 2).

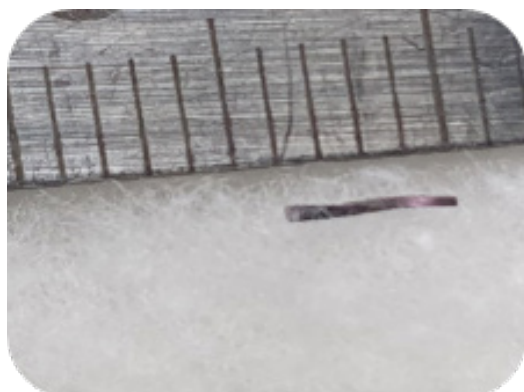
Figure 3. Separated endodontic file measuring 4mm.

fragment within the canal and SEF was flushed out with normal saline (Figure 3). The retrieved SEF was 4mm in length.

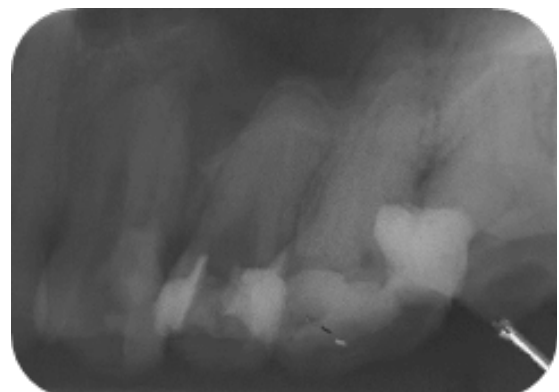
Figure 4. Radiograph after removal of SEF.

Intraoral periapical radiograph (IOPAR) confirmed the removal of SEF and calcium hydroxide as intracanal medicament was placed in the root canal followed by restoration with temporary filling material and scheduled for subsequent treatment at a later appointment (Figure 4).

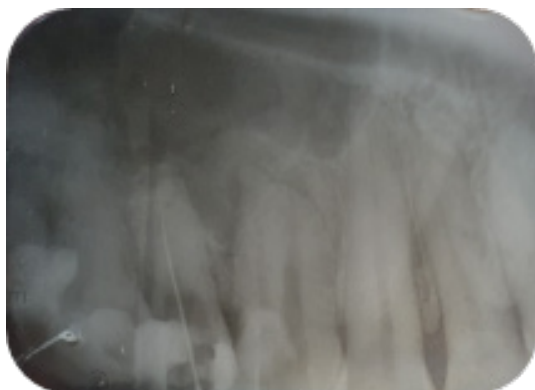
Figure 5. Working length radiograph till apex after opening the blocked canal.

was used while concurrently moving the file apically before its retrieval. Then, a #10 file was inserted into the canal in a watch-watching motion until the file got bonded to the dentin. Little watch-winding motion was done and the file retrieved followed by irrigation of canal with 1% NaOCl. Recapitulation of the canal was done with #8 file followed by irrigation and the cycle was repeated until apical terminus was reached. Once the patient felt some sensation in the periapex, apex locator was used to determine the working length and IOPAR was taken to confirm it (Figure 5).

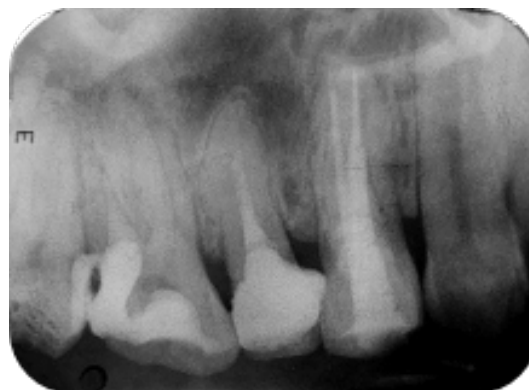
Figure 6. Post Obturation radiograph.

The canal was irrigated and tooth was restored with temporary restoration after placing cotton pellet and further treatment scheduled at a later appointment. In the subsequent appointment, cleaning and shaping were performed manually on both 24 and 25, and obturation was performed with gutta-percha using cold lateral compaction technique and access cavity was restored with resin composite (Figure 6).
