## Post-Earthquake Reconstruction in Kathmandu Valley: Progress and Challenges

### Abstract

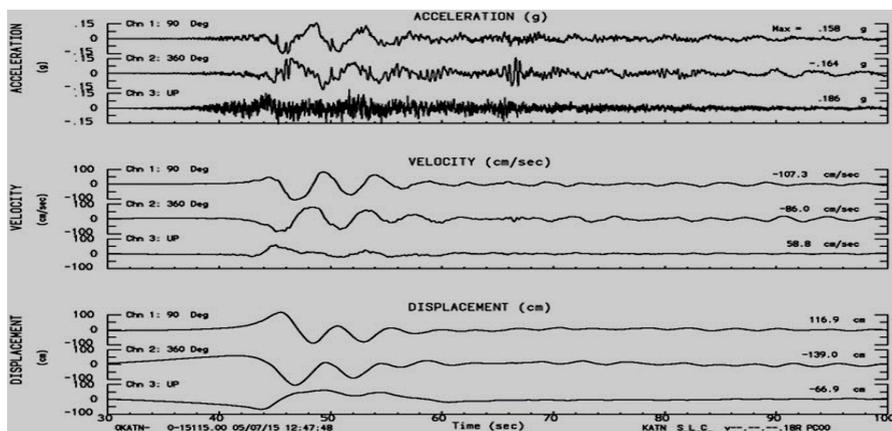
Figure 1: Kanti Path, Kathmandu, Nepal (USGS Sta KATNP), Record of April 25, 2015, 6:11:46.6 GMT (Filtering: Highpass at 02 Hz (50 sec) USGS Strong Motion Processing).

In the above figure, the displacement graph shows the ground's movement or the motion of a specific point on the Earth's surface over time, indicating how much the ground deviates from its initial position. It provides information about the amplitude and duration of the ground movement. The velocity graph, on the other hand, illustrates the speed at which the ground is oscillating during the earthquake, showing how fast the displacement is changing with time. It provides insights into the rate of movement. Lastly, the acceleration graph represents the rate of change of velocity or the acceleration of the ground motion, demonstrating how quickly the velocity is changing. It indicates the ground's acceleration and deceleration during the earthquake. Together, these graphs offer crucial data to analyze the intensity of loss and the potential impact of the earthquake on structures and the human population.

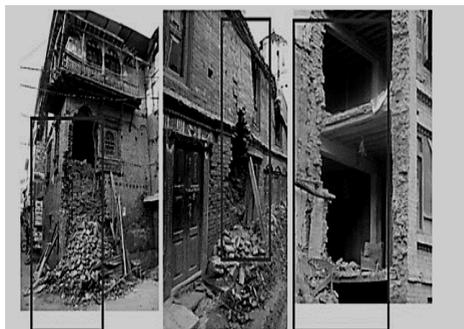
Figure 2: Out-of-plane collapse of facade wall seen in Kathmandu Valley (Varum et al., 2018)

Table 1. Most damaged structures were unreinforced and low-strength masonry due to their low strength and lack of guidelines in the past when they were constructed. RCC structures were also damaged due to poor workmanship and the use of cheap and poor construction materials. The most common types of failures observed in structures were return wall separation and overturning of façade, in-plane failure, out-plane failure, overturning, diaphragm movement, floor collapse, etc. Typical out-plane failure of the façade wall is shown in Figure 2. The condition of the reconstruction of private housing in Kathmandu Valley is shown in Figure 3 & 4.

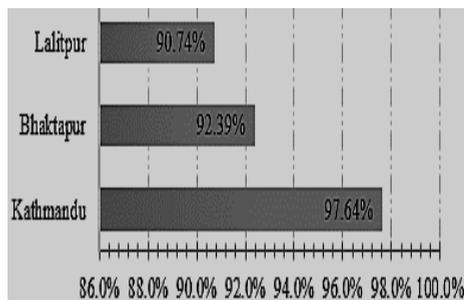
Figure 3: Progress of reconstruction of Private housing in Kathmandu Valley (NRA, 2021)

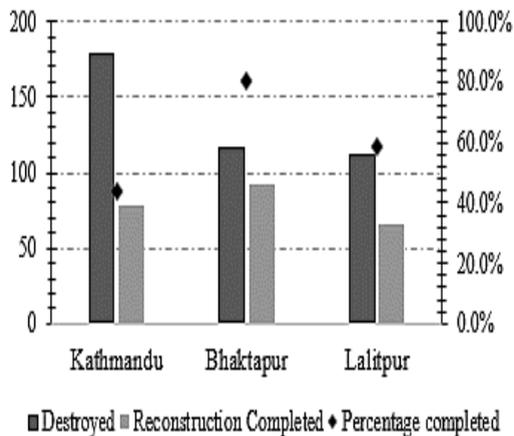
Figure 4: Progress of reconstruction of archeological structures in

### *Kathmandu valley (Sharma et al., 2018)*

During an earthquake, 920 archeological structures were damaged, out of which 170 belong to a world heritage site. The progress of the reconstruction of archeological structures is shown in Fig. 4. In Kathmandu Valley, 406 archeological structures were destroyed. In the Kathmandu district, out of 178 destroyed heritage, 78 have been reconstructed. In Bhaktapur district, 93 out of 116 have been reconstructed whereas in Lalitpur district, 66 out of 112 have been reconstructed.

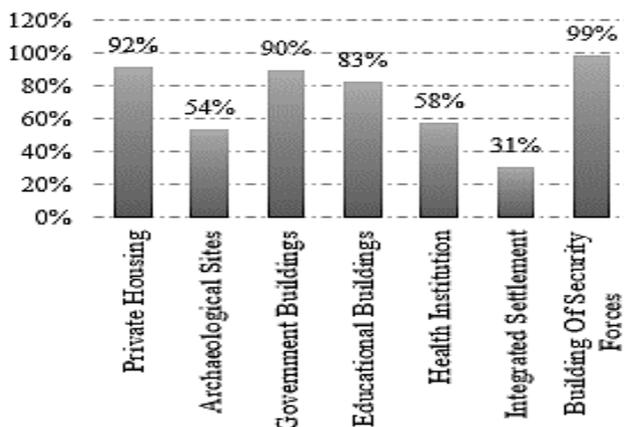
*Figure 5: Types of buildings and their reconstruction condition (RSS, 2021)*

The condition of reconstruction of different buildings in affected districts is represented in Fig. 5. The Total number of educational institutions that collapsed during the earthquake was 7,553 and 6,246 has been reconstructed. 1197 health institutions collapsed over which 698 have been reconstructed. 374 out of 415 government buildings have been reconstructed. 214 out of 216 buildings of security forces have been reconstructed. 493 out of 920 archaeological sites have been reconstructed.

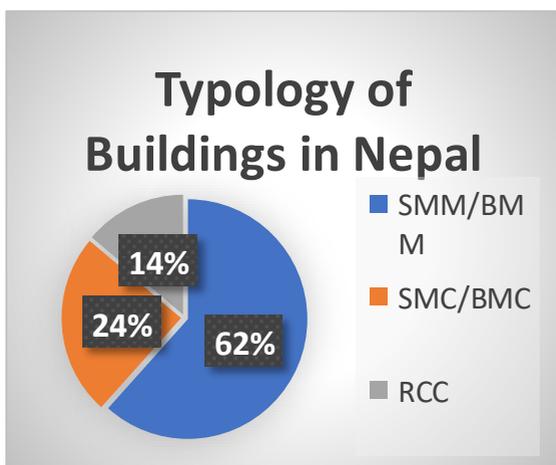
*Figure 6: Types of buildings in Nepal*

Based on the data presented in Figures 6, 7, 8, and 9, it is evident that the prevalent building materials in Nepal are brick or stone with mud masonry. However, within the valley, the proportion of SMM and BMM buildings is relatively lower, with Kathmandu showing the smallest proportion of such structures. Conversely, RCC structures dominate in Kathmandu, while Bhaktapur still maintains SMM and BMM buildings as the primary type, and in Lalitpur, the distribution of building typologies is more evenly balanced among the three types.

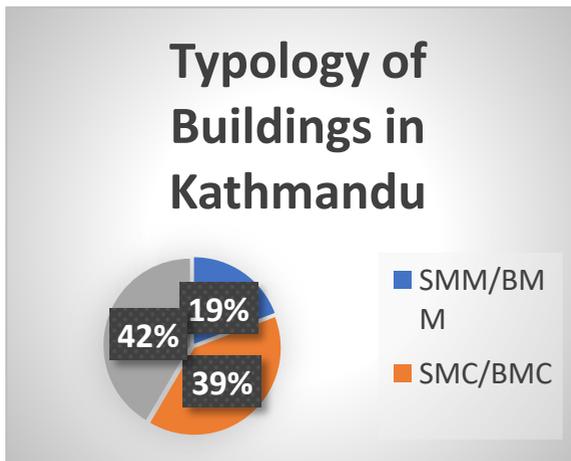
*Figure 7: Types of buildings in Kathmandu*

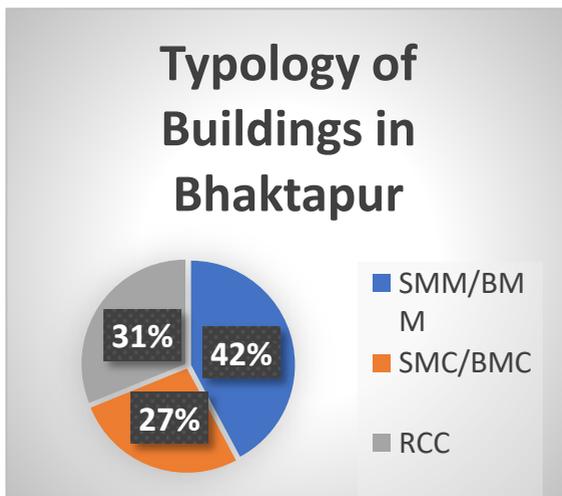
*Figure 8: Types of buildings in Bhaktapur*

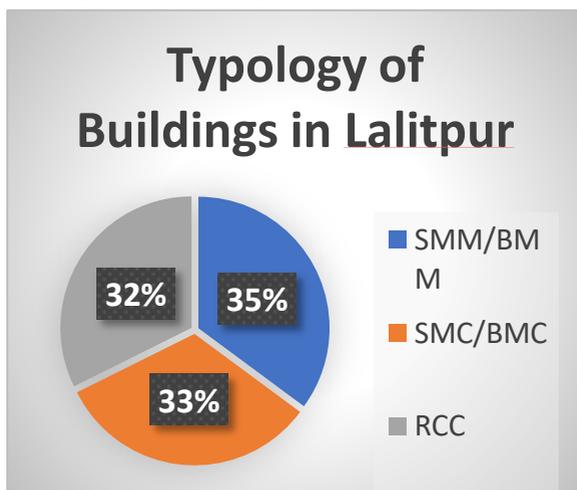
*Figure 9: Types of buildings in Lalitpur*

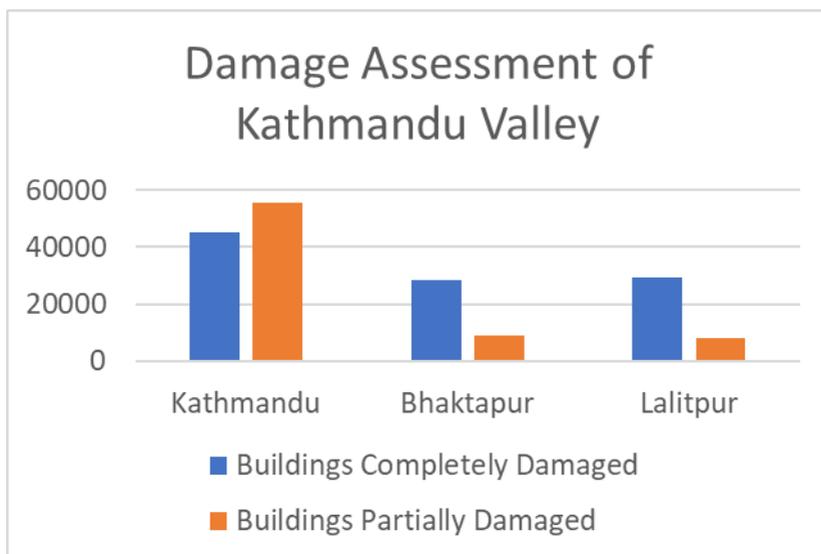
Figure 10. Damage assessment of Kathmandu Valley

According to the chart, Kathmandu exhibits the highest count of damaged buildings compared to the two other districts in the valley. However, an interesting distinction is observed in the types of damage, as Kathmandu has a greater number of partially damaged houses, whereas the other two districts have a higher proportion of completely damaged buildings and fewer partially damaged ones. This can be attributed to the fact that Kathmandu has a higher proportion of RCC buildings than Stone or Brick Masonry structures.

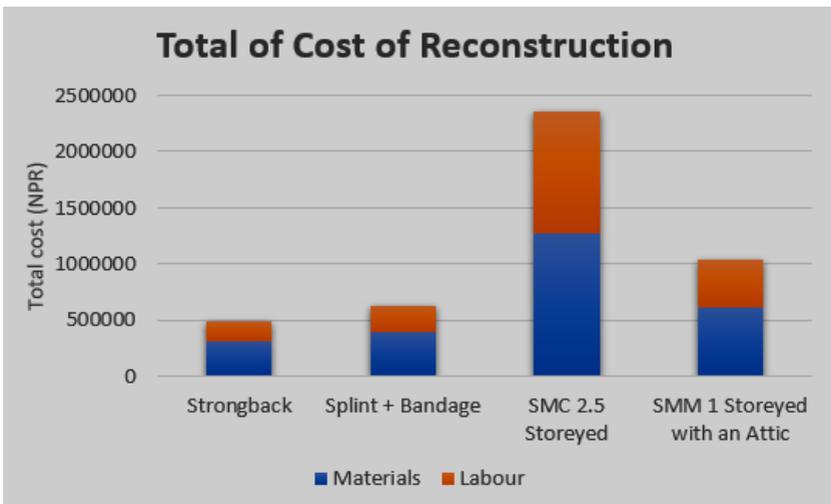
Figure 11: The Total Cost of Reconstruction

The analysis presented in Figures 11 and 12 demonstrates that retrofitting is a more cost-effective strategy for reconstruction. While building a new one-storeyed SMM (Semi-Mechanically Manufactured) structure with an attic might seem initially comparable in cost to retrofitting, the cost per square meter of living space in SMM buildings turns out to be significantly higher due to their limited capacity, resulting in inadequate living space. Moreover, among the various retrofitting methods, the Strong Back method proves to be more cost-effective than the Splint and Bandage method.

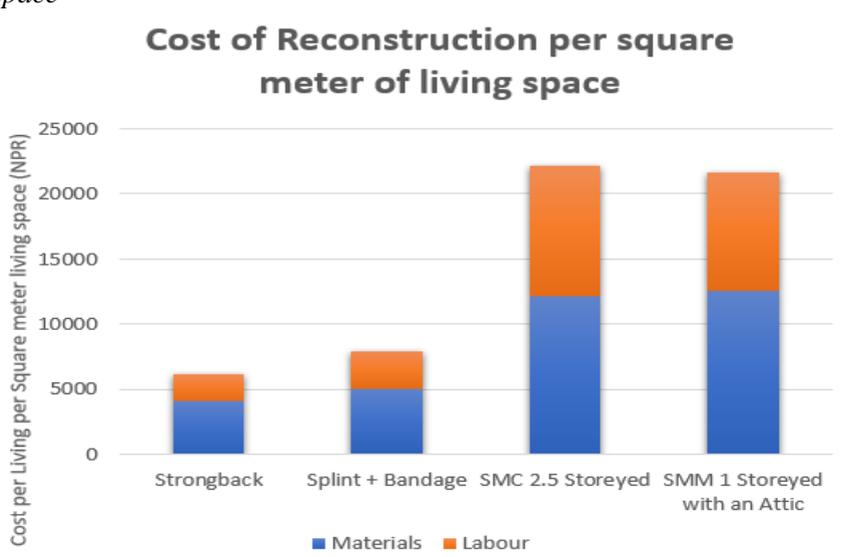
Figure 12: Cost of reconstruction per square meter of living space

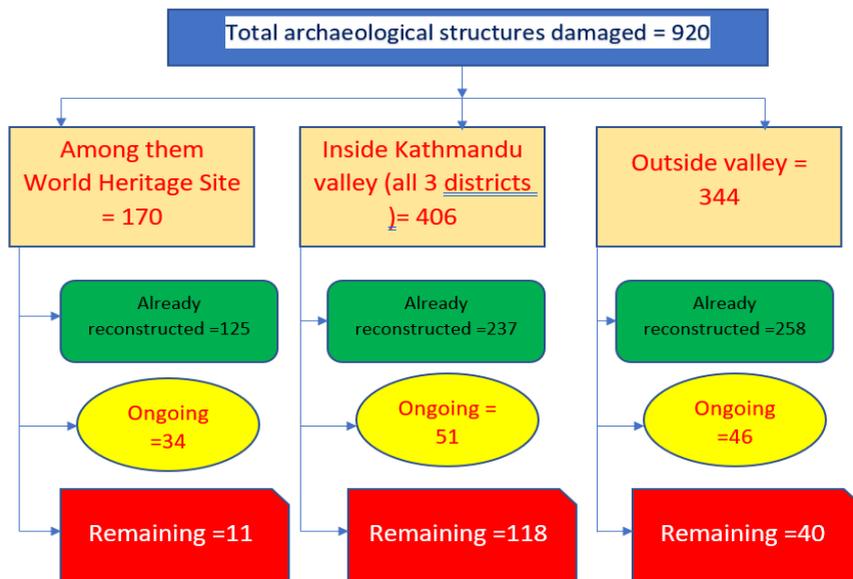
Figure 13: Heritage Damage and Reconstruction by Earthquake 2015

Following the 2015 Gorkha earthquake, there was substantial damage to cultural heritage sites, demanding a concerted effort towards reconstruction. This involved a systematic approach, including damage assessment, prioritization of restoration based on historical significance, and the involvement of experts to maintain authenticity. A comprehensive account of the Heritage Damage and Reconstruction process is depicted in Figure 13 below.

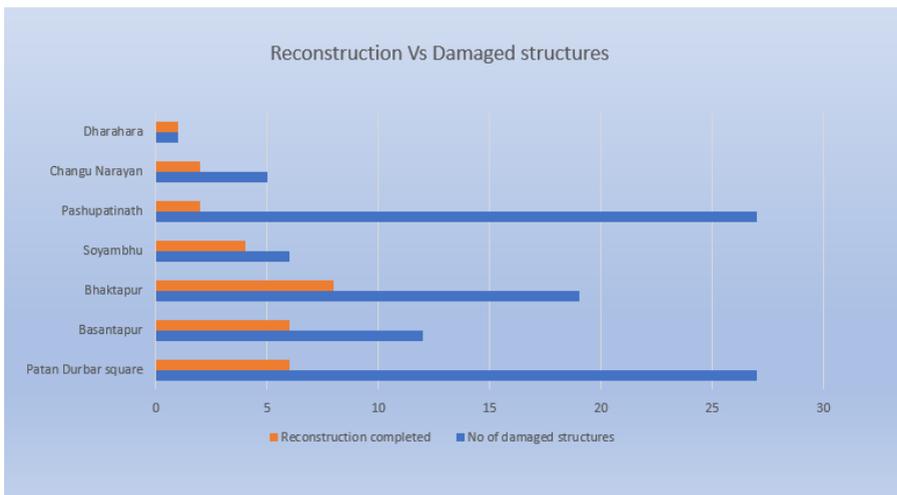
**Figure14:** *The status of reconstruction vs damaged structures*

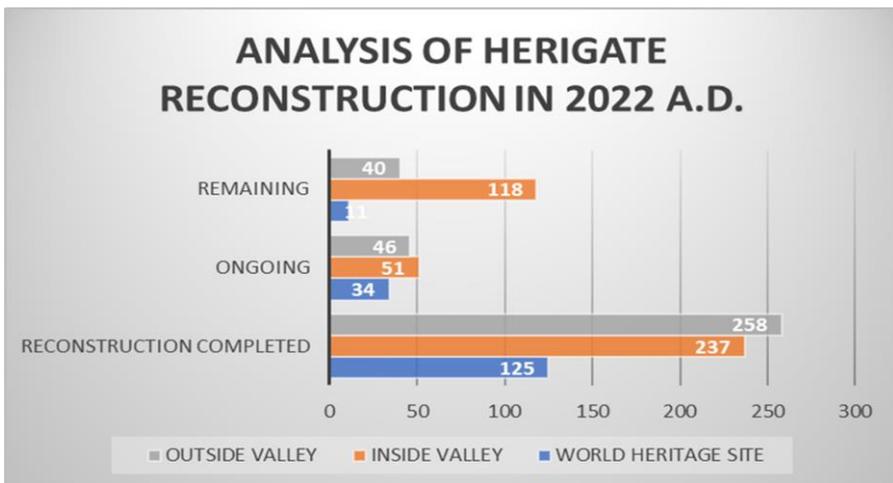
**Figure 15:** *Analysis of remaining, ongoing, and reconstructed heritates*

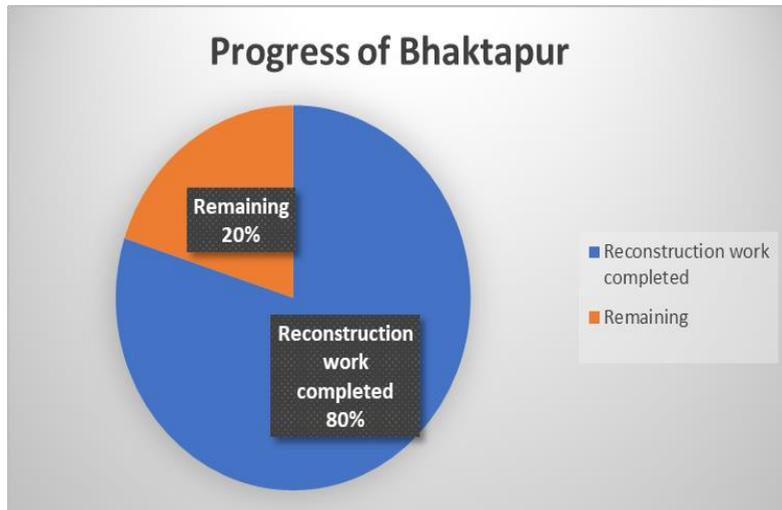
Figure 16: The status of reconstruction progress in Bhaktapur

As shown in Figure 16, as of 2020, the historic city of Bhaktapur had made significant progress in its restoration and reconstruction efforts, with an

impressive 80% of the work already completed. One of the remarkable aspects of this restoration process was the city's ability to maintain autonomy, as the Department of Archaeology was responsible for less than 10% of the restoration efforts on the numerous heritage sites. Instead, the majority of the fundraising and reconstruction endeavors were carried out through local cooperation, with the Bhaktapur municipality taking the lead in renovating a staggering 104 monuments and temples. An outstanding example of this collaborative effort was the restoration of the Nyatapola temple, which alone required a substantial investment of Rs. 3.5 million. Thanks to the generous donation of Rs. 1.5 million from the public, progress was made on this remarkable temple's restoration. Despite these significant achievements, the restoration process faced unforeseen challenges that led to delays in its completion, most notably the global COVID-19 pandemic that impacted various aspects of daily life, including construction activities and project timelines. Nevertheless, Bhaktapur's commitment to preserving its rich cultural heritage has persevered, and the community's collective efforts continue to propel the restoration project forward, ensuring the city's historical gems remain intact for generations to come.

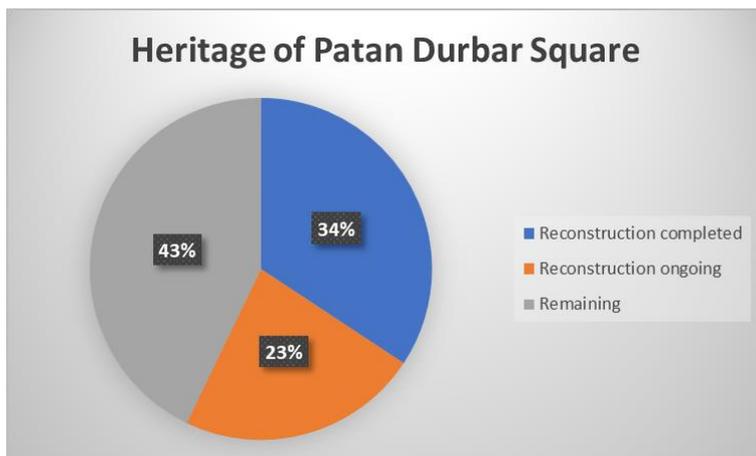
Figure 17: The status of reconstruction progress in Patan Durbar Square

In Patan Durbar Square, out of a total of 35 heritage that suffered varying degrees of damages, restoration works on 12 have been completed and 8 are undergoing reconstruction.

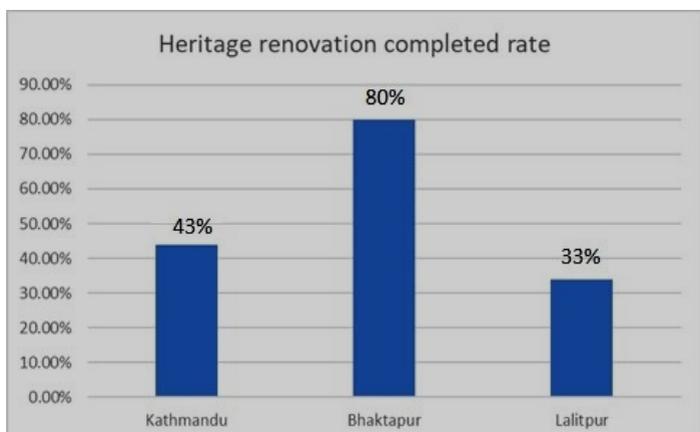
Figure 18: Comparison of Heritage renovation completed rate within Ktm Valley

Overall, in Heritage Reconstruction Bhaktapur district is leading with the highest number of completed reconstruction works after the earthquake.
