The Geographic Base

Geological Causes of Shrawan Danda and Siddhababa Landslides in the Northern Vicinity of Butwal City, Western Nepal

Gaurab Gyawali and Kabi Raj Paudyal*

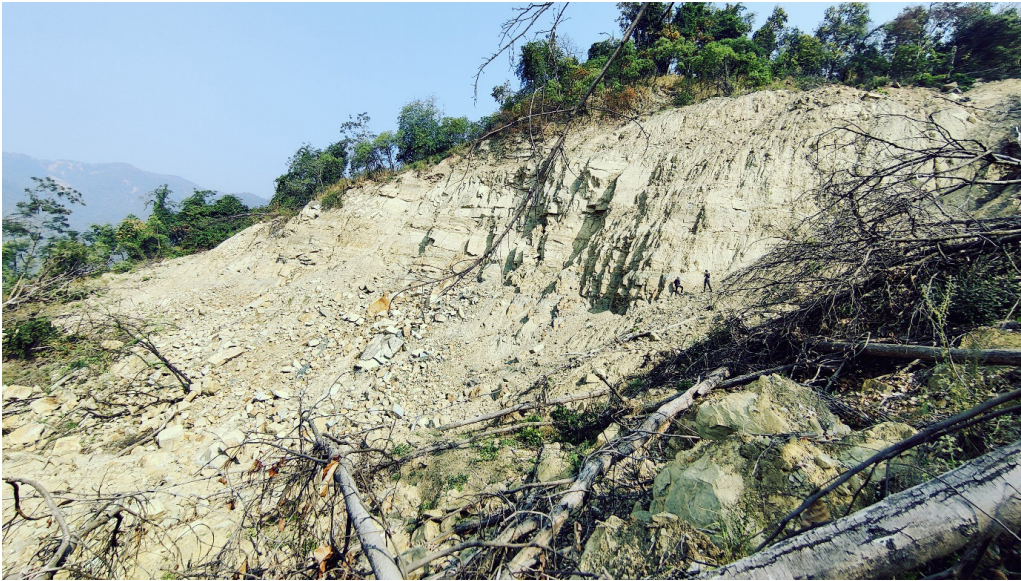
Precipitation: A deep layer of colluvium consisting of mud and sand-sized particles is observed all along the slope. The slope is stable throughout the year but mostly during heavy rainfall especially during monsoons, water enters easily into the soil and thus increases the pore water pressure resulting in debris flow in the settlement residing downwards (Figure 4).

Weak lithology: Through the fractured rock mass found at the crown of the landslide as well as the top of the hill, water enters easily and drains out through

different areas containing the loose colluvial soil downwards resulting in the debris flow (Figure 4).

Figure 4: Crown of Shrawan Danda Landslide (GPS: 27°42'55.77" and 83°28'31.30")

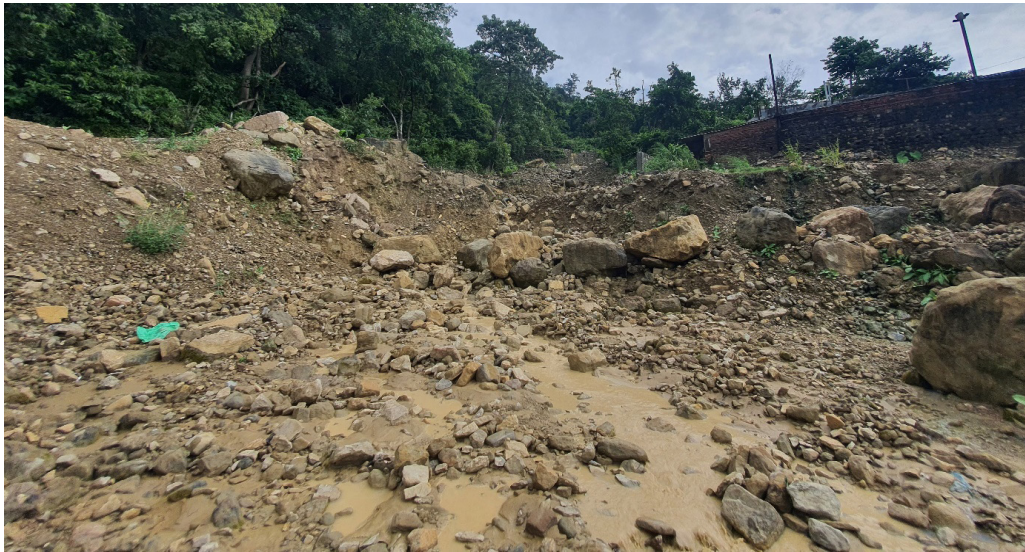
Human activities: Human activities such as deforestation, poor drainage, haphazard use of land, toe-cutting for unplanned settlement and construction of roads, and unscientific landslide control methods have also triggered this landslide (Figure5).

Figure 5: Debris flow in the existing water channel at the base of Shrrawan Danda (GPS: 27°42'44.71" and 83°28'15.44")

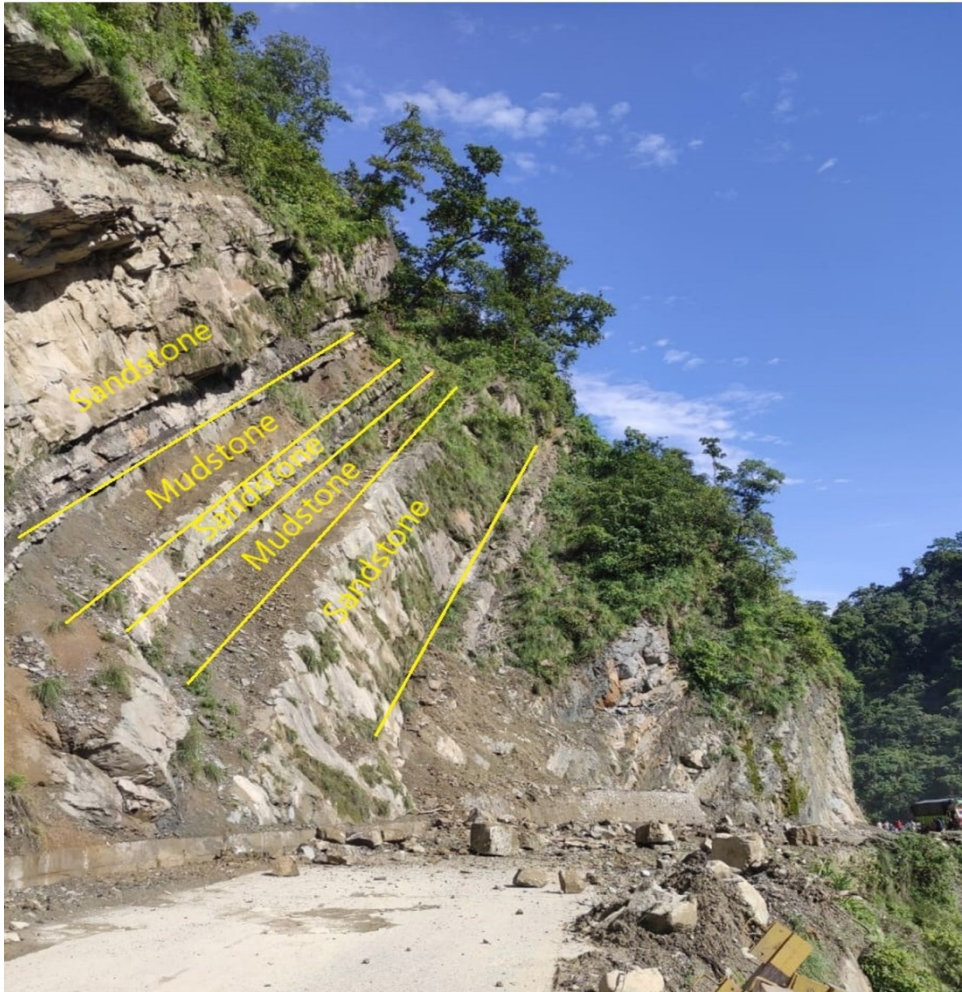
Rockfall: Rockfall refers to the movement of fragmented rock blocks along a vertical or nearly vertical cliff face, primarily triggered by intersecting discontinuities within the rock mass. In the Siddhababa section, the rock mass is characterized by three distinct joint sets and a prominent bedding plane. The alignment of these joint sets with the road on a steep slope is the main factor contributing to rockfall events (Figure 6). The various causes of rockfall include:

Presence of contrasting lithology: The rainwater easily erodes the mudstone/siltstone lying in between massive sandstone beds, causing loss of support for the fractured sandstone (Figure 6). Hence, those fractured pieces of sandstone start to fall in the steep slope as rockfall.

Figure 6: Alternating bands of sandstone and mudstone along with rockfall observed at the section of Siddhartha highway near Siddhababa Temple (GPS: 27°43'58.82" and 83°28'5.22")
