Engineering Geological and Geotechnical Approaches for the Construction of Powerhouse Cavern of Tehri Pumped Storage Plant (1000 MW) - A Case Study

Rajeev Prasad and Nishith Sharma

Keywords: Powerhouse, Geological and Geotechnical investigation, Sheared Phyllite, Excavation Sequence, Tehri PSP, India

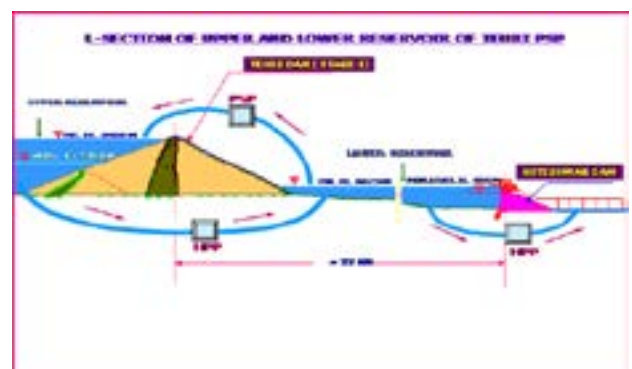
Figure 2: L Section of Upper and Lower Reservoir of Tehri Pumped Storage Plant

Tehri Pumped Storage Plant, comprising four reversible pump turbines units of 250 MW each, involves construction of an Underground Machine Hall on the left bank of river Bhagirathi. The main feature of the Project is the large variation in head, of about 90 m, during the maximum and minimum discharge period, under which the reversible units shall operate. The operation of Tehri Pumped Storage Plant is based on the concept of recycling of water discharge between upper reservoirs to lower reservoir. Tehri Dam reservoir shall function as the upper reservoir and Koteshwar reservoir as the lower balancing reservoir (Figure 2).

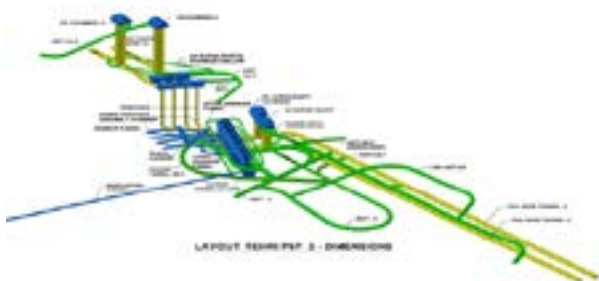
Figure 3: Three-dimension view of Powerhouse complex of Tehri Pumped Storage Plant

a clear picture as shown in Figure 3. This article deals with the specific type of underground cavern design and construction problems, namely stability assessment in Sheared Phyllite zone encountered at the end portion of central drift portion of powerhouse, as well as reorientation of structures like service bay machine hall and location of units.

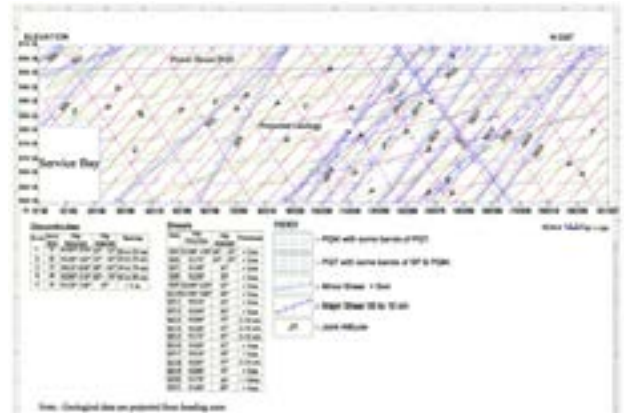
Figure 4: Geological Section along already excavated Central drift of Powerhouse

Geological mapping carried out at the central drift of powerhouse indicates the real picture of lithology and its litho contact. It has also been observed that the cavern was pierced through thinly Foliated Phyllitic Quartzite (PQT), Massive Phyllitic Quartzite (PQM) and Sheared Phyllite (SP) medium to fine grained, grey, silicified at places. The dip of primary bedding and foliation were recorded to be N180° - 220° / 45° - 55° and N130° - 170° / 35° - 45° respectively. Mainly NE and NW dipping joints other than bedding/foliation joints were recorded in the entire area as shown in Geological section (Figure 4).

Based on Geological section, it has been observed that PQT + SP encountered at the end portion of central drift may possess the difficulties to establish the cavern. To finalize the dimensions and orientation, a detailed Geotechnical investigation was carried out to obtain Geotechnical properties and behavior of rock mass.

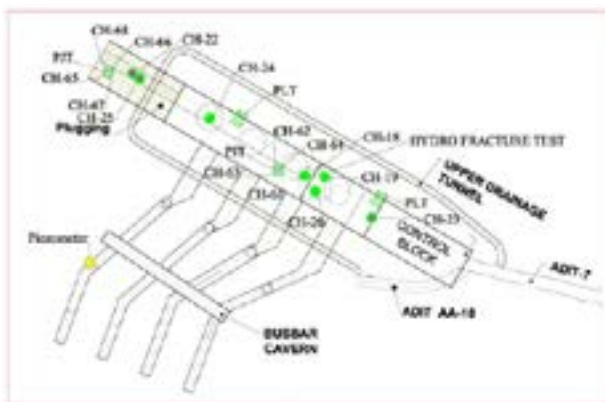
Figure 5: Location of geotechnical investigations in Powerhouse

tests were also conducted to supplement the findings of in-situ tests. Location of geotechnical investigations are shown in Figure 5.

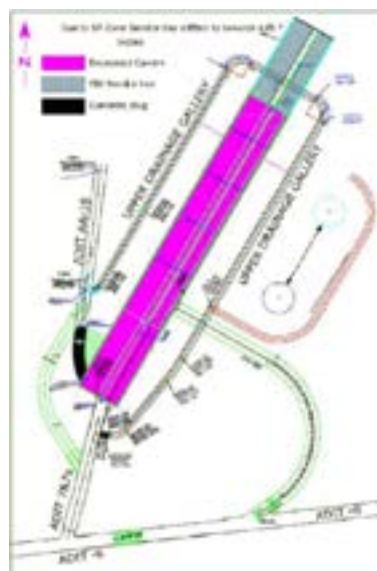
Figure 6: Location of new position of the Powerhouse

On the basis of results obtained from geotechnical investigations, it has been decided that the position of service bay will be in between the machine hall & control bay (i.e. similar to the Tehri HPP). Because of above said test report, the service bay was shifted by 53m towards Adit 7. The Machine Hall center line and the water conductor system remained intact. Access tunnel to service bay (AA8) & ventilation tunnel were realigned to be open in powerhouse at a new location shown in Figure 6.

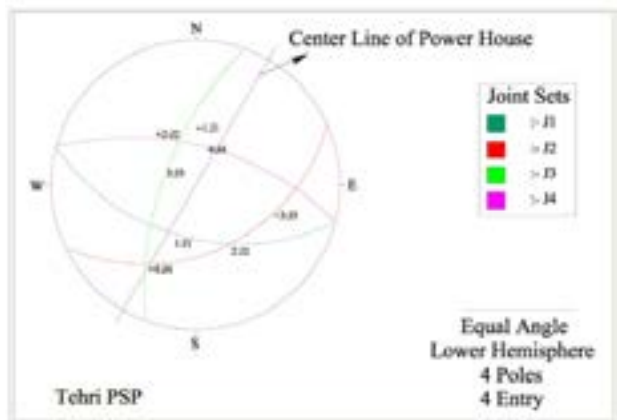
Figure 7: Lower Hemispheric Projection of Joint sets at Powerhouse

rough in nature. Kinematics study was also done for all encountered joints (Figure 7).

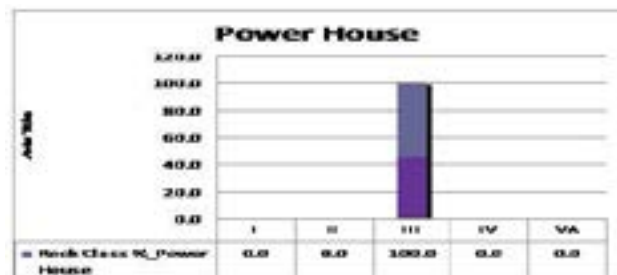
Figure 8: Percentage of Rock Class encountered during excavation of Powerhouse

Dry to damp conditions were observed during excavation. Following joint sets were encountered during the excavation of central drift and side slashing. RQD ranges from 50-70% and RMR value ranges in between 46 to 52 as mentioned in graphical representation of Figure 8.

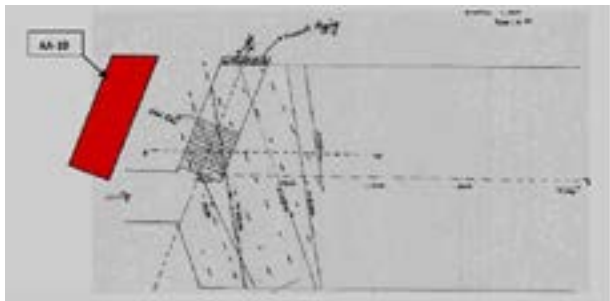
Figure 10: Crossing of Adit AA-10 within cavern layout

The southern end wall of powerhouse has been shifted by about 53.0m due to existence of relatively large shear zone which crosses the cavern gallery at the northern end wall region. Due to this shifting AA-10 (Approach adit to Bus bar) now lying within the cavern top heading (refer Figure 10).

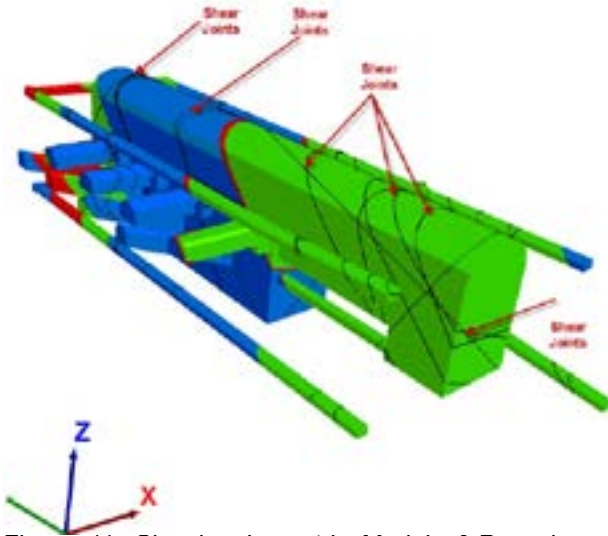
Figure 11: Showing Isometric Model of Powerhouse Cavern and its associated tunnels

Geological model of Powerhouse Cavern was initially established based on 3D Geological logs of Powerhouse and its associated tunnels as well as core logs of Powerhouse executed during investigation. As per 3D Geological log of the overt portion of Powerhouse cavern, the litho variants of PQM, PQT and SP encountered. 88% length of cavern belongs to PQM+PQT rock mass however 8% length belongs to PQM and PQT and rest 4% comes under PQT and SP. PQT and SP represents thinly foliated Phyllitic Quartzite with slightly to moderate weathered and sheared in nature. 50% to 70% RQD, slightly rough & rough surfaces with soft to hard filling. These properties of rock mass represent fair media for excavation.

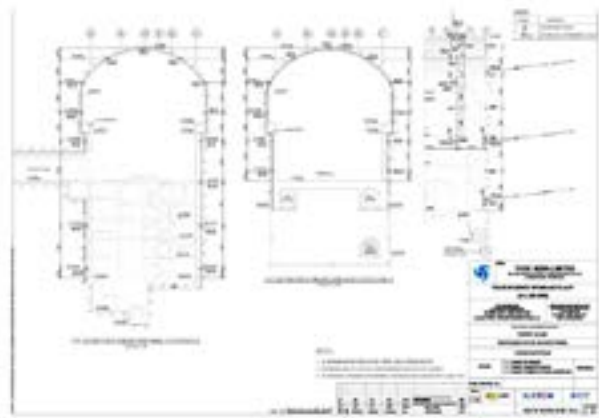
Figure 12: Showing location for the monitoring instruments in Powerhouse Cavern

Multiple structures are under excavation at Tehri PSP along with several adits and tunnels. The structural behaviors of these openings have been monitored by instruments installed at respective location along the length and cross section (Figure 12).

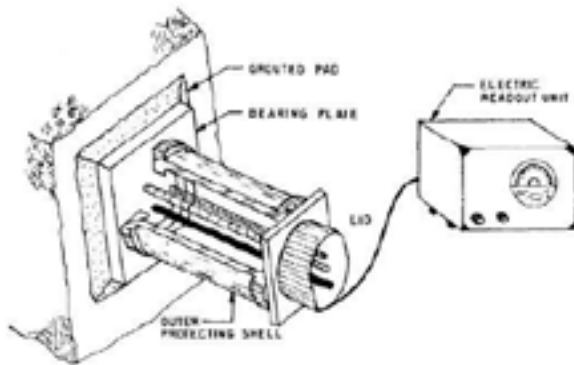
Figure 14: Collar Head of MPBX at the excavated surface

The bore hole extensometer is an instrument used for monitoring movement of rock mass at several points around underground openings, rock slopes and other excavations. The instruments consists of anchors embedded in a bore hole at different depths, movement transferring elements which are fixed to the anchors and extend up to a reference head connected to bore hole collar. Each movement transferring element is covered by rigid PVC pipe, so that these elements are free to transfer the displacements of rock mass from anchor position to bore hole position. The relative displacement between the collar and movement transferring elements is measured by means of an electrical read out unit. The relative displacement is also monitored through a computerized data acquisition system for continuous logging with respect to time. The external face of collar head is used as the reference surface as shown in Figure 14.

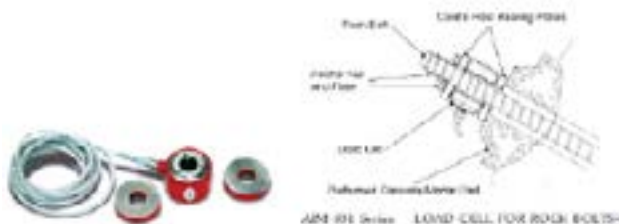
Figure 15: Load cell and its typical arrangement with Rock bolt

The vibrating wire load cell comprises of a set of three or six vibrating wire gauges mounted parallel to each other, equally spaced in a ring in an alloy steel cylinder. The method of construction results in a very robust instrument suitable for use where high performance, longevity and a mechanical strength are important. A photograph and typical arrangement of load cells installed along with rock bolts are shown in Figure 15.

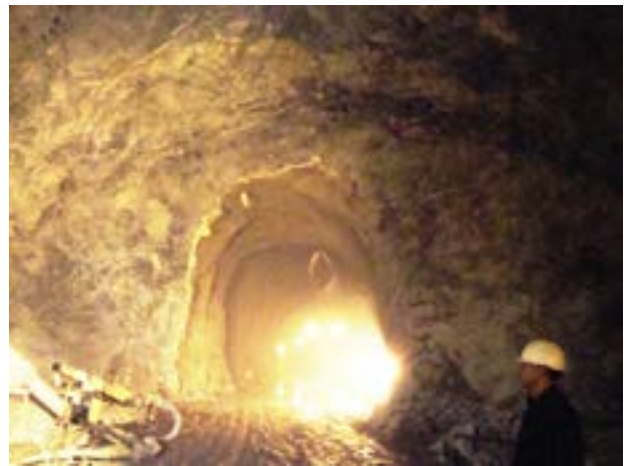
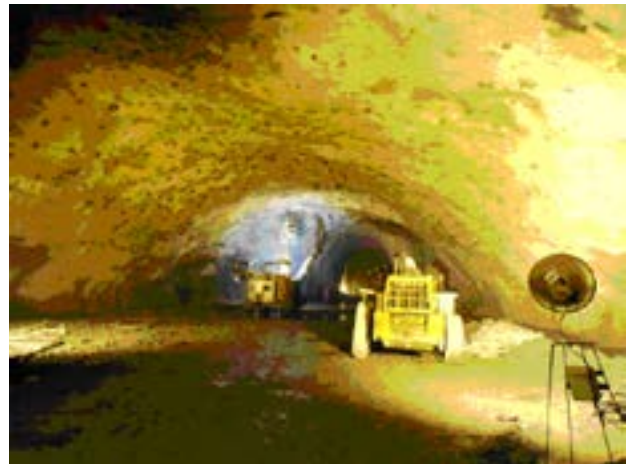
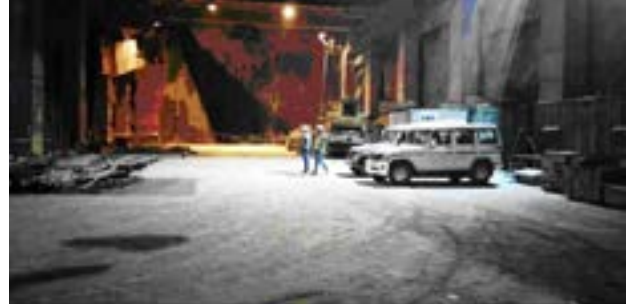
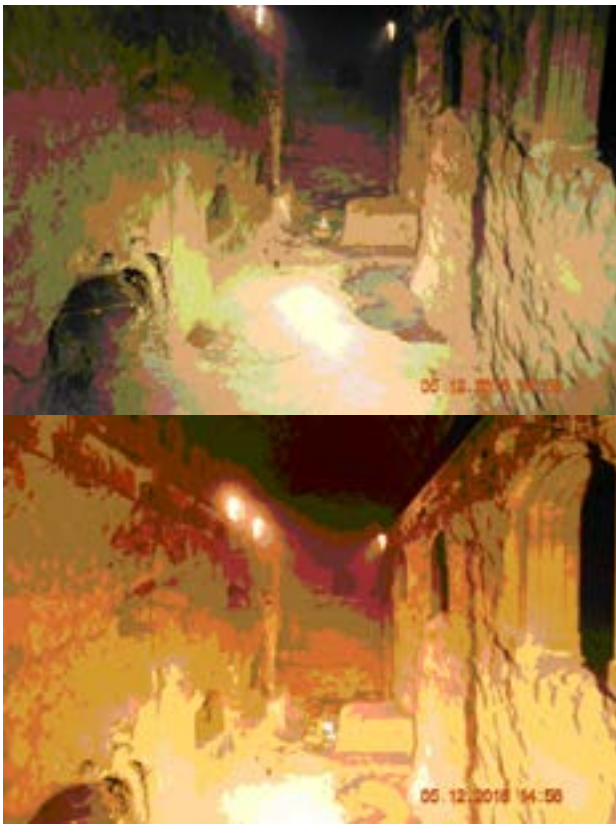
Figure 16: (A) Showing Pilot Tunnel with Slashing in Powerhouse, (B) Excavation of Heading with support, (C) Service Bay area of Powerhouse, (D & E) Machine Hall
