Stabilization Measure Adopted for Controlling Landslide: A Case Study of Upper Mai Hydroelectric Project

Kanchan Chaulagai

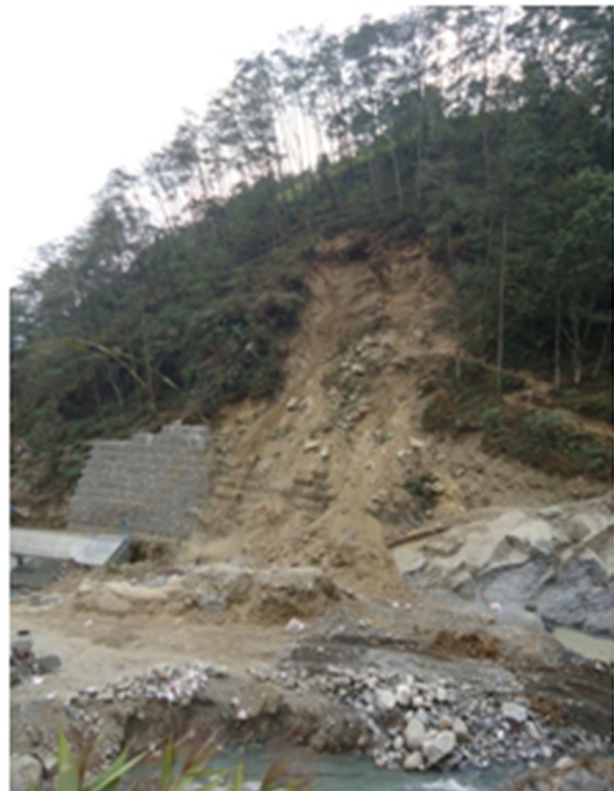
toe of the slope for the construction of settling basin. If the slope has to be cut, retaining structures should be constructed for the stability. As structure lies near the hill slope, second recommendation has to be adopted. The rock mass encounter at the base of settling basing near the toe of hill slope was very hard hence PC 200 excavator with breaker was used for chiseling the rock mass. The breaker was not sufficient for the chiseling because of very hard rock mass so continuous blasting was carried out to get the desire depth for the base part construction of settling basin.

Application of gabion wall as a retaining structure was insufficient for the protection of hill slope after its toe cutting. Hence, the slide occurred (Photo.1) causing huge damage in the structure near its toe area, ultimately hampering in project completion time and cost. Since this paper focuses on the protection work for its stability; it will not discuss in detail the possible causes of the landslide.

Photo 1: Landslide at Headwork's Area.

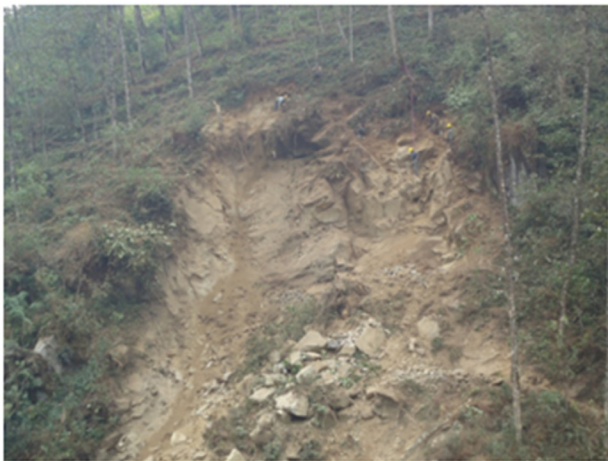
Removal of unstable soil or rock mass at the upper part of the slide is the beginning/basic procedure for the stabilization of the slide. In UMHEP, all the loose soils, detached blocks located at the upper part of the slide were removed to reduce the load and shear force (Photo 2). Removing of unstable materials was continued from top to the bottom of the slide. During the removal process fractured, cracked rock mass was chiseled and gradient of the slope was maintained to standard slope gradient.

Photo 2: Removing loose material from top of landslide

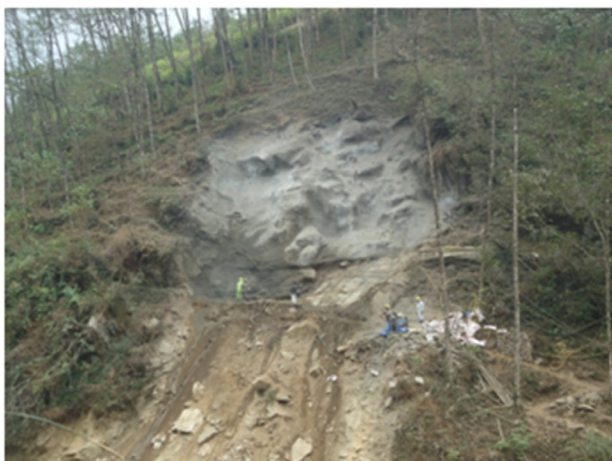
Rock mass condition of the slide area was not so good, it was very loose, open jointed so Mesh reinforced shotcrete was adopted for stabilizing slopes (Photo 3). Weld mesh made from 4 mm diameter wire welded into a 100 mm x 100 mm grid was used. Since, it is strong enough and the sheets are light enough to handle. Weld mesh was tightly pinned against the rock face and anchored with rock bolts. Before applying shotcrete to the surface, the work area was sprayed with an air-water jet to remove loose rock and dust and then later plain shotcrete was applied over it. The final stabilization of the slide is shown in Photo 4.

Photo 3: Application of shotcrete on slope

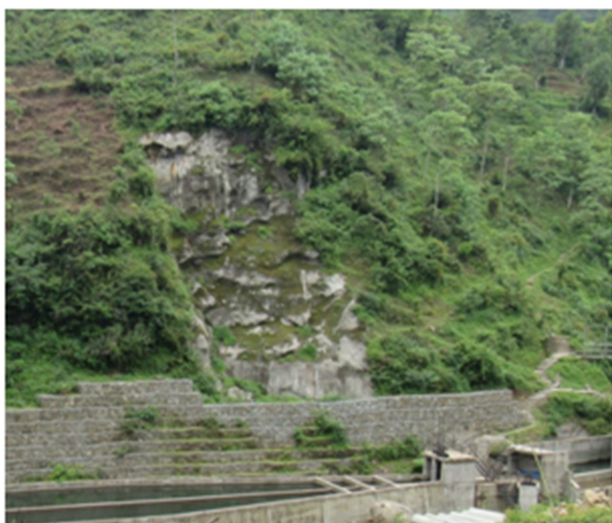
Photo 4: Stabilization of slide
