Geological and Geotechnical Challenges Faced during Excavation of the Underground Powerhouse and Head Race Tunnel for Mangdechhu Project, Bhutan, India

Introduction

Engineering design of the powerhouse complex and salient features of HRT

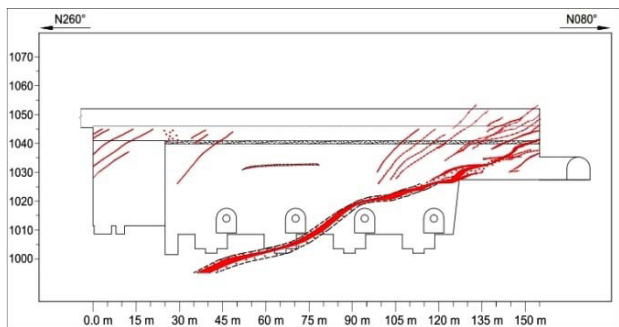
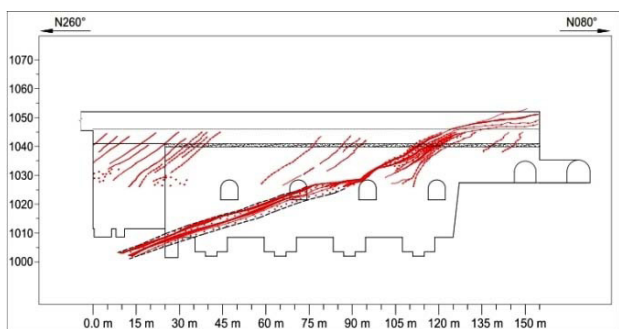
Figure 4. Geological section showing disposition of shear zone along (a) upstream wall (b) downstream wall of power house cavern (c) upstream wall (d) downstream wall of transformer hall cavern (e) across the caverns.

During the excavation of the central gullets, a shear zone of 1.5 to 2 m thickness with associated fracture zone of 2 to 6 m thickness was encountered between RD 125 to 155 m of machine hall and between RD 70 to 90 m of transformer hall caverns. The attitude of the shear zone was N30°E–S30°W dipping 10 to 24° due N60°W. The disposition of the shear was cutting along the walls of the caverns and also the rock pillar between them (Figure 4).

The presence of shear/fractured zone cutting along and across both the caverns was expected to have the following implications during excavation:

1. Instability of the crown above the service bay between RD 105 to 155 m in machine hall cavern and between RD 70 to 110 m in transformer hall cavern.
2. Differential settlements in the crane beams.
3. Instability of both upstream and downstream walls of the caverns
4. Instability of the rock column between the two caverns corresponding to the area above and between the bus ducts.
5. Instability of the bus ducts opening and rock pillar between them.

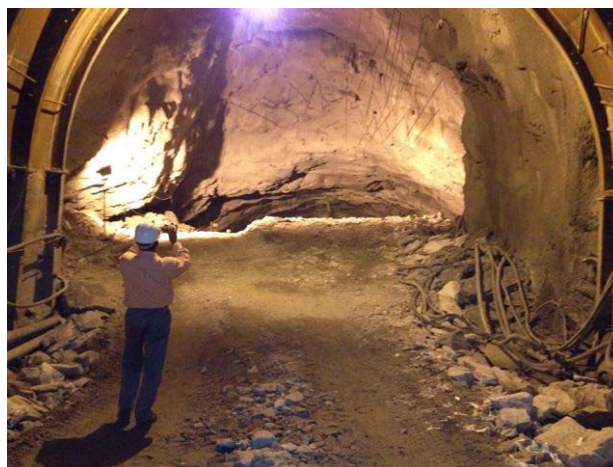
Figure 5. Photograph showing (a) cavity formed by loose falls (b) Rock mass condition of the cavity zone.

Two loose falls occurred between RD 0 to 30 m after widening of the central gullet resulting in formation of 10.5 m high cavity. First loose fall occurred between RD 0 to 12 m, extending 6m towards upstream side and 10 m towards downstream side. The height of the cavity formed due to loose fall was about 5 m. Second loose fall occurred between RD 2 to 30 m. This loose fall extended the height of previous cavity to 10.5 m (Figure 5).

Assessment of the geological conditions along cavity area revealed presence of two shear seams and fractured rock horizons about 2 m above the periphery of the crown. Further low cover zone between the crown of the cavern and overlying drift with distressed intervening rock mass with a possibility of yield zone of both the excavations overlapping each other and inadequate support system, allowed the radial loosening to encroach deeper into the crown. Encountering of shear zone and formation of cavity induced fear psychosis among the workers who refused to continue working in the caverns. An additional access to the cavern was provided by excavating a glory hole escape way above the main access tunnel, to eliminate their fear psychosis of getting trapped into the cavern in an event of any other loose fall.

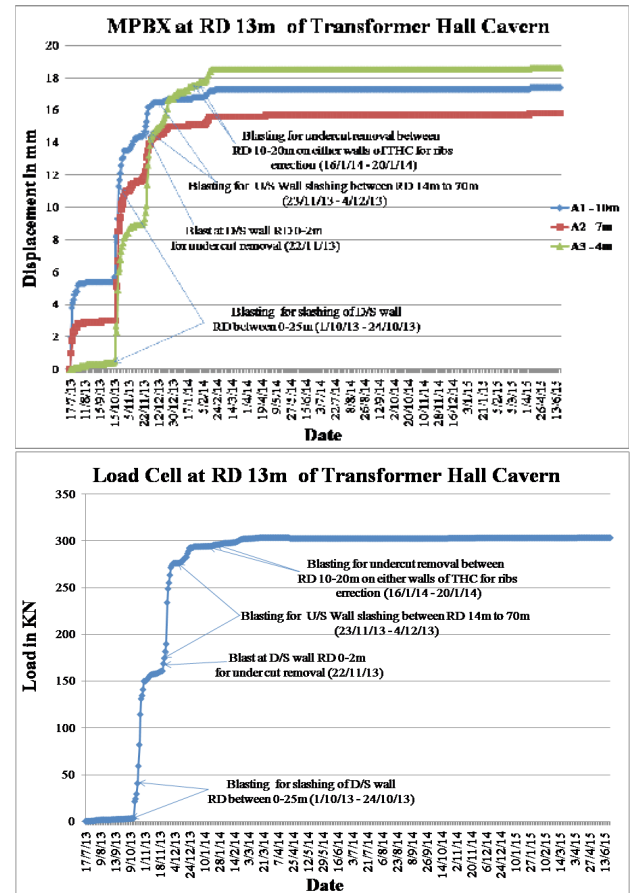
Figure 6. (a) Displacement v/s time graph of MPBX (b) Load v/s time graph of Load Cell at RD 13 m of transformer hall cavern.

During widening of the central gullet of transformer hall cavern, sharp rise in deformation and stress were recorded by instruments installed at RD 13 m. Total increase in displacement and load observed during widening was 18.1 mm and 290.7 KN respectively. The rise in load almost reached the 60% of the ultimate load bearing capacity of the installed support system. In view of continuous and sharp rise in deformation and stress, chances of roof collapse were high. To avoid any loose fall and formation of cavity widening of the cavern was cautiously undertaken by controlled and low intensity blasting. To arrest deformations and stresses steel rib support was also provided. After erection of the steel rib support comprising of ISMB 350 steel ribs at a spacing 0.5 m, the rise in deformation and load/stress ceased (Figure 6 a & b), indicating the stability of the crown after providing rigid support (Mishra et al., 2015a).

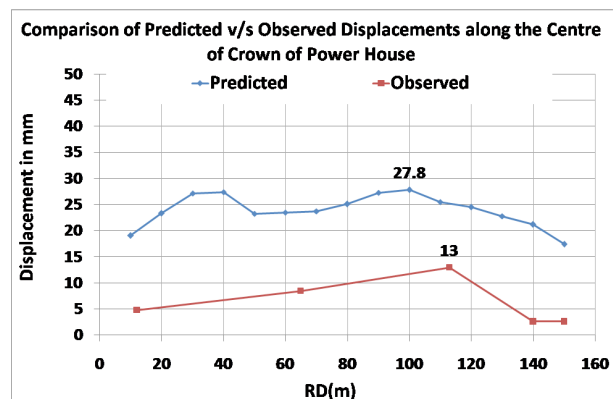
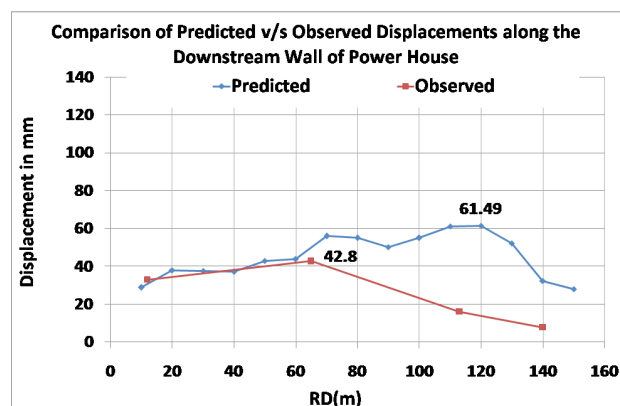
Figure 9. Comparison of anticipated and observed deformations along (a) Crown (b) Upstream wall (c) Downstream wall of machine hall cavern.

and survey target points. A total of 261 instruments (43 MPBX, 28 SPBX, 58 load cells, 8 survey targets and 124 TCP) were installed in the entire power house complex. The readings were recorded and analyzed on daily basis. The observed displacements were regularly compared with the anticipated deformations as obtained from numerical analysis. The deformations recorded at site during excavation were much less than those anticipated from 3-DEC numerical modeling analysis. The maximum deformation anticipated along the crown in machine hall cavern was 27.8 mm, while actual observed maximum deformations along crown was 13 mm only. Similarly, maximum anticipated deformations along upstream and downstream walls were 78.69 and 61.49 mm respectively against which only 27.4 and 42.8 mm of deformation was recorded along upstream and downstream walls, respectively (Figure 9a, b & c).

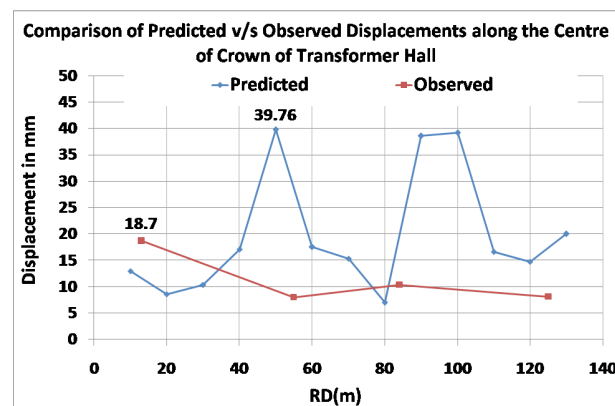
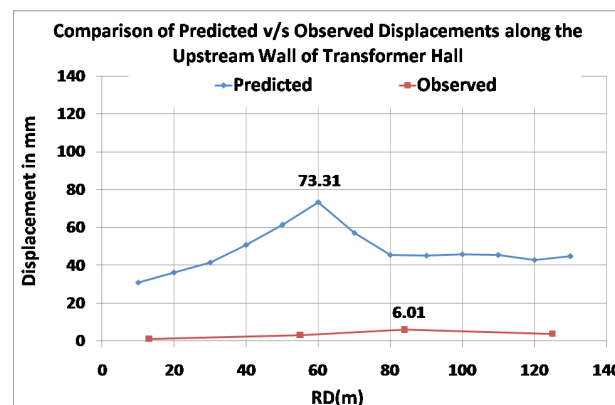
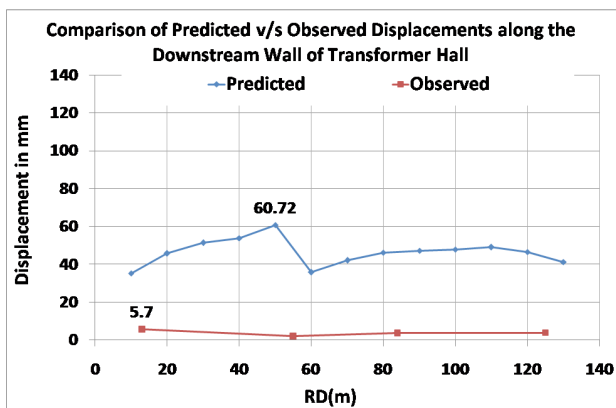
Figure 10. Comparison of anticipated and observed deformations along (a) Crown (b) Upstream wall (c) Downstream wall of transformer hall cavern.

Along the crown in transformer hall maximum deformations of 39.76 was anticipated of which only 18.7 mm of deformation was observed during excavation. Along upstream and downstream walls of transformer hall cavern maximum deformation recorded was 6.01 and 5.7 mm respectively against anticipated deformation of 73.31 and 60.72 mm respectively (Figure 10 a, b & c).

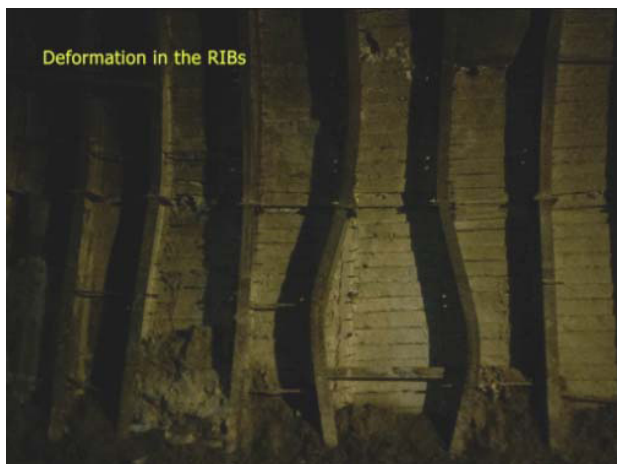
Figure 11. Photograph of buckled ribs in high

Tunnel squeezing/closure and mild rock bursts were observed between RD 4035 to 5950 m along a total tunnel length of 1915 m, covering part of Face-4 and 5 under high cover zone where super incumbent cover varied from 750 to 1000 m. As per DPR (2008), strong and massive granite, with good tunnelling conditions was anticipated along this high cover stretch. However, during excavation, granite was not encountered, and tunnel negotiated through mica schist, quartzitic schist and quartz biotite gneiss. Fragile/incompetent biotite schist was encountered along the stretch being excavated through Face-4, while comparatively competent quartzitic schist and gneiss were encountered along Face-5. High vertical stresses along Face-4 induced tunnel squeezing/closure and buckling of the steel ribs (Figure 11).

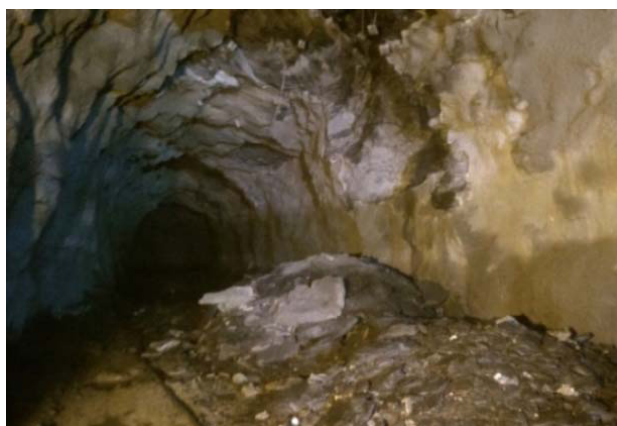
Figure 12. Post excavation dilation resulting in slabbing

Along Face-5 in high cover zone mild rock bursts and post excavation slabbing due to dilation of rock mass under high stress with crown failure up to 1.5 m depth were observed (Figure 12). The most affected stretch of HRT where tunnel closure was observed lied between RD 1196 to 1428 m of Face-4, where convergence of more than 100 mm was generally observed, with a maximum convergence of 562 mm recorded at RD 1358 m. The tunnel closure observed along this stretch is shown in Figure 13.

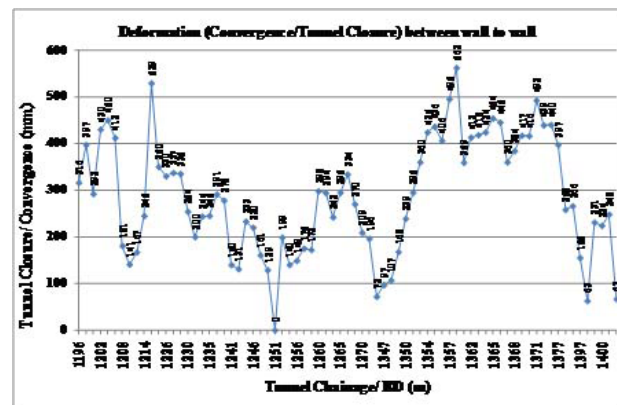
Figure 13. Graph showing convergence (wall to wall) along Face-4 (RD 1196 to 1428 m)

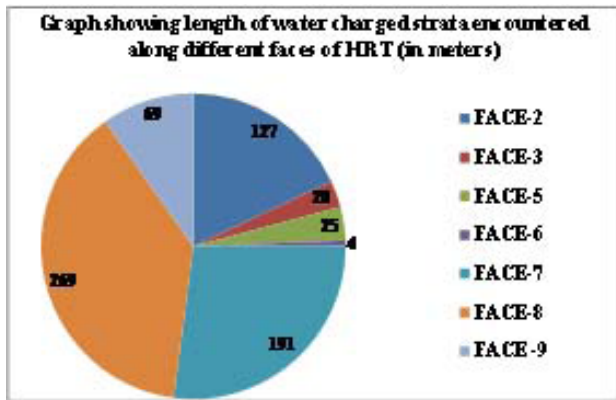
Figure 14. Graph showing length of water charged strata along various faces

HRT, ground water with ingress of more than 100 liters/minute was intercepted along Face-8, 7 and 2, with some intermittent stretches along Face-3, 5, 7 and 9 (Figure 14 and 15). Total stretch of water charged strata was 705 m.

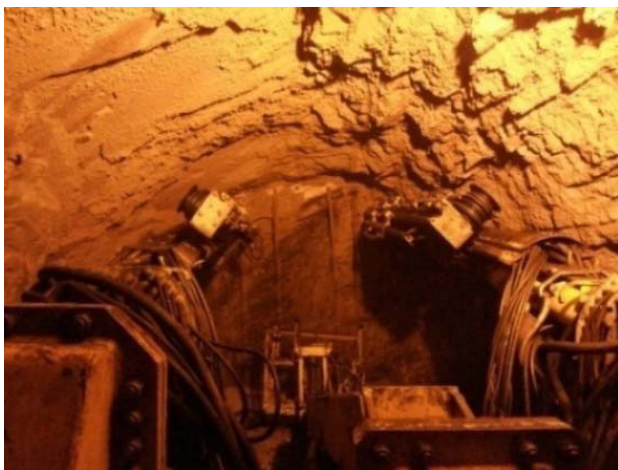
Figure 15. Photograph showing ingress of water from drainage holes drilled prior to face advancement

The methodology adopted to negotiate through these water-charged reaches comprised of diverting water ahead of face by drilling 10 to 15 m long drainage holes of 76 mm diameter, inclined at an angle of 30 to 45° and radiating 15 to 200 m outwards from the face (Figure 16), followed by normal excavation methodology as per rock class. Timely support as per rock class was provided to ensure tunnel stability. Additional drainage holes were also drilled after providing primary and secondary support to ensure free flow of water from the supported reach to avoid accumulation of water and building up of pore water pressure behind the supported tunnel span.

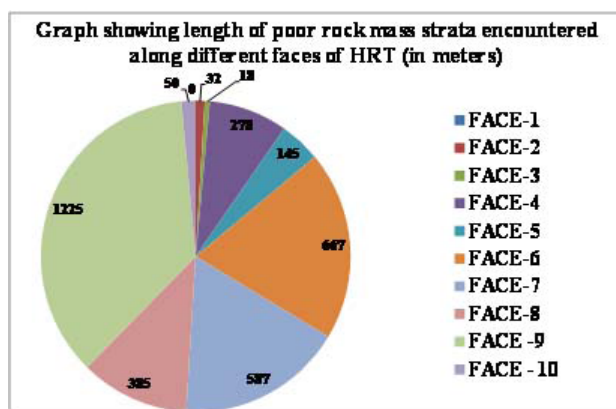
Figure 19. Graph showing length of poor rock mass strata along various faces

Adverse geological conditions in the form of poor rock mass strata were encountered along the entire Face-10, major part of Face-9, 7 and 6, along with some intermittent stretches along Face-2, 3, 4, 5 and 8. Length of poor rock mass condition along various faces is graphically shown in Figure 19. Total length of poor rock mass conditions encountered along the HRT was 3387 m corresponding to 25% of total tunnel length. The poor rock mass along Face-6, 7, 9 and 10 comprised of slight to moderately weathered, thinly foliated biotite schist and quartzite with bands of schist of low strength and intense jointing and were characterized by presence of interfolial shear seams of 1 to 10 cm thickness. This low dipping stratum, especially along Face-9 and 10 where the strike of foliation was almost parallel to tunnel drive direction resulted in continued slabbing and over breaks.
