Earthquake Damage Assessment in the Traditional Town of Sankhu, Kathmandu

Keywords: Sankhu, Traditional Newari Architecture, Earthquake Resilience, Damage assessment

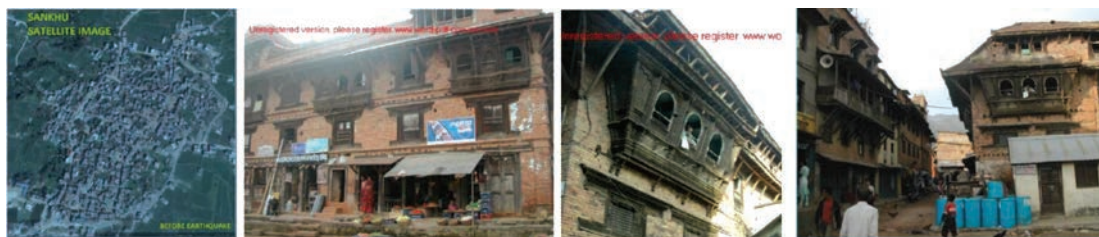
Fig. 2: Map and pictures of architecturally outstanding building and alleys of Sankhu

Settlement Pattern: Like any other ancient town in the Kathmandu Valley, Sankhu is a compact settlement. Aside from the historic necessity for defense and the need for proximity to cultivated farmlands, the compact form of vertically oriented living in Sankhu - or any Newar town for that matter is strongly motivated by concerns to preserve rich farmlands and minimize their use for residential purposes. With the abundance of clay in those times, houses have been uniformly built of burnt and un-burnt clay bricks. The streets are mostly brick paved and the houses, of rather uniform height seldom exceeding 3 ½ stories, built on either side of the streets have at least the brick walls of the compounds adjoining. Houses are closely spaced - built back to back with only a narrow lane between the two buildings.

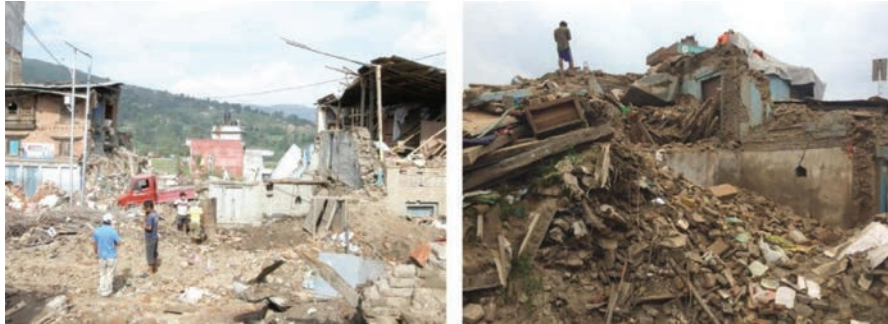
buildings (1%) and others (5%) were collapsed. Out of assessed 631 traditional buildings, 93% of the buildings suffered substantial damage and more, including complete destruction of 70% traditional buildings. In contrast, out of 217 assessed modern buildings, 22% suffered substantial damage and more including complete collapse of 5% (Table 1, Fig. 3).

Fig. 3: Earthquake damage in Sankhu

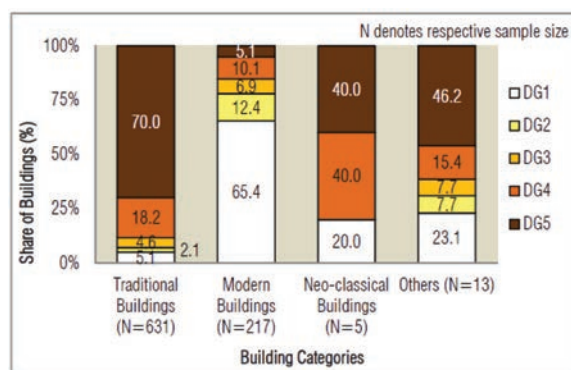
Fig. 4: Share of buildings according to types and damage grade

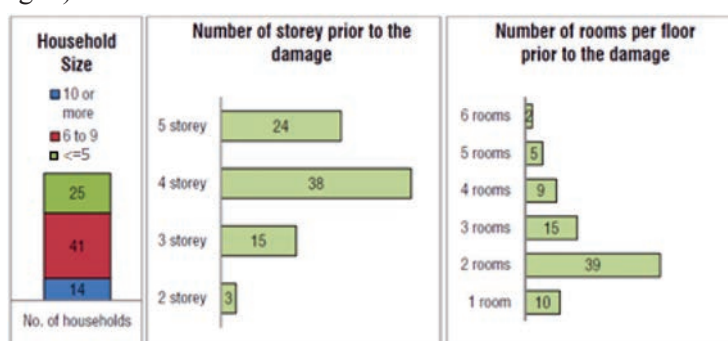
The household sample survey indicates a significant loss of houses. Prior to the earthquake damage, most of the surveyed households had 4-storied buildings, and most buildings had at least 2 rooms per floor. The household size was large - 68% (55 out of 80) of the surveyed households had 5 or more members (Fig. 5).

Fig. 5: Household size in surveyed households (left), number of storey (middle) and rooms per floor (right) prior to the damage

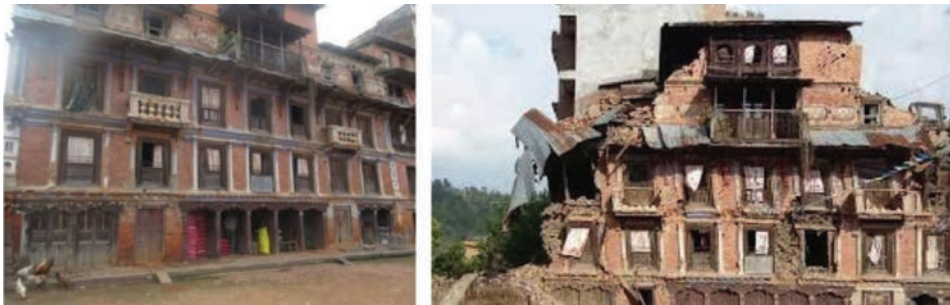
Fig. 6: Salkha Tole- before (left) and after (right)

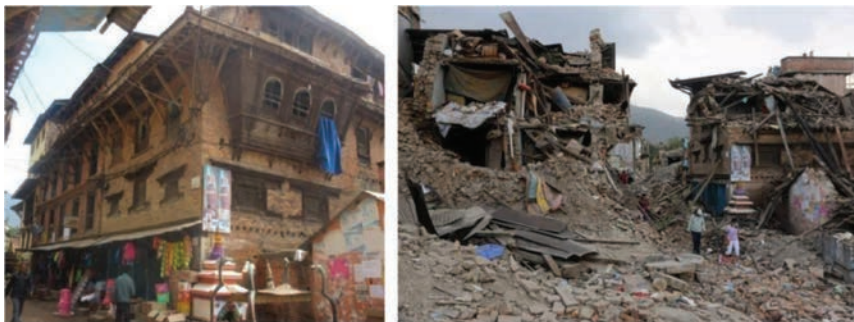
Fig. 7: Salkha tole- before (left) after (right)

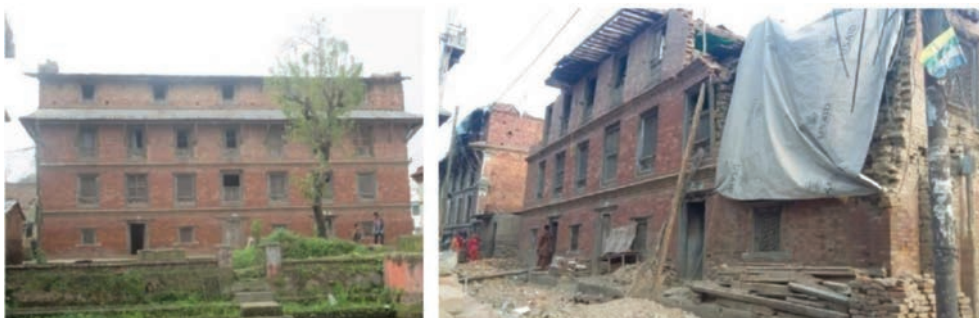
Fig. 8: Pukhulachhi Tole- before (left) and after (right)

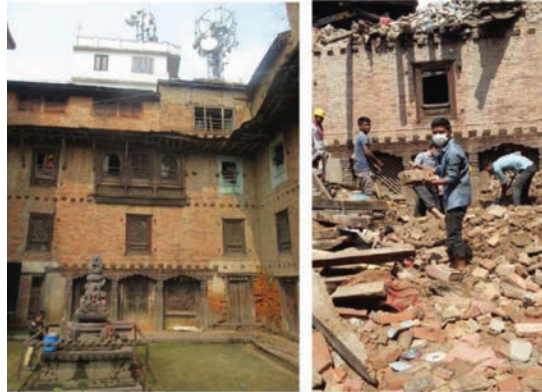
Fig. 9: Dhunla Tole- before (left) and after (right)

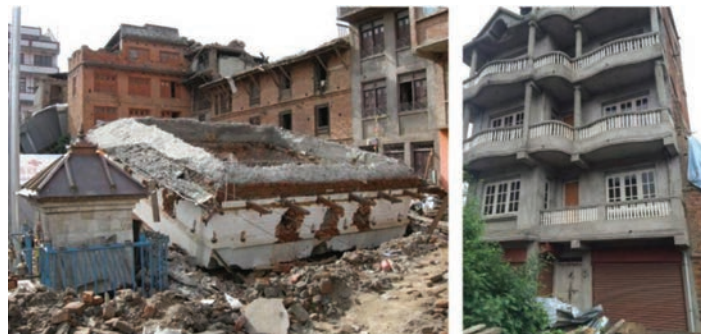
Fig. 10: Pancake failure of a Sankhu temple (Left), soft storey on ground floor in a tall building in Sankhu (right)

If buildings are built without sufficient gap and the interaction has not been considered, the buildings may pound each other during an earthquake (Fig. 10). Building pounding can alter the dynamic response of both buildings, and impart additional inertial loads on both structures. Buildings that are of the same height and that have matching floors will exhibit similar dynamic behavior. In such case, when the buildings pound, floors will impact other floors, so damage due to pounding usually will be limited to non-structural components. When the floors of adjacent buildings are at different elevations, floors will impact the columns of the adjacent building and can cause structural damage [7].

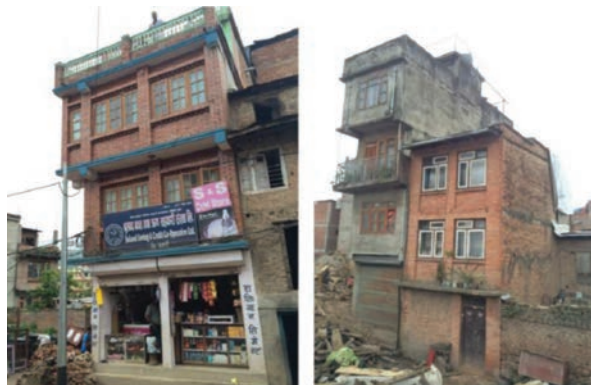
It is also important to note that incremental vertical expansion of buildings is very prevalent in urban Nepal; Sankhu is also not an exception. This often results into an incompatible mix of new stories - often brick-in-cement types or even concrete structures - over old mud mortar stories, ageing lower stories which are now forced to withstand the unintended load. In terms of seismic behavior, such buildings are the opposite of a monolithic structure, and hence very vulnerable to earthquake damages.

Fig. 11: Vertical irregularity in Sankhu buildings

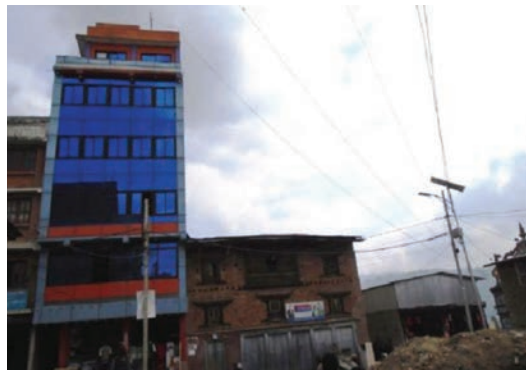
Fig. 12: Neighboring buildings of different heights in Sankhu

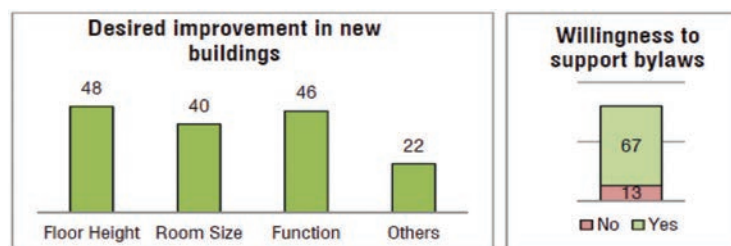
Fig. 13: Desired improvement in new buildings (left), willingness to support bylaws focused on traditional construction (right)

Regarding the preservation of traditional built form at the building level, acceptance level was found to be almost 84% (Fig. 13, right). Respondents were asked whether they would support building bylaws that would require them to preserve or rebuild buildings in traditional styles. About 16% of the surveyed households opposed rebuilding in traditional manner citing reasons such as high costs, economic inability to invest, and incompatibility of traditional houses for modern way of living. Aside from the majority of the surveyed households, participants of the key in-formants interviews (KIIs) strongly supported the need to preserve the traditional identity of Sankhu even if some compromises in the form of improvisation would be required to suit modern way of living and to address seismic risks.

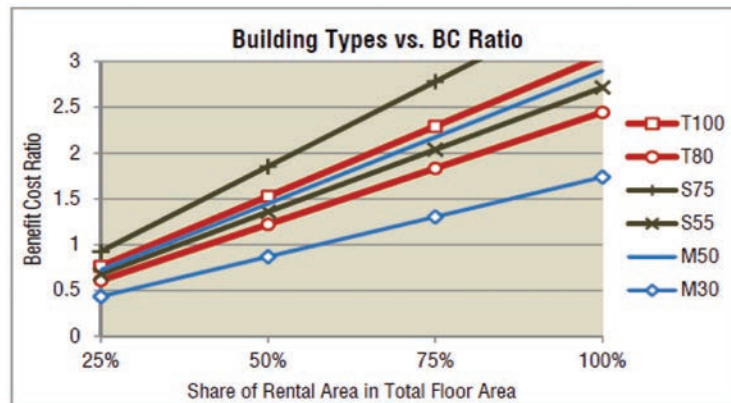
ground coverage. The total built-up area is therefore 2738 sq.ft. Three alternative building styles are considered: (1) traditional, (2) semi-traditional, and (3) modern. Construction costs vary accordingly. Different rental areas (%) are considered. For simplicity, floor rents are assumed to increase annually at the rate equivalent to the interest rate - this way, discounted amount equals the present value. The life of building is assumed to be 20 years, which is checked against calculated payback period. The operation and maintenance (O&M) cost is supposed to be 30% of the gross rental income.

Fig. 14: Building types versus BC ratio
