Earth Block Construction in Nepal as Alternative to Reconstruction after the 2015 Gorkha Earthquake

Abstract: On April 25, 2015, 7.8 magnitude earthquake occurred in Central Nepal with epicentre in Gorkha District at 11:56 NST (local time). A major aftershock of magnitude 7.3 on May 12, 2015 resulted in enhancement of damages. Almost 800,000 buildings were fully or partially damaged. This paper highlights the different types of buildings in Nepal and the damage patterns recorded from the earthquake. Different causes of failures are highlighted for different types of building including masonry, wooden, reinforced cement concrete etc. 44.2% of the buildings in Nepal are masonry type which in fact performed the worst during the earthquake. One of the main reason was the poor quality of bricks used in the buildings. Most of the masonry buildings in Nepal are located in the rural areas where the economic condition of people are not up to the level. Utilization of local resources and people skill is important. Thus, as an alternative to it, we have put forward the idea of earth block construction which is not only earthquake resilient but lighter, greener sustainable and economical.

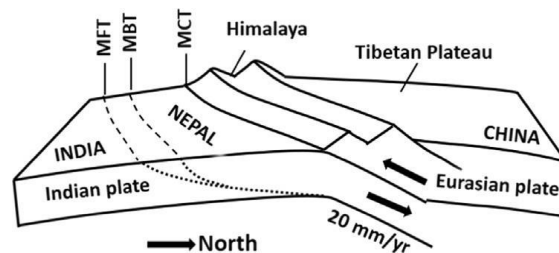
Fig. 1: Type of plate boundaries in Nepal (Primary surface ruptures of the great Himalayan earthquakes in 1934 and 1255) [2]

Nepal lies in the center of Himalayan mountain chain, which is one of the most active seismic regions in the world due to the faulting between the sub ducting Indian Plate and the overriding Eurasian plate as shown in Fig. 1.

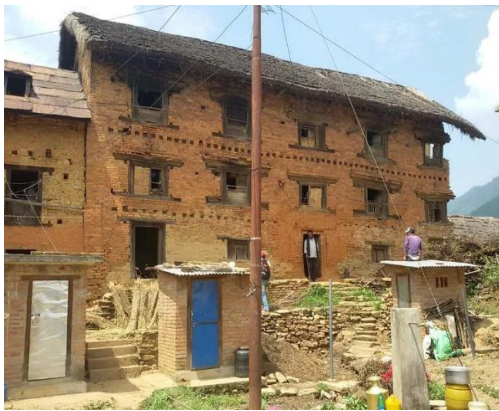
Fig. 4: Brick Masonry with mud mortar [14] **Fig. 5: Typical Stone Masonry with mudmortar[12]**

The average height of buildings in Nepal is about 2.5 to 3.2 meters with wall thickness varying from 230mm to 300mm. The traditional brick masonry buildings are generally 1 to 5 floors high. The brick masonry is generally found in the plain areas and where the road is easily accessible. The walls of these buildings are constructed using fired bricks or fired and sun dried bricks as shown in Fig. 4. The traditional brick masonry buildings are described by its heavy mass. It possesses very low strength and show brittle nature for failure resulting in sudden collapse of building during earthquake. However, the performance is better compared to stone masonry. Modern brick masonry are up to 6 floors high, uses cement sand mortar and are less vulnerable compared to traditional ones although most of the modern are still non-engineered.

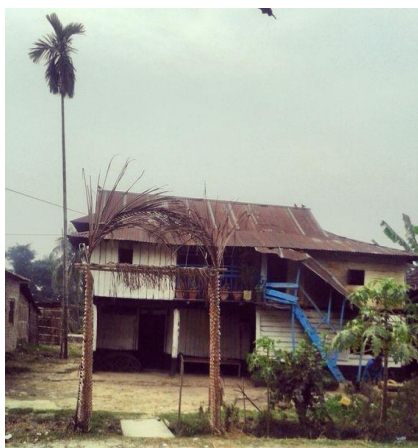
Fig. 6: Wooden Building[15] **Fig. 7: RCC building under construction in Kathmandu, Nepal [3]**

The Wooden buildings are commonly used in major cities of Kathmandu, Patan and Bhaktapur (Traditional wooden buildings) and in the rural areas. These are used for both religious and residential buildings in old downtowns. A typical wooden building is shown in Fig. 6. The RCC building is widely used in the developed region of Nepal. It is popular among the wealthy families. These buildings are mostly common in government offices, hospitals, schools, hotels etc. Most of the buildings haven't followed the seismic design code except for government and public buildings. The RC buildings are generally 3 to 5 stories high as Nepal does not have much high rise buildings. A RCC building with infill walls under construction is shown in Fig. 7.

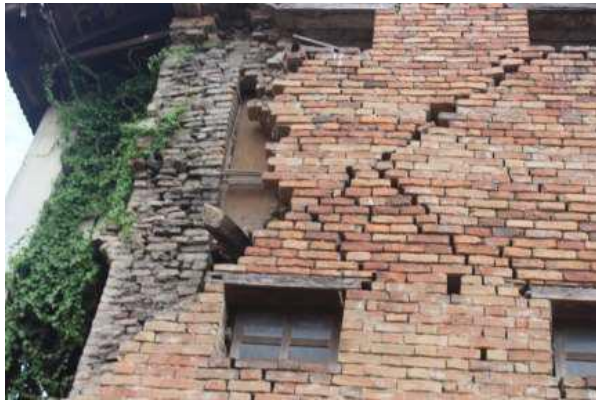
Fig. 9: (a) Binding Material Failure[15]

The recent earthquake in Nepal on 25th April 2015 has drawn much international attention due to the damage of buildings and loss of human lives. The Brick/Stone Masonry buildings performed the worst compared to other types of buildings (Fig. 9). The main reason was the use of poor quality of mortar and bricks that were unable to bear the deformation during earthquake. This has led to high casualty. The quality of bricks and stones matters in every step of bonding process. The size of bricks used was found to be inconsistent and the crushing strength less than the specified, i.e. less than 3.5N/mm² as prescribed by the National Building Code (NBC 205 : 1994). 240*115*57mm standard size of brick is preferred. The heavy weight of the building has also led to greater extent of damage.

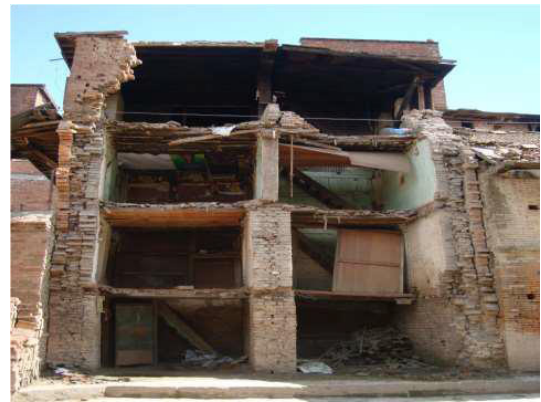
(b) Out of plane failure [15]

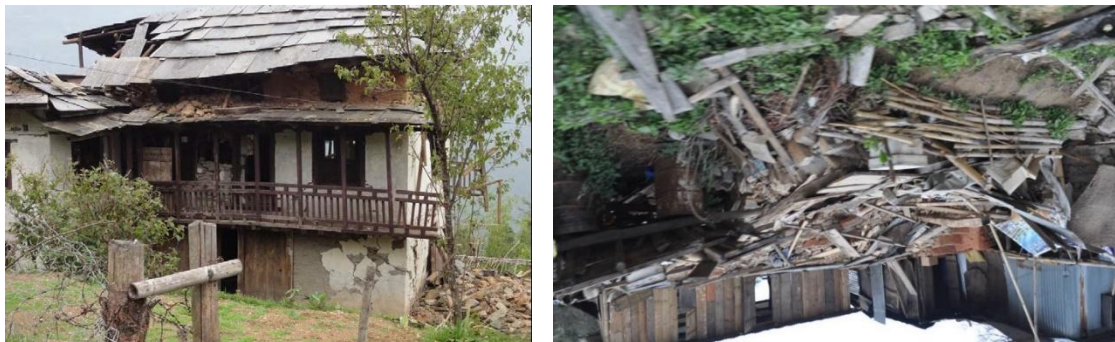
Fig. 10: Wooden buildings after Earthquake on 25th April 2015 (Source: EERI) [7]

The damage in wooden frame buildings has been due to slope failures and large ground movements during earthquake. Cracking and collapse of brick veneer on building exterior can be seen (Fig. 10).

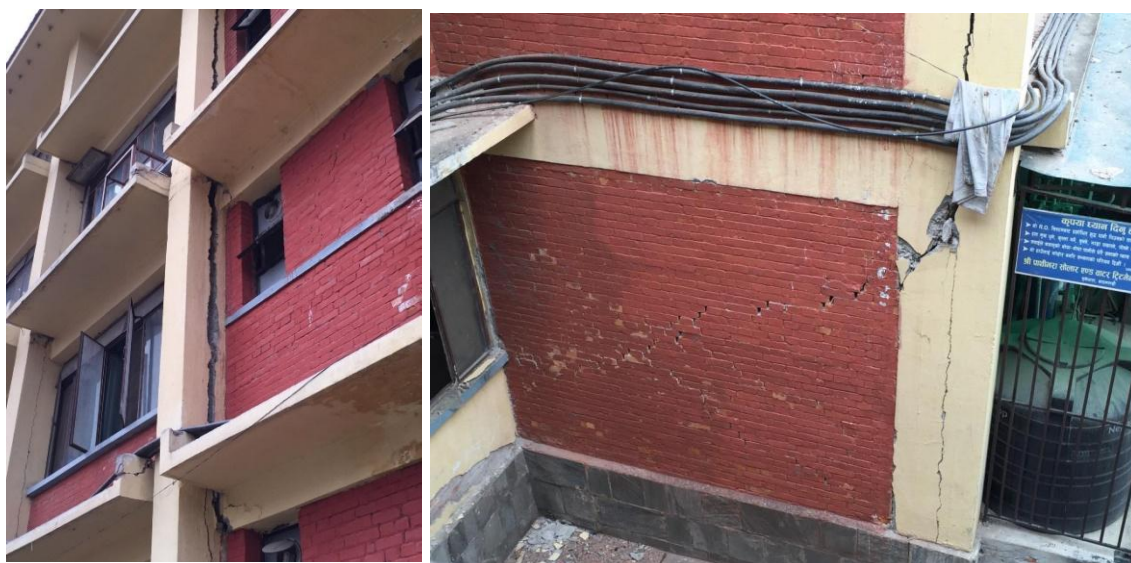
Fig. 11: Failure of Column Joints during April 2015 Earthquake (Source : EERI) [7]

The RC buildings are generally found in the urban areas of Nepal. The recent earthquake has affected the RC buildings too. In Nepal, generally burnt clay bricks or stones are used as the wall filling materials. There is absence of RC or masonry bond above doors and windows. Failure of beam column joints has been seen in many RC buildings as a result of the earthquake (Fig. 11). Weak detailing at the beam column joint, widely spaced stirrups i.e. spacing of stirrups is larger than specified by Nepal National Building Code are some of the causes of failures. Short column failures have been due to intermediate staircase landing between 2 floors and for requirements as ventilation. Short columns are generally vulnerable to earthquakes. Poor detailing, poor quality of concrete are some other reasons for failure.

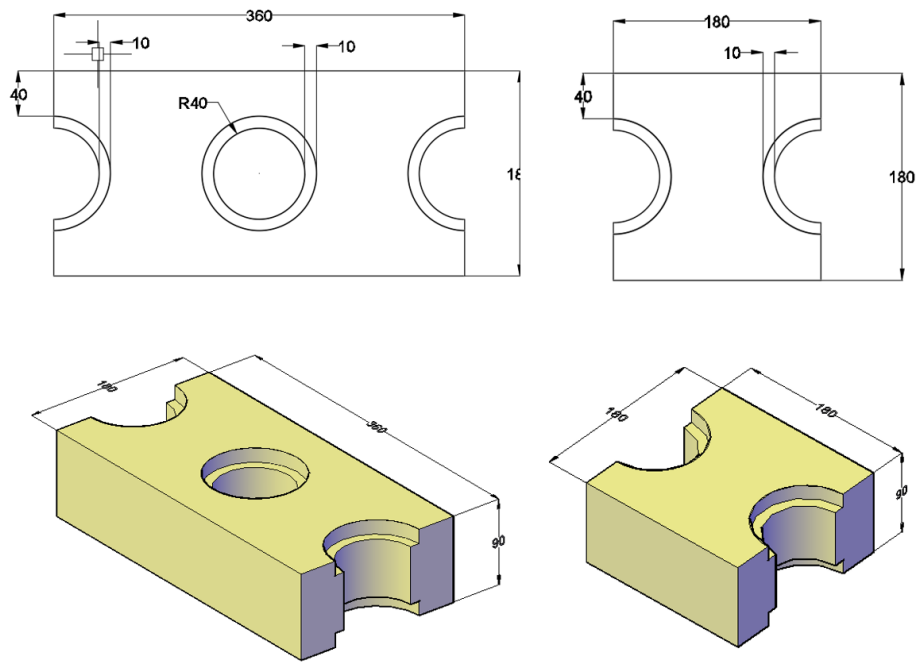
Fig. 12: Full Block and Half Block

Based the objective of ease of construction and placing mortarless, and the dimensions of brick used in Nepal, we have designed a new type of earth brick. It consists of two types of block: (a) a complete block (b) a half block as shown in Fig. 12.

The block has holes and grooves but not protrusions as shown in Fig. 12. The protrusions in the block account to the difficulty in processing and hence not provided. The blocks have a dimension of $360\text{mm} \times 180\text{mm} \times 90\text{mm}$ and $180\text{mm} \times 180\text{mm} \times 90\text{mm}$ for a full block and half block respectively. The dimension of the block is considered according to the brick sizes used in Nepal. The arrangement of blocks is shown in Fig. 13.

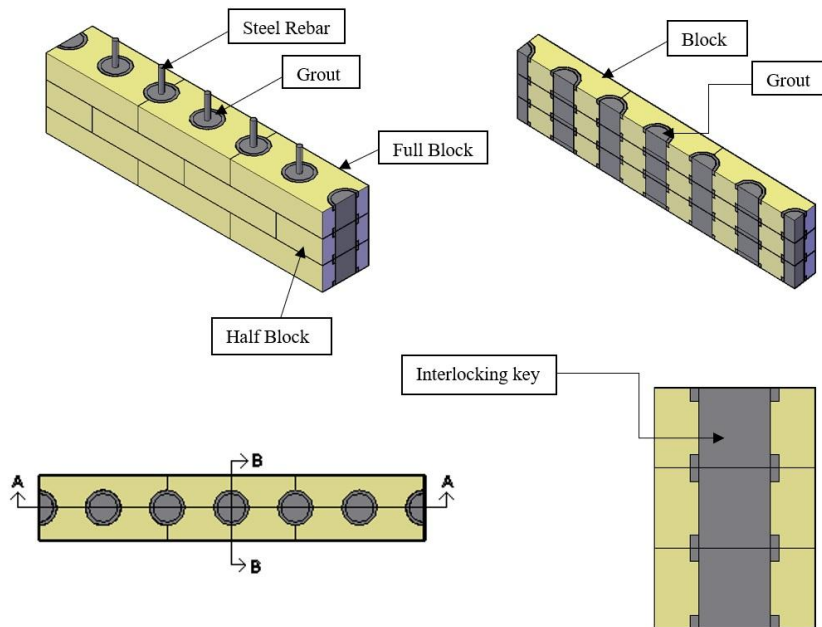
Fig. 13: Embed pattern of Blocks

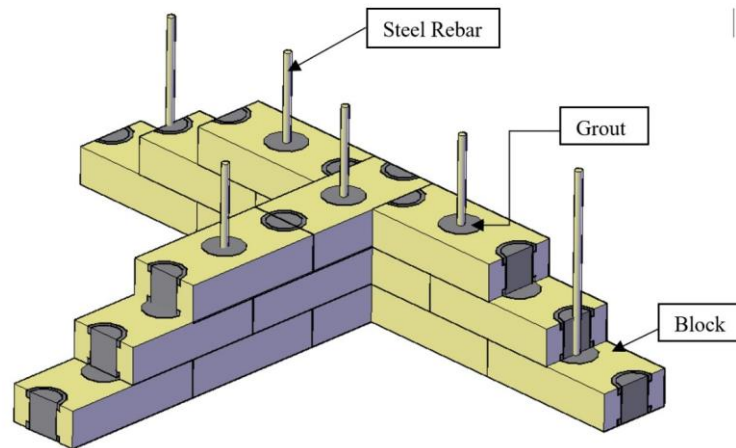
Fig. 14: Block arrangement at T-section

As there is no self-locking mechanism due to the elimination of protrusions, the process of aligning the blocks are much easier. The masonry can be set up with the vertical reinforcements passing through the holes and can be completed with the pouring of the grout through the holes which can efficiently increase the shear strength and the overall performance of the wall. The presence of steel helps in the improvement of the ductility of the wall. There are holes provided in the bricks which is much larger at the contact surface. This helps the grouting material at that section to be larger which can increase the bearing capacity and reduce the stress concentration at the blockhole caused by shearing. The arrangement of the bricks at T-section and corner is shown in Fig. 14 and Fig. 15 respectively.

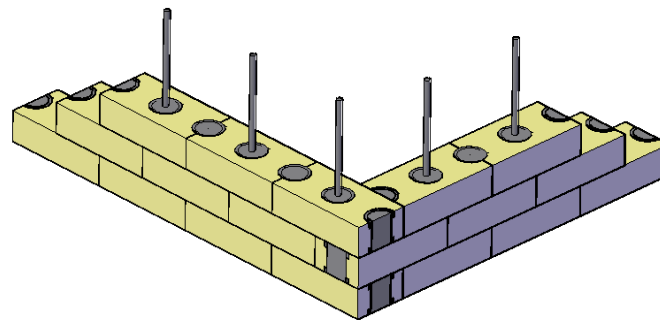
Fig. 15: Block arrangement at the corner
