## **A preliminary engineering geological study in the northern part of the Taplejung Window, far eastern Lesser Nepal Himalaya**

### **ABSTRACT**

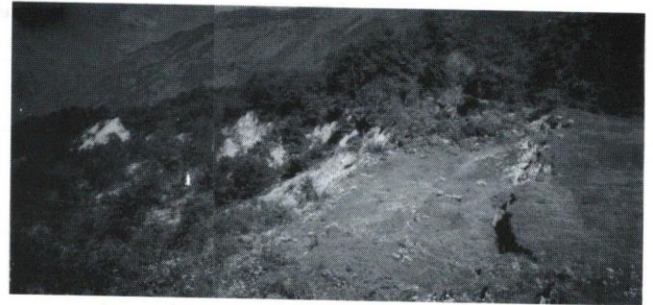
**Fig. 3: The crown part of rotational slide occurring in the Hangdewa landslide. View towards north east.**

Hangdewa landslide was initiated more than 100 years ago. The Hangdewa Khola flows centrally through the landslide. Although the landslides are distributed on both banks of the Hangdewa Khola, the left bank of the valley is severely affected and top part shows rotational slides (Fig. 3). The mass-movement is frequent along the small tributaries and subsequently on their valley sides.

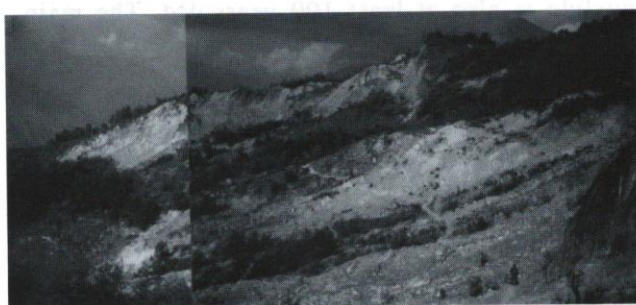
**Fig. 4: Eastern part of Hireba landslide. View towards east.**

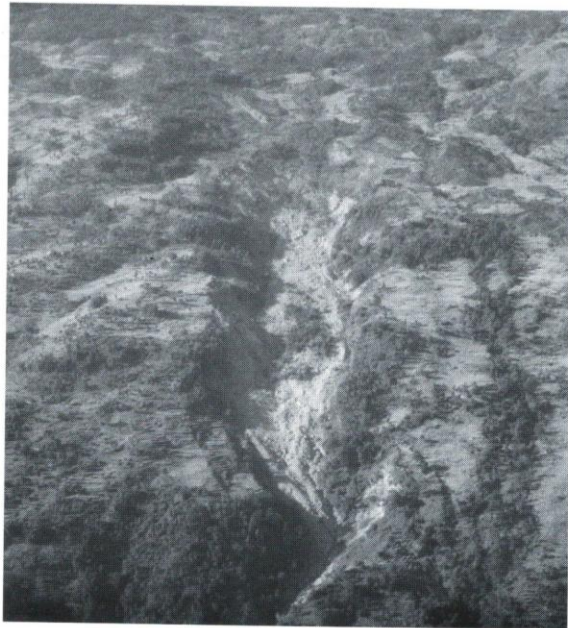
**Fig. 5: Paire landslides at Paire village. View towards southwest.**

This landslide lies on the right bank of Tamor River and on the northern slope of the Phulbari Village. The landslide consists of both active and old mass movement areas. The Paire landslide is one of the active and largest landslides on this slope (Fig. 5).

direction. The stepped and converging type of slope curvature exhibits convex nature (Fig. 5).
