Ice–rock avalanche of 2002 in Genaldon River valley, North Caucasus, Russia: consequences and problems

ABSTRACT

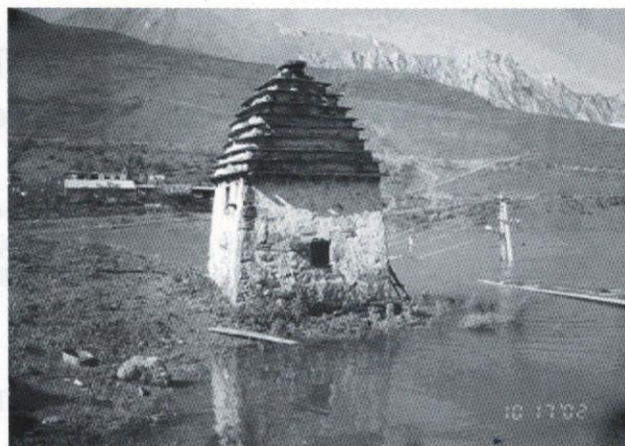
Fig. 2: Water level of dammed lake reaches the basement of XVII century crypt in Gornaya Saniba village. Photo by E. Zaporozhchenko, 17 October 2002

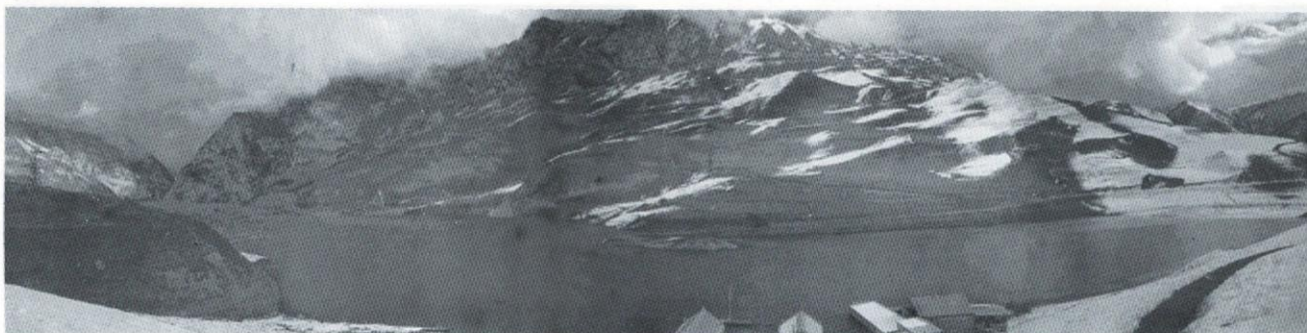
Fig. 3: Gornaya Saniba dammed lake and adjacent parts of ice-rock dam. Photo by S. Chernomorets, 9 August 2004

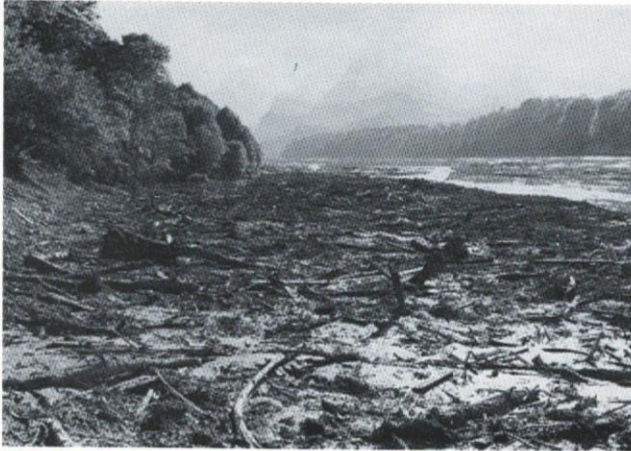
Fig. 4: Debris flow deposits in transit accumulation zone near Genaldon River mouth. Photo by S. Chernomorets, 7 October 2002

- An increase in slope angle of the Genaldon riverbed between the Kolka Glacier tongue and the Karmadon valley;
- The filling up of the Karmadon hollow by the ice-rock material (i.e. the blockage near the N. Kani village, Fig. 3);
- The formation of a dammed lake near the Gornaya Saniba village; and
- The filling up of the Genaldon valley (down the Karmadon Gates) and the Gizeldon River (down the Genaldon River) by debris (Fig. 4).

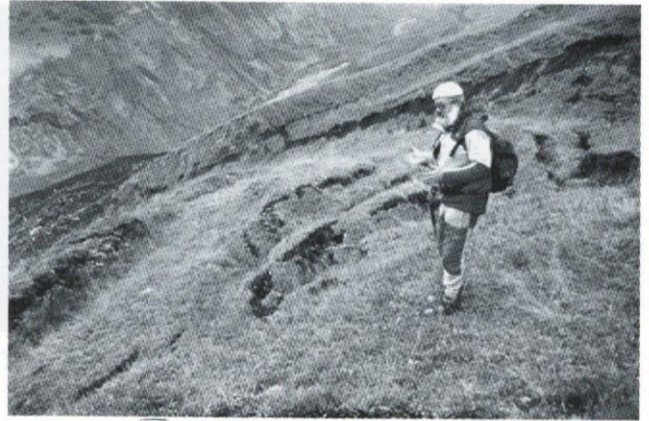
Fig. 5: Close-up view of Aktivny landslide. Photo by S. Chernomorets, 5 October 2002

Since 2003 the movement of the ancient landslides (Fig. 5) has ceased and there is hardly any probability of landslide dam formation across the Genaldon River. Only an earthquake of magnitude 8 (or larger) on the MSK scale and complete submergence of large (5–6 times bigger than actual) landslide blocks could trigger instability. Such a scenario seems to be quite unreal. The situation with the new low-volume landslides of 2003 and 2004 as well as with the Kolkinsky landslide is the same. The ice-rock debris mass is being rapidly eroded away in the form of slope splashes. The small debris flows and landslides triggered by ice melting have not affected the natural flow regime and the slopes tend to be stabilised.

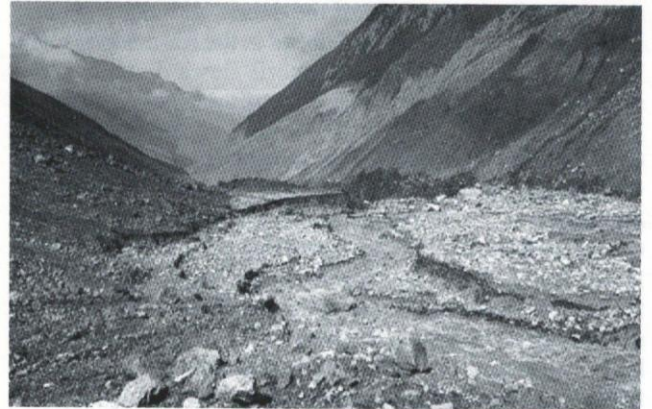
Fig. 6: Debris flow deposits of 12 August 2004 (from upper Karmadon sources) being washed out by Genaldon River. Photo by D. Petrakov, 14 August 2004

The situation in the transport zone does not influence the debris flow regime. The mudflow of 11–12 August formed in the three mudflow sites was an ordinary one (Fig. 6). Though it had a volume of 500,000 m^3 (including water) it did not stop in the Karmadon valley (i.e. at the hydrological post located at the toe of the 2002 blockage).

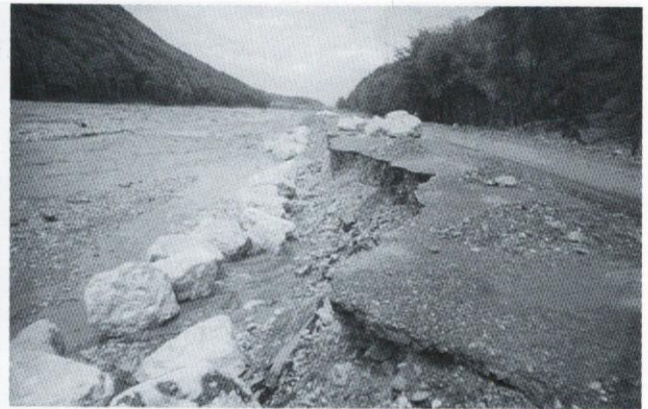
**Fig. 7: Right bank of Gizeldon River down the Genaldon River mouth. Debacle of 16 June 2003 has destroyed the road. Photo by E. Zaporozhchenko**

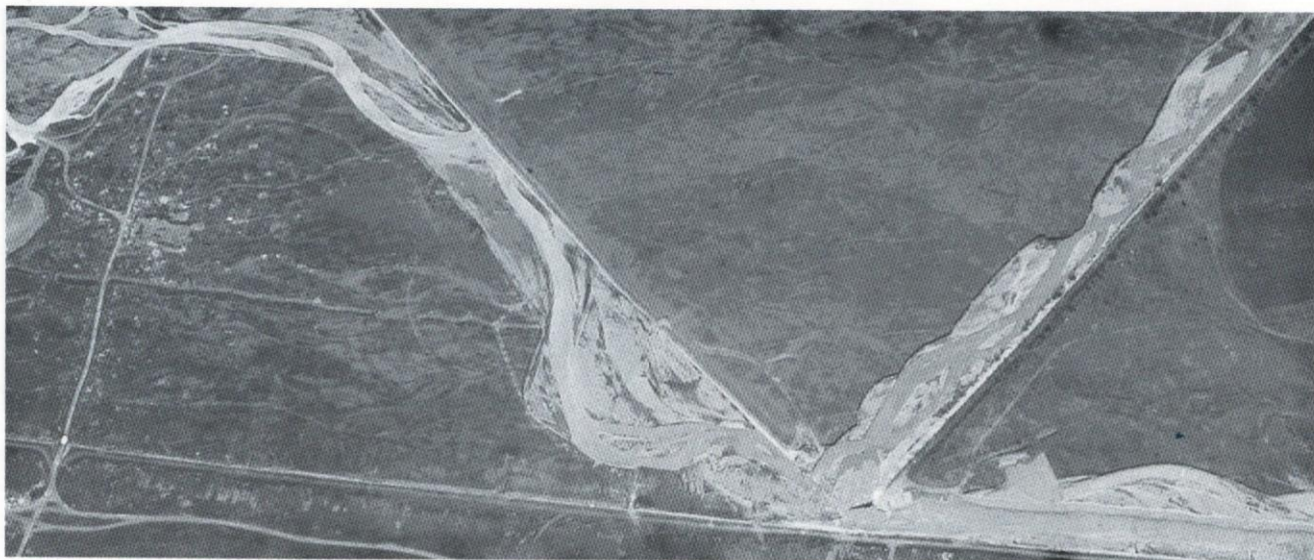
Fig. 8: Arkhon water divider. Photo by I. Galushkin, 30 April 2003

The devastating floods of June 2002 (which have not been seen here since the last 100 years) in the Genaldon–Gizeldon River system caused the destruction of the Arkhon watershed (Fig. 8), seriously damaged the Gizeldon Hydro-

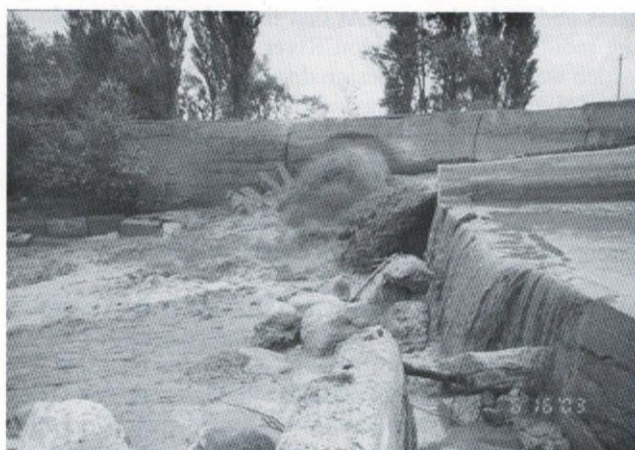
Fig. 9: Flood (with a discharge of about $30 \text{ m}^3/\text{sec}$) through Gizel Hydro-Engineering complex. Photo by E. Zaporozhchenko, 16 June 2003

Engineering complex constructed in 1960s (Fig. 9), filled up the Arkhonka and Kizilka riverbeds, and also scoured bridge piers and embankments. At that time, the discharge down the mouth of the Genaldon River was about 230 m³/sec, which was close to the design discharge (295 m³/sec) of the Gizel Hydro-Engineering dam. The rate of consolidation of the debris flow deposits by the ice–rock flows from the upper reaches of the Genaldon River is very slow. The debris flow (with ice) filled up the Genaldon and Gizeldon valleys for a distance of 12 km. The debris has also obstructed the machinery access since September 2002 (Fig. 10).

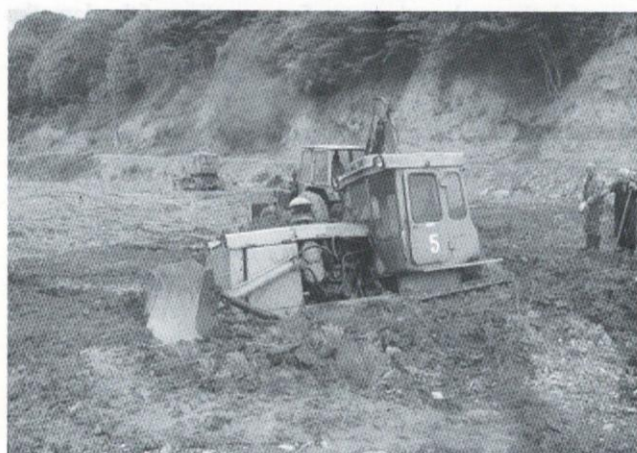
Fig. 10: Right bank of Gizeldon River about 1 km down the Genaldon River mouth. The road was washed away by an ordinary summer flood of $10 \text{ m}^3/\text{sec}$. Photo by E. Zaporozhchenko, 1 June 2004

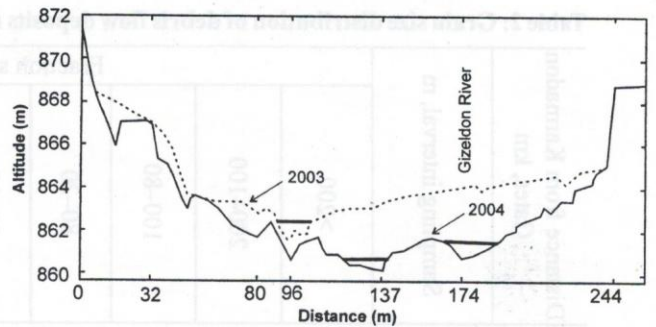
Fig. 12: Changes in river cross-section at CS 1 (see Fig. 11) in 2003 and 2004. Bold lines indicate high flow levels.

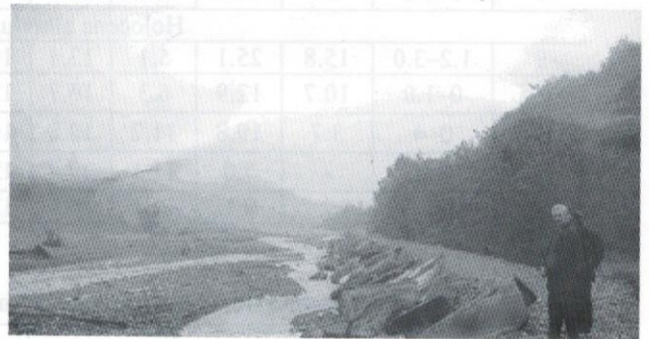
Fig. 13: Right bank of Gizeldon River about 1 km below Genaldon River mouth (Ph1 in Fig. 11). The road was washed away by an ordinary summer flood (10 m³/sec). Photo by E. Zaporozhchenko, 1 June 2004

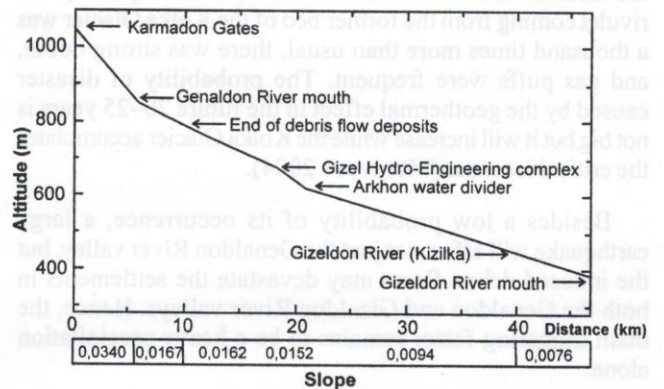
Fig. 14: Longitudinal profile of Genaldon and Gizeldon Rivers between the Karmadon Gate and the Gizeldon River mouth (Flagdon River), taken in January 2005

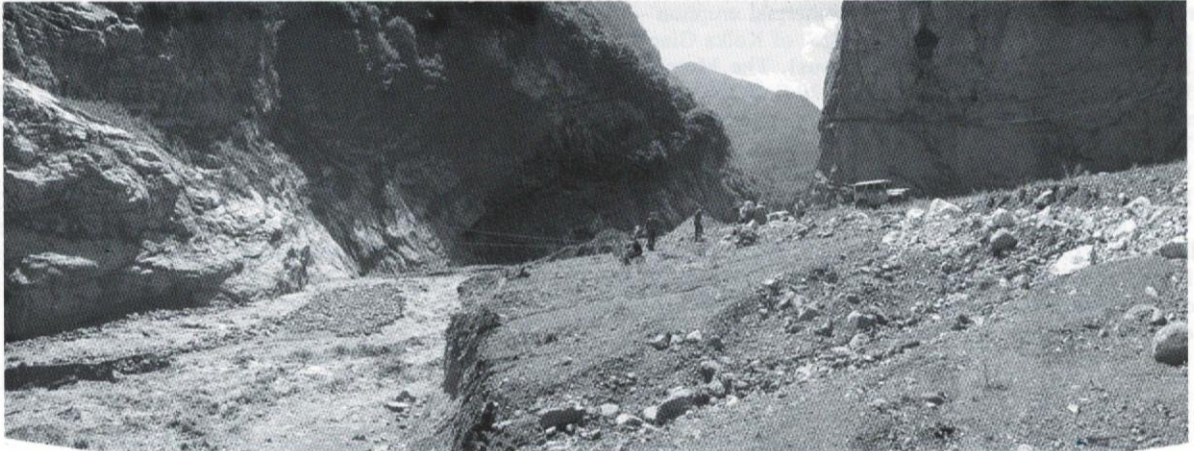
Fig. 15: Genaldon River immediately downstream from Karmadon Gates where a hydrological station is proposed (Ph2 in Fig. 11). Photo by E. Zaporozhchenko, 25 June 2004

As the debris flow leaves the narrows of the Karmadon Gates, the velocity of this wave attenuated by the blockage masses in the Karmadon hollow would define the course of the riverbed processes. On 20 September 2002 the discharge of the debris flow down the rocky section (judging by the high wave marks) was about $2000 \text{ m}^3/\text{sec}$ (Zaporozhchenko 2004). This section is the best place for installing a hydrological station (Zaporozhchenko 2005). Besides measuring floods (or debris flows) it is planned to put here an automatic radar sensor and also an alarm system to warn the population in the downstream areas. The alarm system will be triggered by a rising water level (Fig. 15).

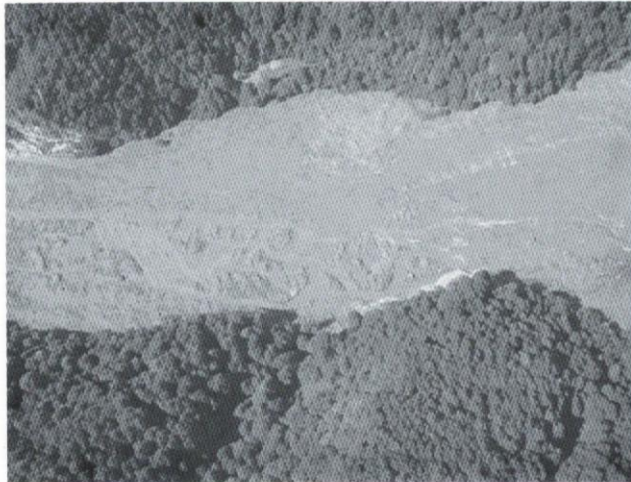
Fig. 16: Scenario after debris flow in Genaldon River (Ph3 in Fig. 11). Photo by I. Galushkin, 21 August 2002

of the Gizeldon riverbed. The debris flows of September 2002 (Fig. 16) followed the July 2002 storm floods and the outburst wave of 16 June 2003. Such flows severely hampered the emergency works (clearing, aligning, and bank protection).
