Bank instability and erosion problems in Bishnumati River, Kathmandu, Nepal

*Basanta Raj Adhikari and Naresh Kazi Tamrakar

Central Department of Geology, Tribhuvan University

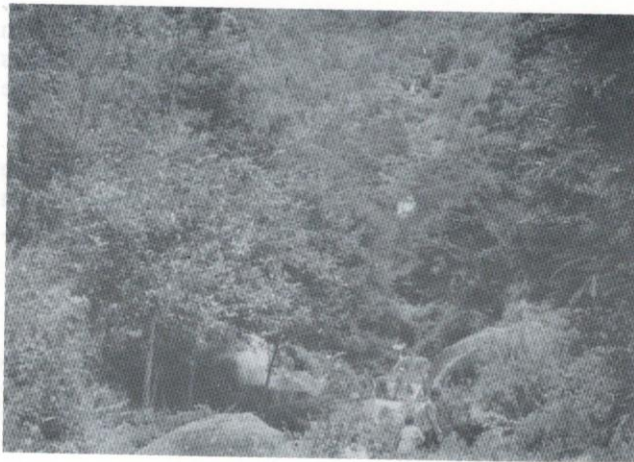
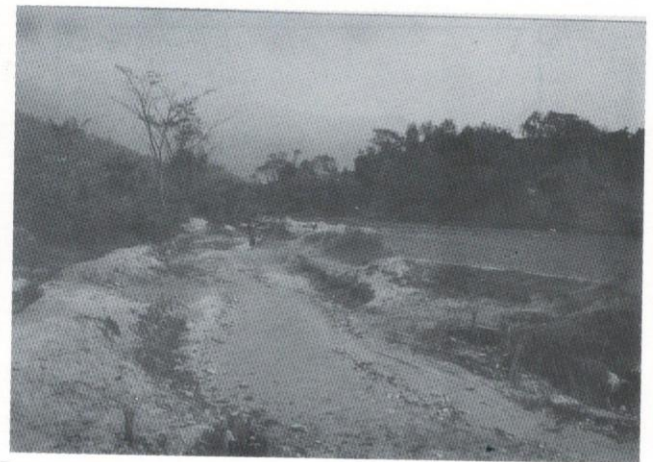
Fig. 6: a. Upstream view from Bishnumatigaun segment showing stream bank sediments and vegetation, b. Riparian vegetation in Okhaltar segment

The Bishnumatigaun segment has a better canopy than the rest of segments (Fig. 6 a). Some bamboos line up on the banks in addition to other plants. Downstream of S1, Banmara (*Eupatorium adenophorum*) is abundant and in some other places Utis (*Alnus nepalensis*) is found. The Okhaltar segment also possesses good riparian vegetation (Fig. 6 b). Discontinuous riparian vegetation with sparse trees forming a weak canopy is observed in the Mahadevtar segment. The shrubs, trees, and grasses in the Tamsipakha segment occur in patches. Some parts of this segment have been re-vegetated by the Kathmandu Municipality. However, in some reaches of this segment trees are sporadic and therefore the canopy is almost absent. In other words, the riparian vegetation is poor in the Mahadevtar segment, is fair in the

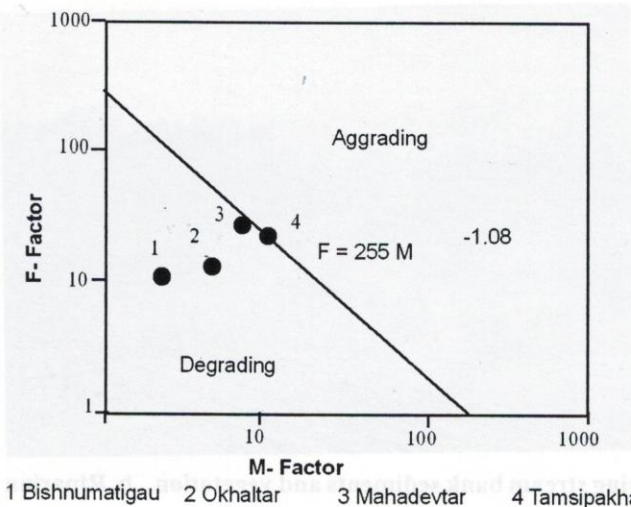
Fig. 7: F versus M diagram indicating dynamic equilibrium in Bishnumati River segments; boundary between aggrading and degrading fields: after Schumm (1963).

Schumm's (1963) F versus M plots (Fig. 7) also indicate that the Bishnumati River is in a degrading condition. The sixth-, fifth-, fourth-, and third-order stream segments of the Bishnumati River are in an increasing order of degradation respectively. However the sixth-order segment is in a critical condition. The other three segments have low F and M values due to their higher bankfull depth than the bankfull width and the presence of coarser sediments.
