Sacred Buddhistic monuments in the Himalaya: indicators and protectors from mountain hazards

Johannes T. Weidinger^{1, 2}

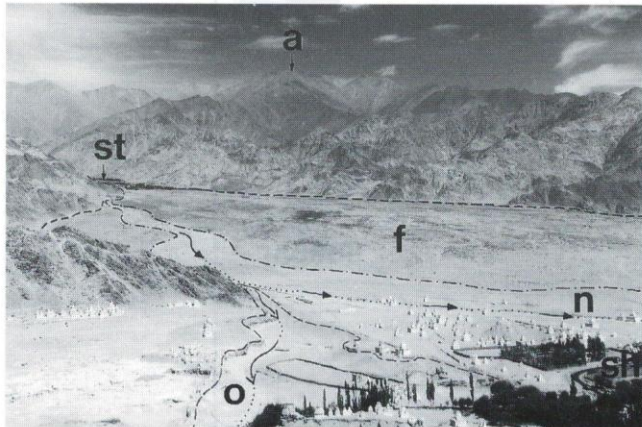
Fig. 3: The hodge fan (f) of alluvial debris (boundary = thick dashed line in the background) coming from the village of Stakma (st) near the mouth of the Stakma river between Shey palace and Tikse Gompa, seen from the old Shey palace, view towards NE. It can be recognized that hundreds of chörten have been erected to protect Shey village (sh) from flowing waters and deposited debris. The special scheme of these erected chörten is not only of religious sense but also to devide flowing waters for reducing their velocity forcing the river to sediment the freight immediately just before to reach the village; another effect of the chörten was the changing of the old bed of the river (o), which had its way right towards the village (boundary = thin dashed line) towards E, were the new bed (n) is passing by the village; a = Arzu mountain.

about 30 km² (Fig. 2). The deposited material in the form of a giant fan of alluvial debris covers the northern side of the Indus valley between Shey and Tikse. It is evident that despite the dry climate of Ladakh, the Stakma River must have had a rich volume of water during rainy season or in times of extraordinary precipitation events not only in the past but also recently. A fresh cone of mud- and debris-flow represents the last depositional events on the western end on top of this fan (Fig. 2 and 3).

Exactly along the wide end of a mud-flow lying at the foot of the rocky hill at the northern front of the farm land of Shey village, hundreds of chörtens have been erected. These are the oldest sacred cultural Buddhistic-Lamaistic structures in the area dating back to 1000 years (Fig. 2 and 3). These structures are erected at a geomorphologically very critical place. The village lies along the main flow direction of the debris-flow in front of the giant alluvial fan. The recent deposit of a young and fresh debris flow shows that it was stopped by the chörtens before it reached to the village (Fig. 3). The position of these chörtens gives evidence that they were constructed for the protection of the village from the debris flows. Numerous chörtens of different size with special positioning must have additionally been used for almost

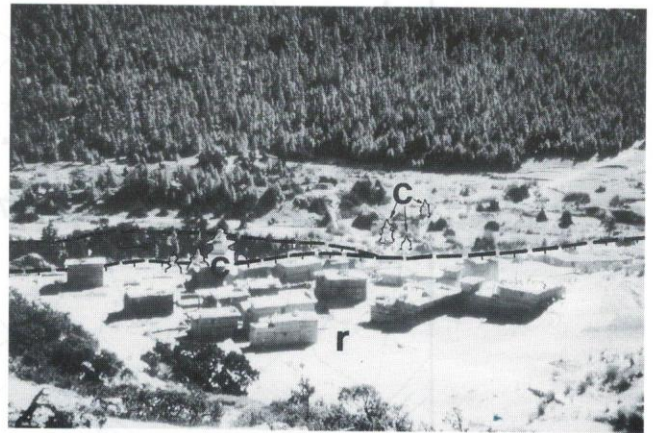
Fig. 4: Ringmo (r), the village in western Nepal, which is positioned on top of the deposited landslide-material, which has dammed the river Phoksundo Khola. Its tibetain name is "Tsho wa", which means "On the shore of the lake". This is one of the ethnologic indications for a former higher water level of the lake. The gully (boundary = thick dashed line, arrow shows direction of flowing) created by an eventually catastrophic outbreak of the lake is flanked by hodge chörten (c), (Photo: H. J. Ibetsberger 1995).

the Dhaulagiri Limestones of the southwestern Dolpa Synclorium of the Tibetan-Tethys Sediments (Fuchs and Frank 1970), the river was dammed by a giant 40,000 years old landslide (Yagi 1997). An estimated volume of 1.5 billion cubicmetres of dislocated material on the bottom of the valley led to the creation of the 5 km long, 800 m wide and 200 m deep Phoksundo Lake, which has remained stable until now (Weidinger and Ibetsberger 2001). On the top of the landslide deposit a small village named Ringmo is located (Fig. 4). A monastery exists on the eastern side of the holy lake.

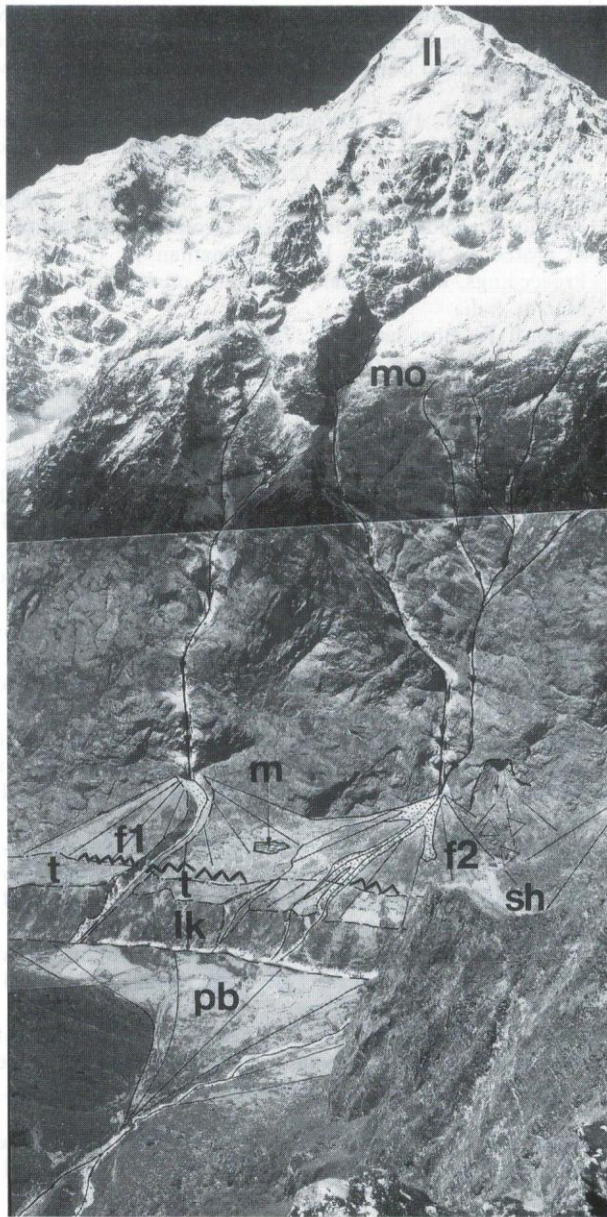
Fig. 7: Panoramic view from the southern side of the Langtang valley (altitude of standpoint: 4,550 m) to the north, showing the village Möldrong (m) at an altitude of 3,600 m. Langthang Lirung (ll) in the background is overthroning this scenery upto an elevation of 7,234 m, exactly 3,634 m above one of the highest permanent settlements in this region. Positioned between two hudge debris fans (f1 and f2) created by avalanching along active erosional channels (à) from this steep wall, Möldrong has remained for hundreds of years without any damages by natural hazards. The farm land in front of the village positioned on a glacial terrace (t) along the river Langtang Khola (lk) has been protected from debris flows by walls (zig-zag-line) which are build of stones with the carved bouddhistic mantra „Om mani padme hum“ on them; sh=Shingdum village, pb=Palbag alp.

and moraine-material has been endangering the most populated area in the centre of this narrow valley between the villages of Langtang, Möldrung, and Shingdum (Fig. 6 and 7). Two giant cones of debris on the foot of this flank originating from different sized galciers in the rocky ice-wall are silent witnesses of hazardous processes that has gradually reduced the size of the little farmland on the bottom of the valley. The cultivated glacial terrace has been reduced to a slightly south-dipping narrow stripe. This land is also endangered by the lateral erosion of the main river Langtang Khola. Both debris fans have reached to a height of about 50 m resting on the postglacial terrace. The terrace was created due to a temporary damming of the main valley just west of the Langtang village by a glacier, which flow from the northern glacial cirque on the footwall of Mera Peak (6,958 m) (Heuberger and Ibetsberger 1998).

The east-west orientated trail leads around the debris cones in nearly two half-circled ways; this path is flanked by endless mani-walls on the side towards the northern cones and the high mountains (Fig. 6, 7 and 8). In some parts, the trail is even flanked by holly walls on both sides. The trail itself is used as water-channel during heavy rainfalls. The height of the walls varies from 1.2 to 2 m. The width is about 1 to 2 m depending on the standpoint around the alluvial fans and requirements for torrent hazards. On several spots the wall has outlets, from where huge volume of water and even sediments coming from the cones can find their way without damaging the wall itself (Fig. 8). Most parts of the wall are 200–300 years old. Perhaps this may be the period when the first Tibetans settled in this remote area.

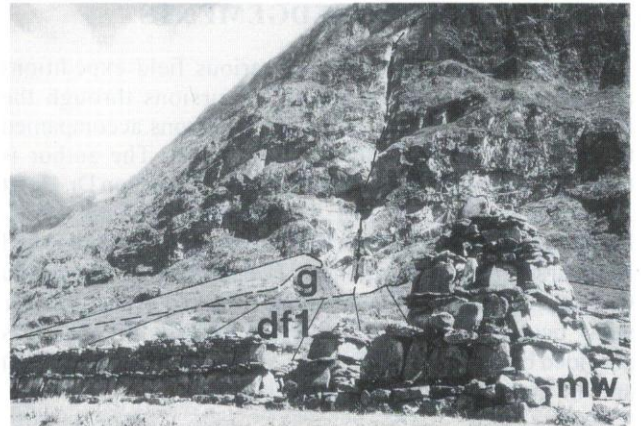
Fig. 8: View of the mani-walls with an outlet and a Chörten nearby (mw), which all are building a close half-circle around the western, hudge cone of debris (df 1) at Möldrong. Gully (g) in the background coming from an active erosional channel of the steep Langthang Lirung-southflank (à). The wall is preventing the tiny acres and the farm land from mudflow and gully-erosion.

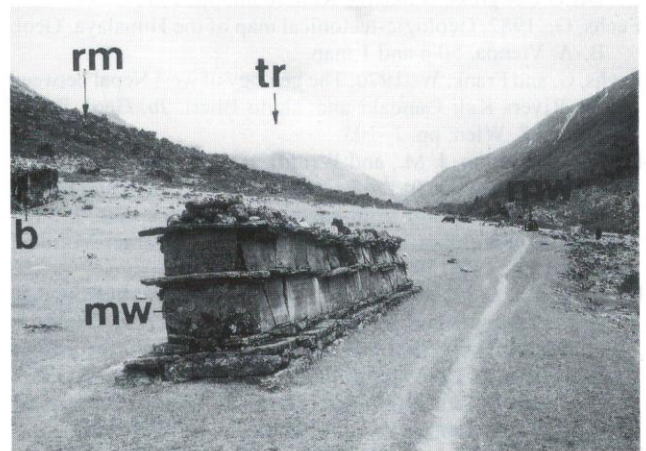
Fig. 9: Isolated mani-walls (mw) functioning as barriers against rolling and bouncing boulders (b) of rockfall material (rm) originating from Pangshungtramo (5,321 m) and endangering the Alp meadows and the path near Nösapalli in the Langtang valley; view towards E, tr=giant landslide-deposit of Tsergo Ri (4,984 m) in the background.

(Weidinger and Schramm 1995) is partly flanked by mani-walls. This area is sometimes endangered by huge falling boulders from the top of the fan which reaches the bottom of the valley (Fig. 9). The height of the fan is over 450 m.
