Study of a debris torrent in the Dolomites, Italy

ABSTRACT

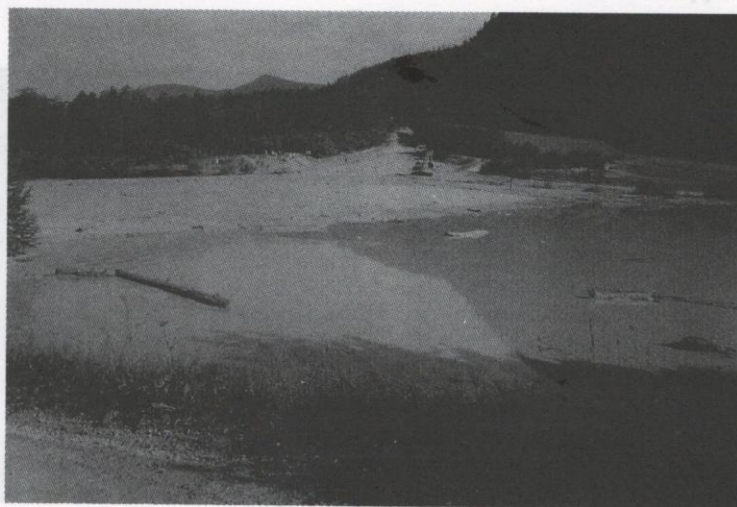
Plate 2: View of the lake formed after the debris torrent deposition. The final reach of the torrent Fojedöra is seen in the background.

For San Vigilio, the month of July 1995 was rather hot, with seasonal temperatures slightly above the mean. As far as the precipitation is concerned, storms occurred during the first three days of the month, and then again in the week of 10–17 July. During the remaining days, the temperatures were very high, which allowed the ground to dry out completely. On 26 July, there was a brief storm and, finally, on the 27th at 7 p.m., while in the village it had not rained at all, on the slopes of Piz da Peres and Monte Paraccia a violent storm arose with hailstones, but, naturally there was no trace of this in the data collected on San Vigilio. Towards 8 p.m., the inhabitants of the village heard a loud boom and at the same time the torrents of Ermo and Fojedöra deposited a great quantity of debris in the valley bottom, dragged down the bridge of the road to the Natural Park of Fanes–Sennes–Braies, and obstructed the torrent San Vigilio. The whole event did not last longer than half an hour. In a few hours, a small lake had formed on the valley bottom that would have overflowed if had there not been timely intervention with scrapers (Plate 2).

Of great importance during this event was also the presence of a dyke, built in 1971 at the top of the alluvial fan, which was constructed to deviate the course of the Fojedöra from the village of San Vigilio. On that occasion, the dyke contained most of the debris torrent and carried it to an uninhabited area of the alluvial fan. In this way, the deposition of debris dammed temporarily the torrent San Vigilio and formed a small lake.

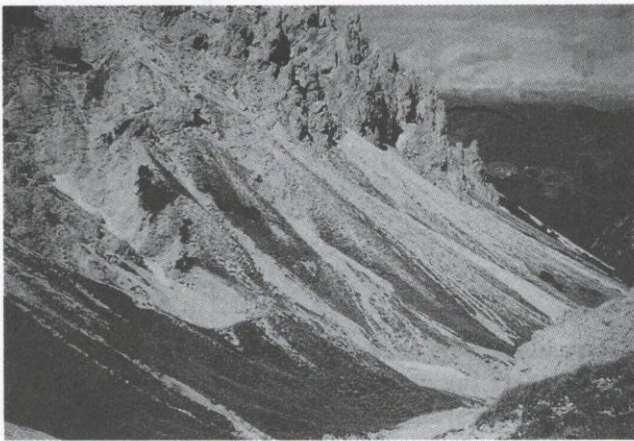
Plate 3: Debris cones in the upper reaches of the torrent Fojedöra

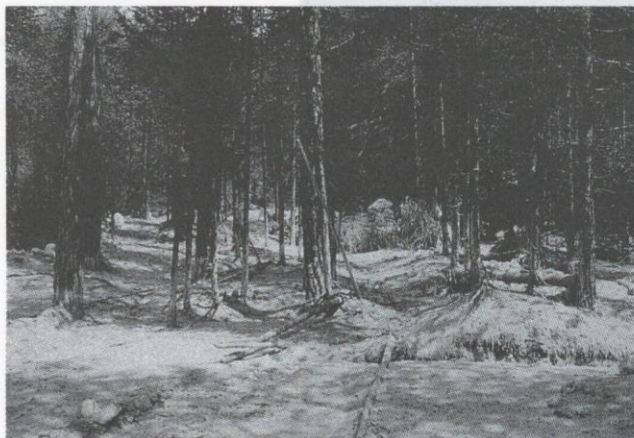
Plate 5: The fir forest invaded by the debris torrent. Photograph taken the day after the event

The observations made after the event have demonstrated that a small part of the material transported by the debris torrent was not contained by the dyke and invaded the forest located at the top of the alluvial fan. The likelihood of a flow reaching the village was studied by preparing a slope map and a vegetation map of the whole alluvial fan. From a comparative analysis of the two maps, it was possible to affirm that the presence of the forest and the gentle slope can prevent any flow not contained by the dyke from reaching the village of San Vigilio. In the present situation, the greatest risk to the village seems to be from the damming of the torrent San Vigilio in the event similar to that of 27 July 1995. The breaching of the dam can cause heavy damage in the village.

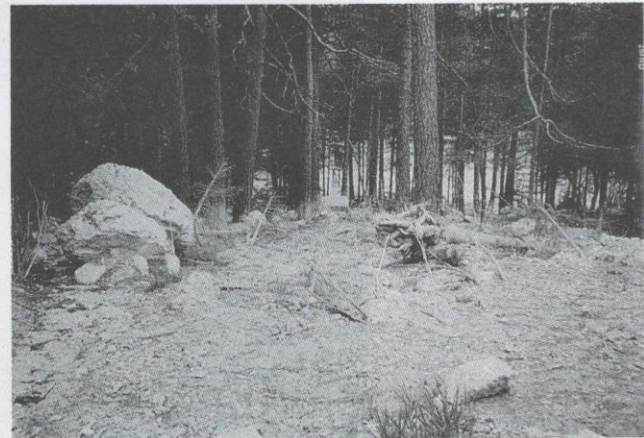
Plate 6: The same as Plate 5, but taken from another spot a year after

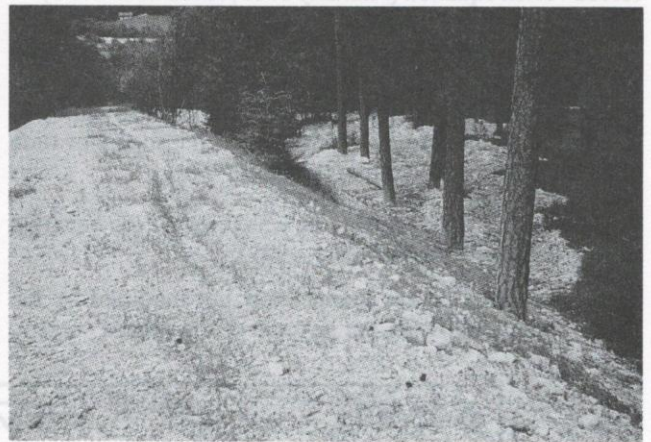
Plate 8: Debris overflow beyond the dyke. The torrent Fojedöra is to the left of the dyke.

A dyke begins at an altitude of 1,340 m and it diverts the torrent Fojedöra leftwards. Here, most of the material was deposited against the dyke itself. The velocity of the flow was such that a small part of the debris was able to pass over the dyke to invade the outer fir trees growing on the alluvial fan (Plate 8). One year after, there was practically no trace of the debris that had accumulated against the dyke as
