Recent landslide studies in the Dolomites (Eastern Italian Alps) for hazard assessment and mitigation

F. Mantovani¹, A. Pasuto², and S. Silvano²

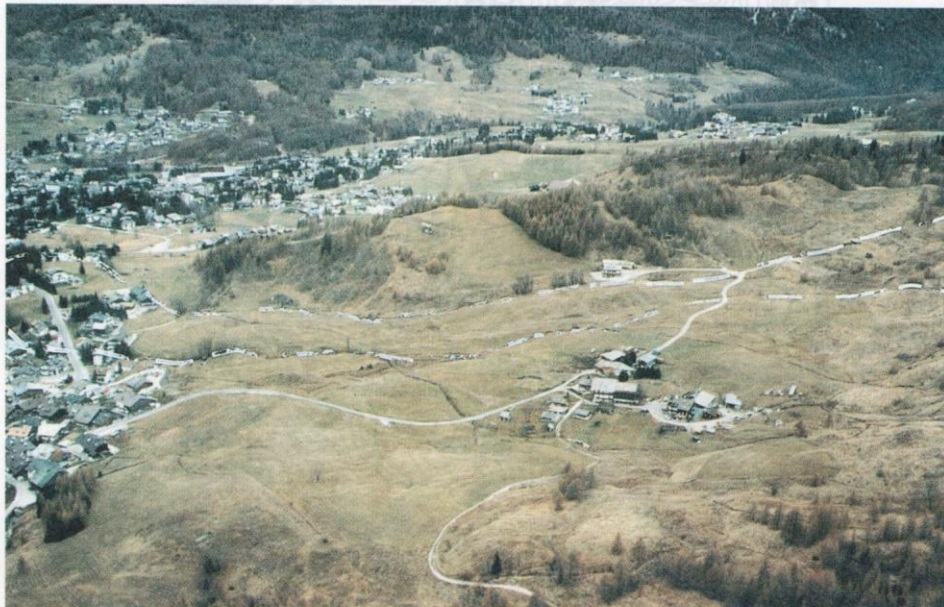
Plate 1: Aerial view of the mid-lower part of the Alverà Landslide. The boundary of the landslide is reported.

widely crops out all over the area (Plate 1). Since the study area is characterised by its high environmental and economic values as well as intense urban development, this landslide was monitored for obtaining the kinematic and hydrogeological parameters. Various types of information collected on the evolution mechanism of this landslide during the past ten years were used in a numerical model for an accurate prediction of the ongoing instability processes.

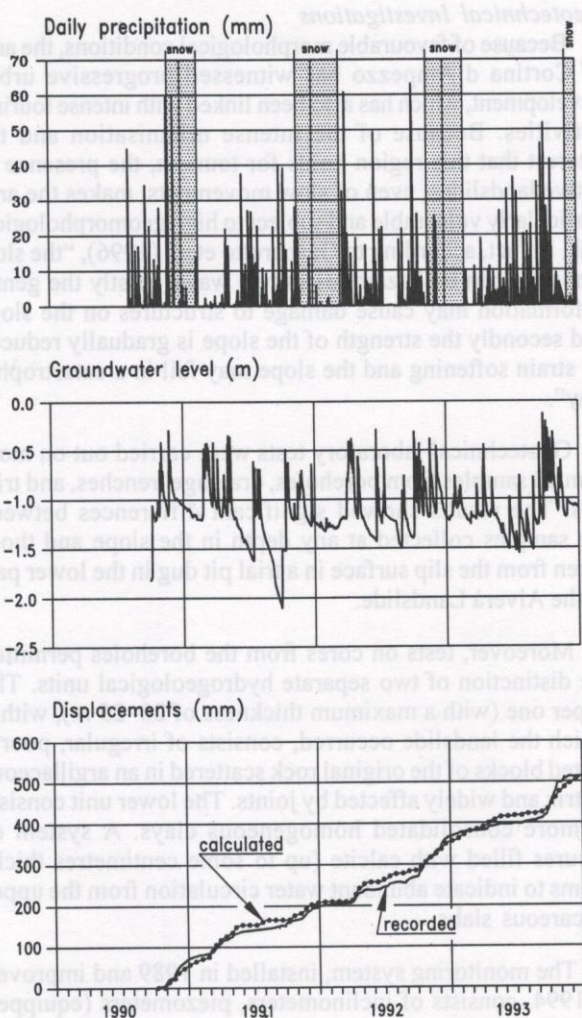
Fig. 3: Precipitation depth, groundwater level, recorded and calculated (by means of a visco-plastic rheological model) displacement in the Alverà Landslide.

The above information was used for generating a numerical behavioural model (Fig. 3), which can accurately reproduce the ongoing instability processes (Angeli et al. 1996, 1998). It is also able to forecast the magnitude of landslide movements in low-gradient clayey slopes, which are widespread in the Dolomites and many other mountain regions.

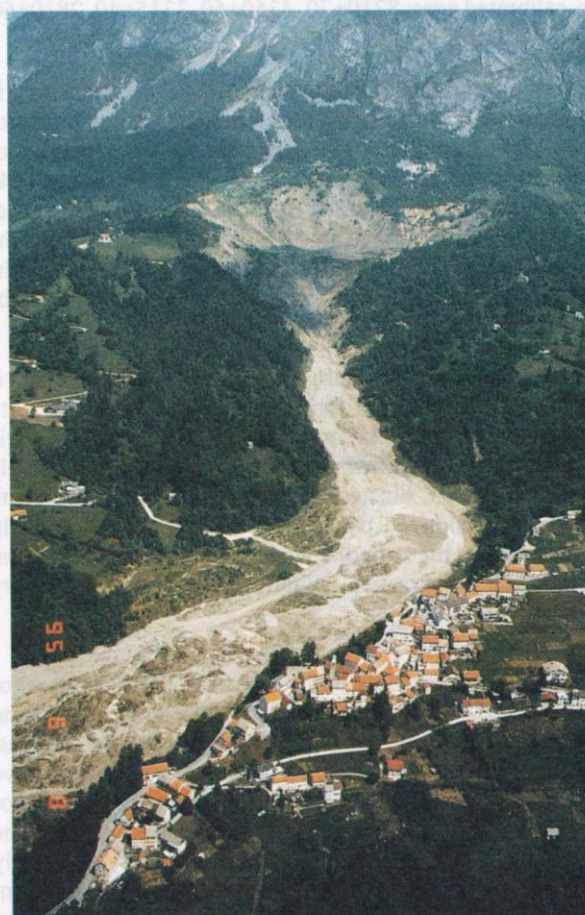
Plate 2: Aerial view of the Tessina Landslide with the threatened village of Funes.

The Tessina Landslide (Plate 2) is a complex gravitational movement affecting the Tertiary Flysch Formation and is situated within the watershed of the Alpago (east of Belluno). In addition, in this case the particular urban
