Mountain hazards in the Kanchanjunga area, eastern Nepal: landslides developed on lateral moraines

Teiji Watanabe¹, Naohiro Nakamura¹, and Narendra R. Khanal²

ABSTRACT

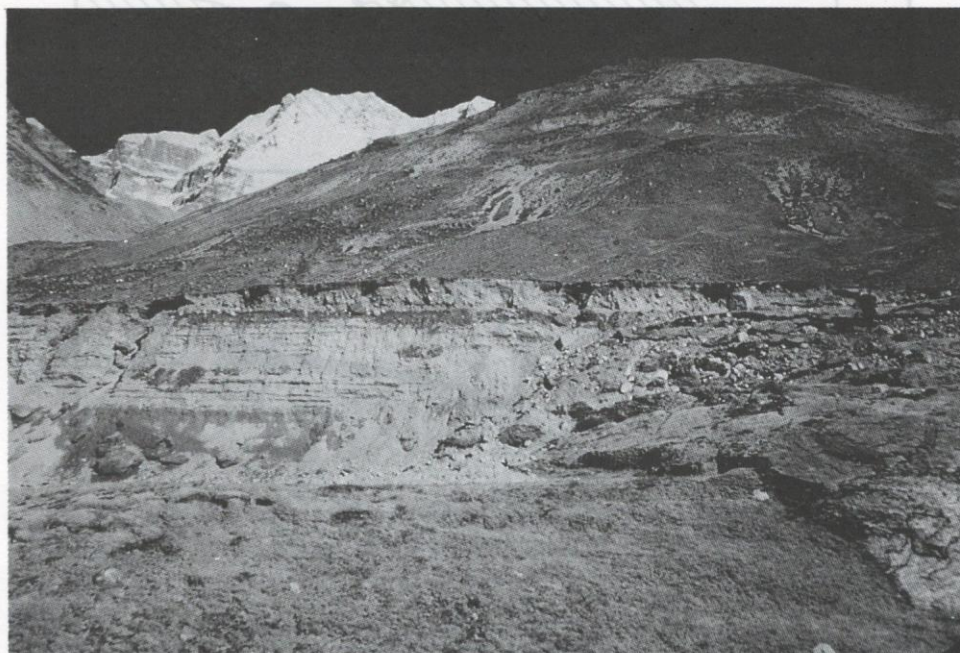
Plate 1: Slipped blocks of the lateral moraine of the Kanchanjunga Glacier at the Pangpema Base Camp. The landslide scarp in the centre is 13.5 m high. Stratified sand deposits are seen on the left of the scarp. The right side of the scarp is composed of morainic deposits.

The landslides are observed only on the right bank of the lateral moraines (Fig. 2). The total length of the landslide scarp attains 7,600 m (Table 1), although some of the scarps are unclear at some sites. The relative height of the scarp ranges from 0.5 to 70 m (Plate 1).

Also, the right photograph of Plate 1 shows that one of the landslide scarps continues to the side and front slopes

of the Little Ice Age moraine of the tributary valley glacier from the north. This demonstrates that the landslides on the lateral moraines of the Kanchanjunga Glacier were formed after the Little Ice Age.

The lateral moraines are not composed of homogeneous materials (besides tills, debris flow deposits fill the upper part of the moraines at places). There are also some laminated sand layers (Plate 1) with frequent seeps. Table 1 shows that the altitude of the landslide occurrence ranges from 4,400 to 5,200 m. If the lower limit of the present permafrost lies between 4,850 and 4,890 m, the landslides at Sites A, E, F, and G appear to have occurred when the permafrost existed at the lower altitudes.

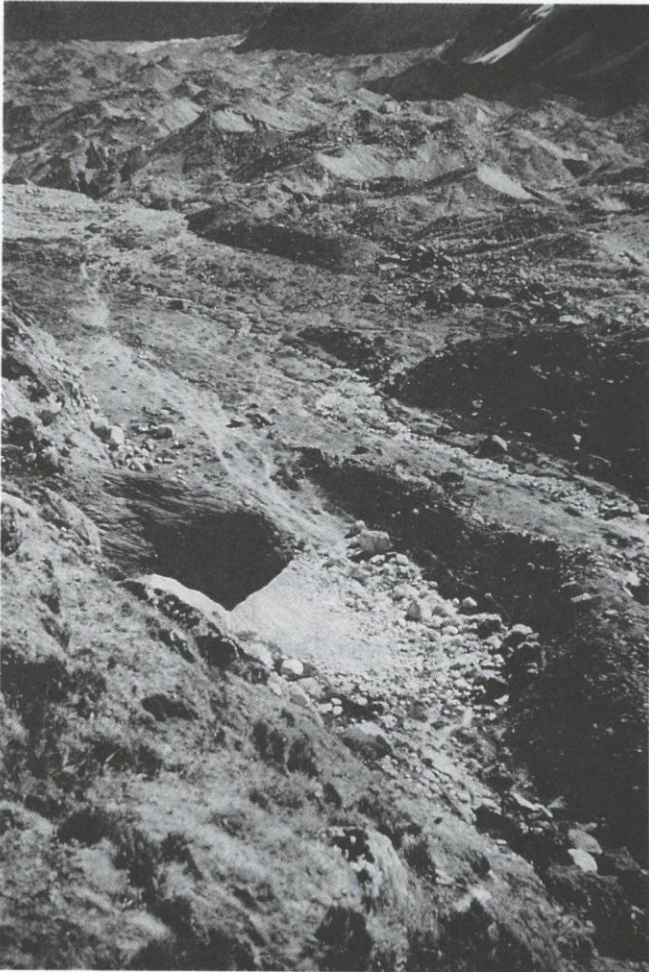
Plate 2: A trail to the Pangpema (Kanchanjunga) Base Camp, which is stretching on the morainic material displaced by sliding. Note that part of the trail is buried by rock fall debris from the landslide scarp. The trail abruptly disappears at the head of the scarp near the upper left corner of the photograph, indicating that the landslide occurred after the establishment of the trekking trail between the Lholak and Pangpema Base Camps.

The landslide on the lateral moraines cut the trail at some sites. The trail seen on the slid moraine, for example, disappears at the crown of the landslide near the upper left corner of Plate 2. The establishment of the trail network in the high mountain areas must be recent phenomenon, and therefore the landslide began to occur only recently. There are also some dormant landslides with many tension cracks indicating that the sliding is still going on.

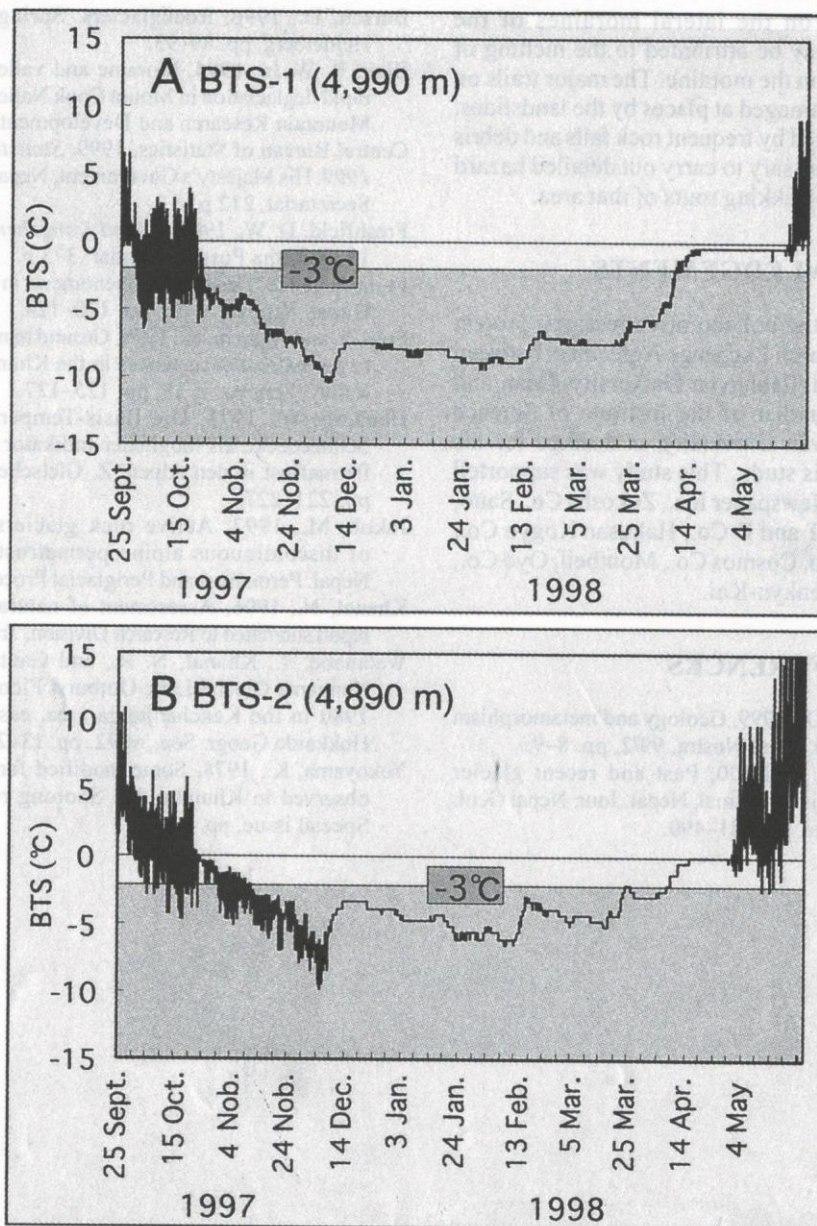
Fig. 6: BTS values in the winter of 1998 for the Nupchu Rock Glacier. Locations are shown in Fig. 4.

At an altitude of 4,990 m (Site BTS-1) on the newest rock glacier, the BTS values were below -3°C (A in Fig. 6), and at an altitude of 4,890 m (Site BTS-2), they were higher than those at Site BTS-1 but were well below -3°C (B in Fig. 6). These data support the existence of permafrost at these altitudes.
