## A case study of the Bungmati Landslide on fluvio-lacustrine sediments of the Kathmandu Valley

### ABSTRACT

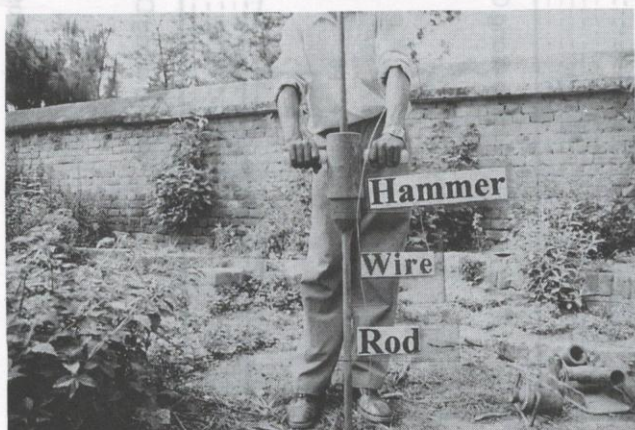
Plate 1a: Installation of RDT and VWE

The Rod Driving Test (RDT) is applicable only for soft soils. It is a rather new and simple method. In the RDT, a cone of 5 cm in diameter is driven into the soil by dropping a 5 kg hammer from a height of 1 m (Plates 1a and 1b). The number of blows to drive each 10 cm is recorded. The total number of blows in each test was limited to 60. The rod was easily driven to the dept of 6–7 m (Fig. 4).

The Vertical Wire Extensometer (VWE) is useful for monitoring the landslide movement. In the Bungmati Landslide, eight VWEs were installed in the same hole where the RDT was carried out. Three VWEs were set up near the toe of the landslide, and other three were in the vicinity of the crown. The remaining two VWEs were installed near the centre of the landslide. The location points of VWE (which coincide with the RDT sites) are shown in Fig. 2. Except for the location P6 (Fig. 2), two wires were fixed in each hole at different depths in between which the sliding plane was expected. From two to three metres of wire was left at the surface for recording the future movement of the landslide.
