Rock slope deformation analysis of the powerhouse cut-slope at Middle Bhotekoshi Hydroelectric Project in Sindhupalchok District, central Nepal

Subarna Dhakal, Suman Panthee*, and Durga Acharya

Central Department of Geology, Tribhuvan University, Kirtipur, Kathmandu, Nepal

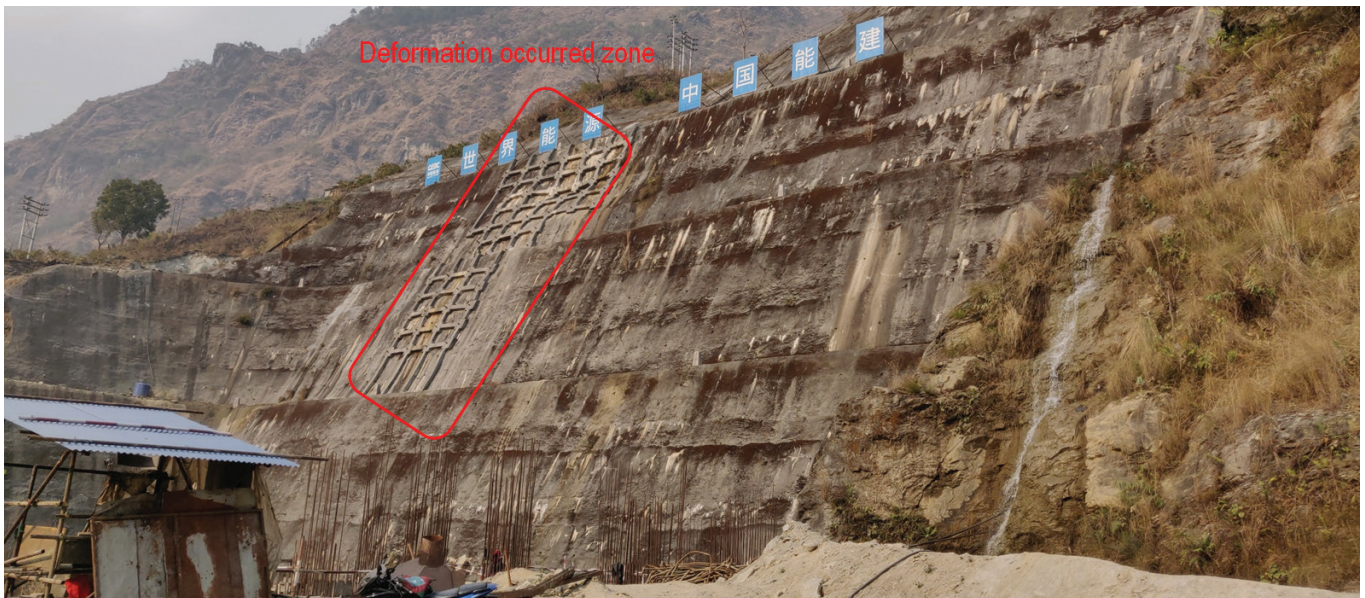
The rock slope deformation analysis was investigated in the deformed slope (Fig. 2) using kinematic analysis, inclinometer as well as numerical modeling. The field study, a 1: 50000 scale topographic map, a geological map by Stöcklin and Bhattarai (1977), as well as an engineering geological map by the Middle Bhotekoshi Hydroelectric Project were all used to define the deformation characteristics and analysis. The study area is located in the intercalation of the psammitic schist and pelitic schist in the ratio of 4:1 ratio that was determined by the geological study. Stöcklin and Bhattarai (1977) named this formation the Kunchha Formation which has grey-green gritty phyllite and metasandstone, however, the phyllite is metamorphosed into schist in the study area.

Fig. 2: Deformation area in cut-slope and secondary support application.

Later, to avoid the displacement of slope that was incurred in the initial analysis and deformation record, the project used the rock bolt of length 10 m which helps to decrease the displacement of the cut-slope. The bolts were applied in a pattern with concrete blocks. The second support can be seen in Figure 2. During the study time, the project had not designed the second support, so the detailed analysis of the second support was not analyzed in this study.

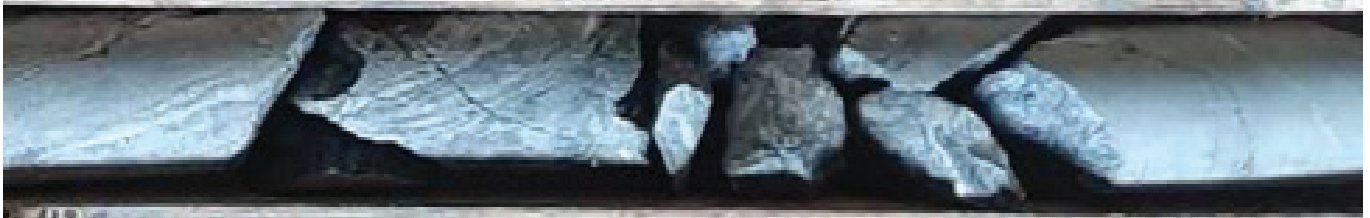
In the core study, quartz veins were densified layers that were developed during tectonic deformation in ductile conditions were distributed in several sections (Fig. 5). Close observation of the cores found that several sections have ductile-deformed schist but the information in the core log record was not mentioned. The distributions of the deformed quartz vein sections were distributed unevenly.

Fig. 5: View of core of the deformed section of PSIN-1.

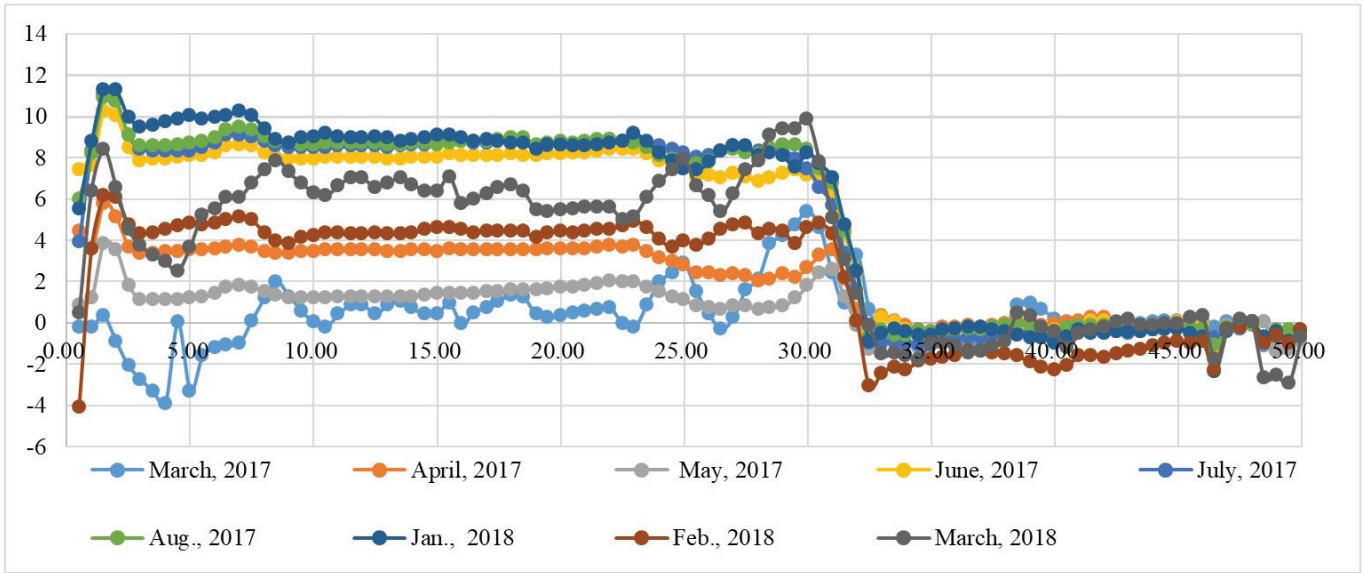
Among five boreholes, only PSIN-1 borehole shown significant deformation in the cut-slope which can be seen in the depth-displacement trend graph with respect to time obtained by inclinometer data reading (Fig. 6). The graph shows both negative and positive displacements. The positive displacement can be related to the movement outside the slope surface, whereas, the negative displacement is related to the movement towards inside the slope. The zero value of displacement indicates that the slope has no deformation.

In the inclinometer data, at depth of 30 m to 35 m, the deformation (in mm) of the slope was observed. At the depth drastically movement of the slope was found. because from the core log data this zone lies in psammitic schist with pelitic schist parting and after that, there is psammitic schist only. So in psammitic schist deformation becomes low due to strength

(UCS = 26 MPa). From 0 m to 32 m there may be a role of pore water pressure which increases deformation. In that zone, the joint is 3 to 4 sets which also plays role in deformation due to weakness made by joints in bedrocks.

Fig. 6 : The graph of displacement with respect to depth of PSIN-1.

The borehole log of PSIN-1 is located section shown displacement of the slope towards downward from the depth of around 30 m below. In this section, quartz veins were observed and a weak zone was developed due to several quartz veins aligned almost parallel to the foliation. The shear strength of the foliation along with such overburden seems critical for slope withstand. That was the reason why the slope has gone gradually displaced in the section. About 14 mm displacement was calculated at 28 to 31 m depth from numerical analysis. Displacement of 10–12 mm was recorded in the inclinometer which verified the numerical analysis information. This indicated that the quartz vein bearing weak layer which is almost parallel to the foliation was the main reason for the deformation.

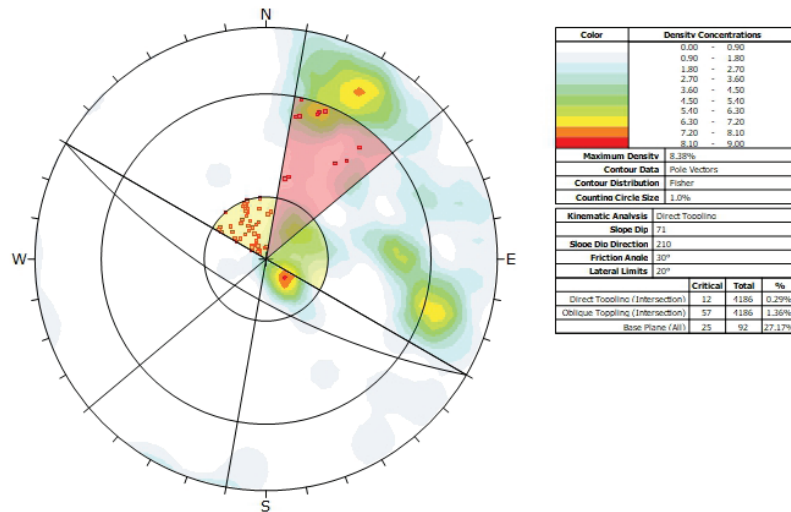
In the study area randomly, oriented structural data were collected and analyzed based on DIPS 6 software program. The facility is given by this software then a percentage of the possibility of failures was calculated. Analysis of discontinuity data and their relation to the slope face, taking the lateral limit is 20 and friction angle of the rocks is 30. Three modes of failure have been recognized which include plane failure (Fig. 7) wedge failure (Fig. 8) and direct topple (Fig. 9) that indicate probability of failure.

Fig. 9 : Analysis of direct toppling at the cut-slope.
