Quality assessment of bricks produced in Chitwan District, central Nepal

ABSTRACT

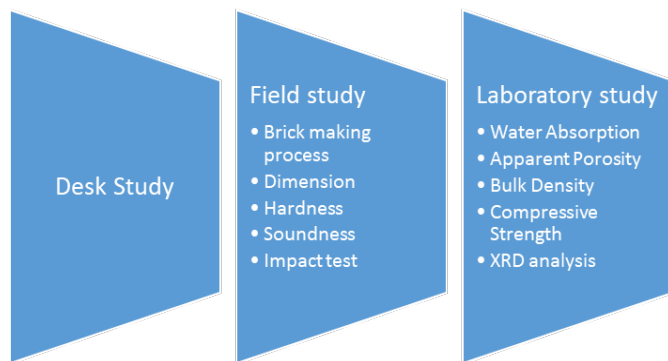
Fig. 2: Flowchart of methodology used in research study.

the aforementioned characteristics. The research study's approach is best described by the flowchart (Fig. 2). The field visit starts with the brick manufacturing process, followed by a field test, and ends with sampling collection for laboratory tests. The brick manufacturing process is initiated with the pugging of raw materials, moulding, drying and stacking, and ends with the firing process (Fig. 3). Pugging guaranteed the homogeneity of soil with different additives. Prior to pugging, effort should be taken to thoroughly eliminate all extraneous objects. If the extraneous objects were not removed before pugging, it would be difficult to mould the soil into bricks and the final product would be of low quality. Manual and mechanized pugging was followed for this purpose. Moulding is a second stage where a shape was provided to the clay. For this, each brick manufacturing industry has its own rectangular mould box having its own mark as an identification. The ground was properly labeled and cleaned before molding. The area was watered the day before the soil begin to mould. To prevent freshly laid bricks from sticking to the mould box and ground, releasing agent (fine sand) was sprayed on mould box and on the surface before moulding. The green bricks were carefully removed from the mould box after moulding. Then the drying phase was initiated. The drying process was conducted such that uniform drying of brick samples are recorded. The plasticity of soil and its grain size has a vital role for determining the time of drying. Bricks having large pores dry faster as compared to the bricks with clayey soil because

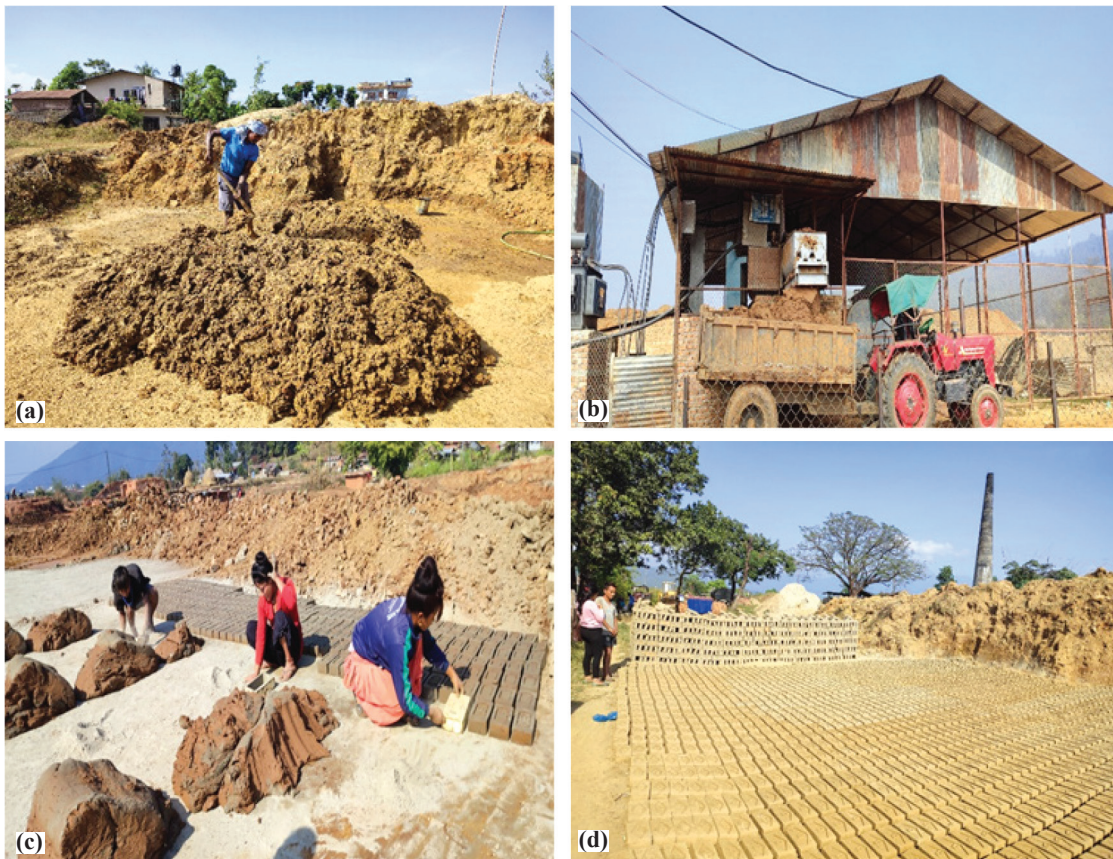
Fig. 3: Field observation of brick manufacturing sites; (a) manual pugging, (b) mechanized pugging, (c) moulding, (d) drying and stacking.

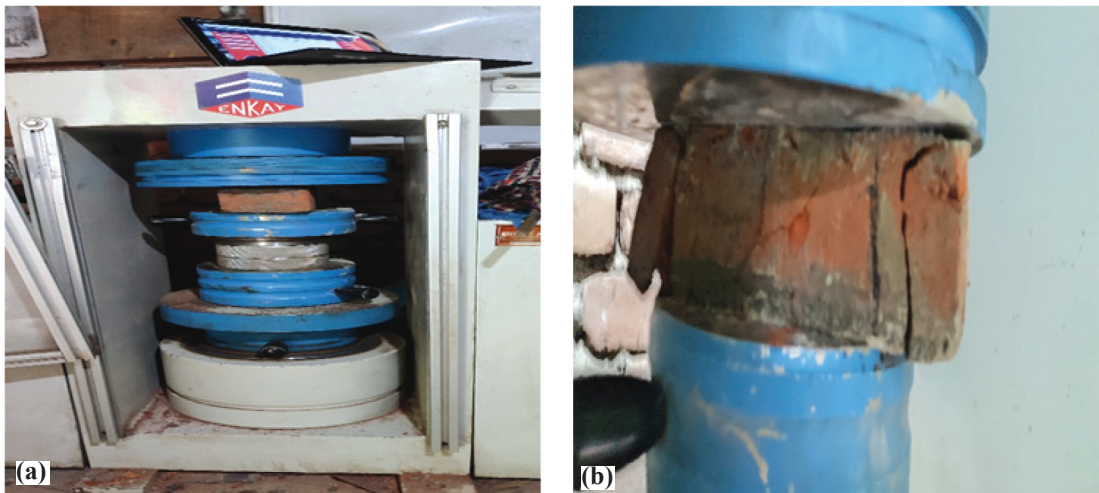
Fig. 4: Laboratory test of compressive strength for brick samples using Enkay software (a) compressive strength testing, (b) breaking of bricks after applying load.

Smart Drilling & Testing Pvt. Ltd. measured the compressive strength test using an automatic compression testing machine from Enkay Enterprises (Fig. 4). IS 3495 (Part 1): 1992 was followed for this test. The unevenness of the brick sample was removed using sharp objects. After this, the brick samples were immersed in the water for 24 hrs. The frogs or voids

of each brick sample were filled with mortar (1:3 cement mortar). After 24 hrs, the dimensions of each brick sample that can be measured with the machine were measured. These measurements were then used in Enkay software (Fig. 4) and the maximum load causing failure was noted (Eq. 4).

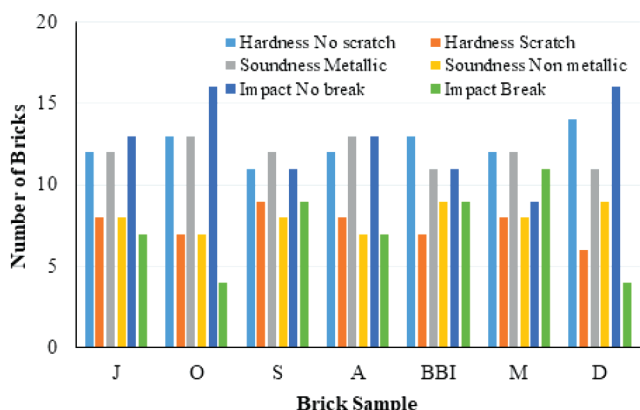
Fig. 5: Hardness, soundness, and impact test result for twenty samples from each brick industries.

each brick production sector follows the standard (Table 1). Figure 5 depicts the results of the hardness, soundness, and impact tests performed on the 20 brick samples from each brick manufacturing industry. The hardness test results showed that 20 brick samples from each brick industry have different hardness depending upon their manufacturing process, firing temperature, exposure to water and sunlight, and the selected samples' quality. The test results revealed that the 'D' industry's chosen brick samples are substantially harder than those from any other brick industry. Additionally, for seven brick industries, the range of broken brick samples is 4 to 11.

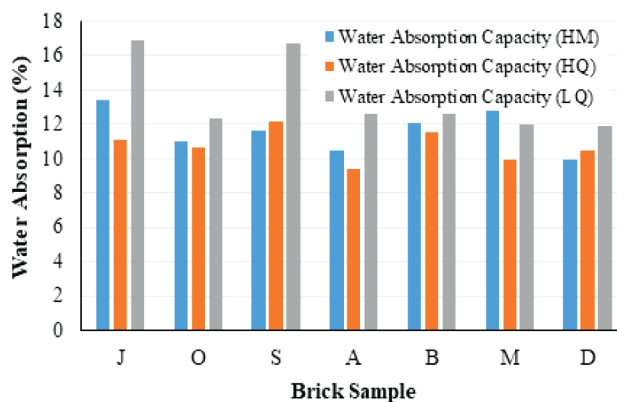
Fig. 7: Water absorption capacity of different brick samples.

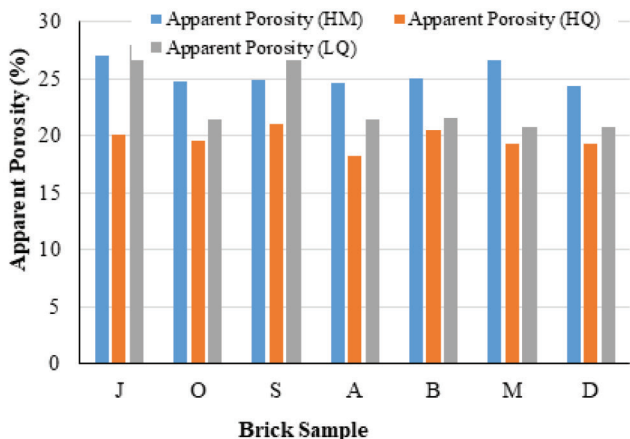
Fig. 8: Apparent porosity of different brick samples.

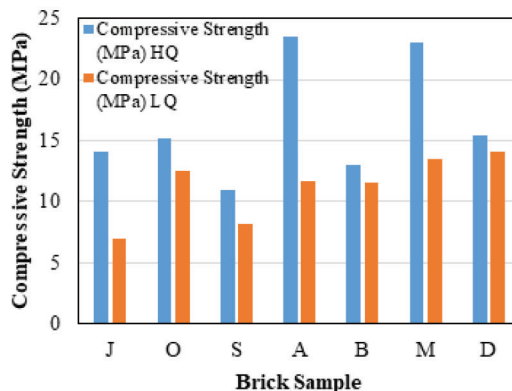
Fig. 10: Compressive strength of different brick samples.

Under the mechanical method of fire brick testing, the compressive strength of 14 brick samples from seven brick industries was examined. IS 3495 (Part 1): 1992 was followed for this purpose. The compressive strength for 14 brick samples ranges from 7.02 MPa to 23.49 MPa (Fig. 10). For high-quality brick samples, ‘A’ has the highest compressive strength of 23.49 MPa while ‘S’ has the lowest value of 10.95 MPa. Similar results may be seen for low-grade brick samples, where ‘J’ has the lowest value of 7.02 MPa and D has the highest value of 14.13 MP. The compressive strength of 33 brick samples from the Bhaktapur District ranges from 7.83 MPa to 22.10 MPa (Shrestha, 2019). The compressive strength of 49 brick samples of 17 grades was reported to range from 3.35 to 10.53 MPa (Chapagain, 2020). On seven Kathmandu brick samples, the compressive strength ranged from 5 to 23 MPa (Bhattarai et al., 2018). The test results revealed a modest similarity between Shrestha (2019) and Bhattarai et al. (2018) compressive strength value and our findings. The test results also followed the NBC 109-1994 standard which state that the brick's crushing strength must not be less than 3.50 MPa.

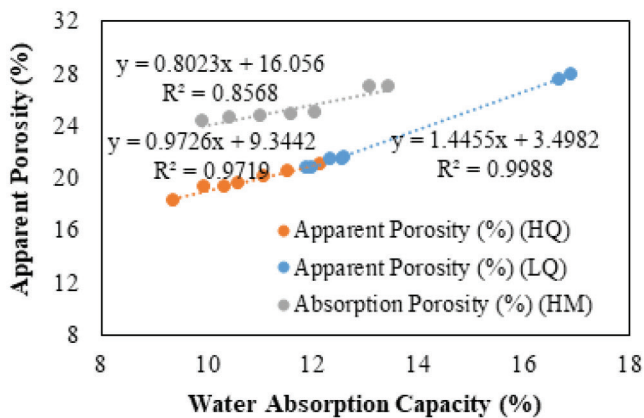
Fig. 9: Correlation between water absorption capacity and apparent porosity of the high-quality, low-quality, and handmade brick sample.

The correlation between water absorption capacity and apparent porosity between low-quality, high-quality, and handmade brick samples showed an R² value within the range of 0.8568 to 0.9988 (Fig. 9). The higher value of R showed that there is a good relationship between the water absorption capacity and

apparent porosity, and indicates that the brick sample absorbs the required water with a higher value of apparent porosity. With R-values of 0.9858 for high-quality brick, 0.9993 for low-quality brick, and 0.9256 for a handmade brick sample, it can be seen that low-quality brick has the greatest propensity to absorb enough water due to its higher apparent porosity value.

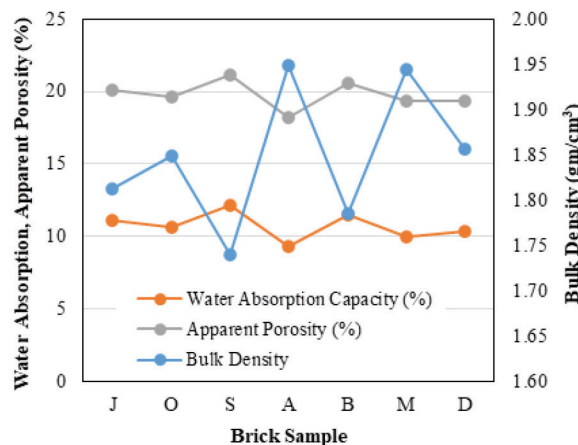
Fig. 11: Variation between water absorption capacity and apparent porosity with bulk density for high-quality brick.

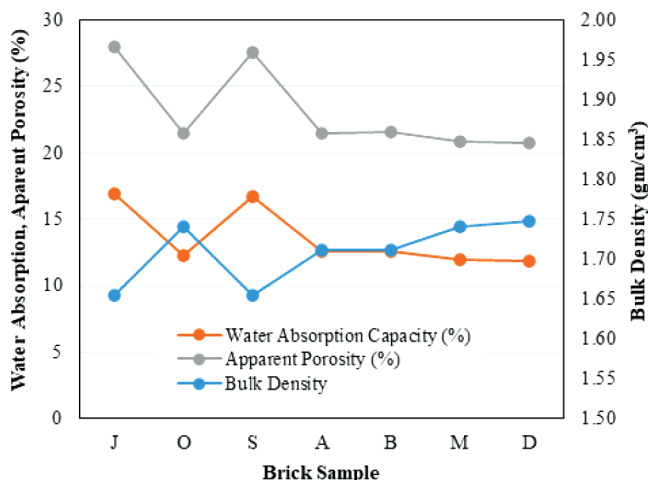
Fig. 12: Variation between water absorption capacity and apparent porosity with a bulk density of low-quality bricks.

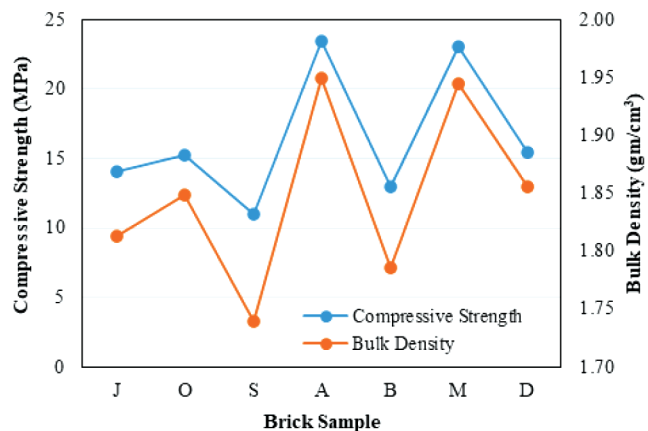
Fig. 14: Variation between compressive strength and bulk density of the high-quality brick from different brick samples.

The compressive strength and bulk density of the brick samples are directly correlated. The association of bulk density and compressive strength of seven brick samples from seven brick manufacturing industries was shown in figures 14 and 15. When the bulk density of brick samples rises, their compressive strength also rises. It signifies that they are directly proportional to each other. Therefore, it can be suggested that in order to improve mechanical properties i.e. compressive strength of the clay bricks, efforts should be concentrated on reducing both the water absorption and the apparent porosity as well as on increasing bulk density. This is because the physical properties are largely responsible for the improvement of all ceramic bodies, including clay bricks.

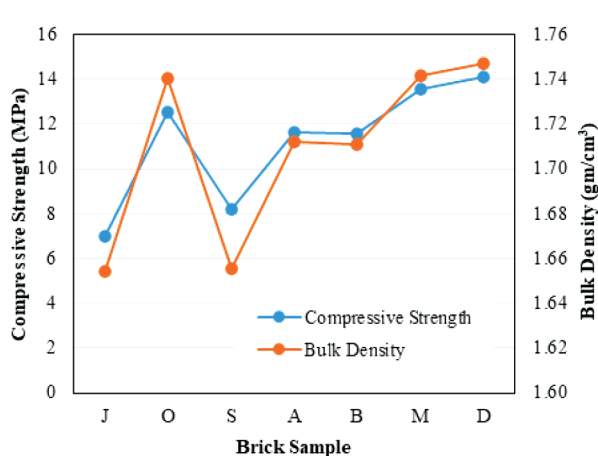
Fig. 15: Variation between compressive strength and bulk density of the low-quality brick of different brick samples.

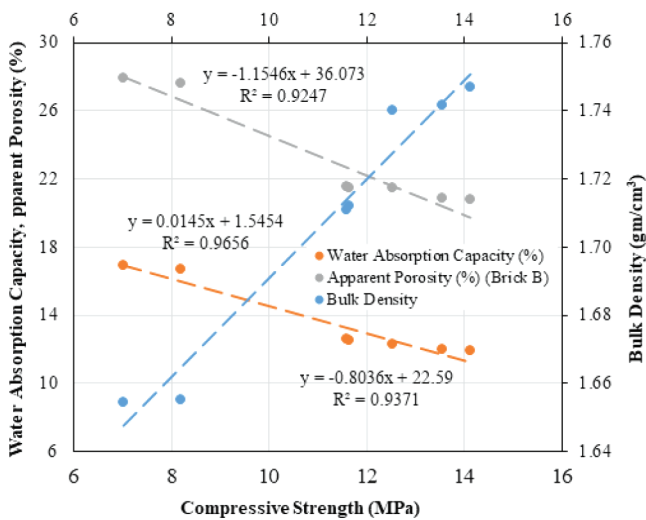
Fig. 17: Change in bulk density, water absorption capacity, and apparent porosity as a function of compressive strength for low-quality bricks.

Also, there is a strong association between the brick samples' apparent porosity, compressive strength, water absorption, and bulk density. The changes in bulk density, water absorption capacity, and apparent porosity as the function of its mechanical properties i.e., the compressive strength are shown in figures 16, 17. The bulk density of high quality brick samples has the highest correlation values than the other two parameters. In contrast to this, the water absorption capacity and apparent porosity R-value of high-quality bricks are less than that of low-quality bricks. It indicates that with the increase in compressive strength, and bulk density, low-quality bricks absorb more water than high-quality brick samples. Hence, with the increase of compressive strength, bulk density shows a positive increment, whereas water absorption capacity and apparent porosity showed a negative response which indicates the goodness of the brick sample to be used as construction materials

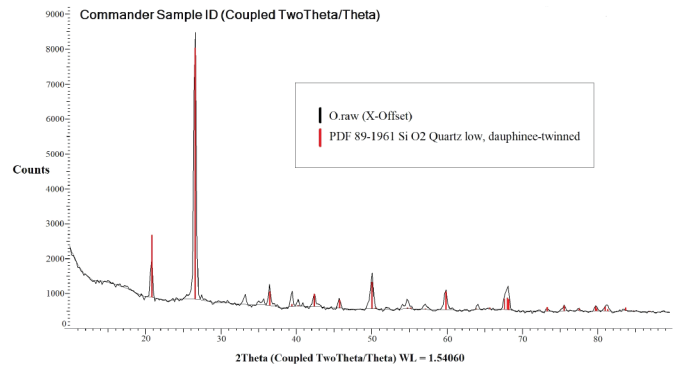
Fig. 18: XRD pattern of ‘O’ brick samples using secondary data obtained from Nepal Academy of Science and Technology (NAST).

The XRD test results i.e. the secondary data of the ‘O’ brick samples obtained from the Nepal Academy of Science and Technology are shown in Figure 18 as a sample representation of seven brick manufacturing industries.
