Construction of Mahadevtar Tunnel and Challenges Faced During its Stabilization

Abstract

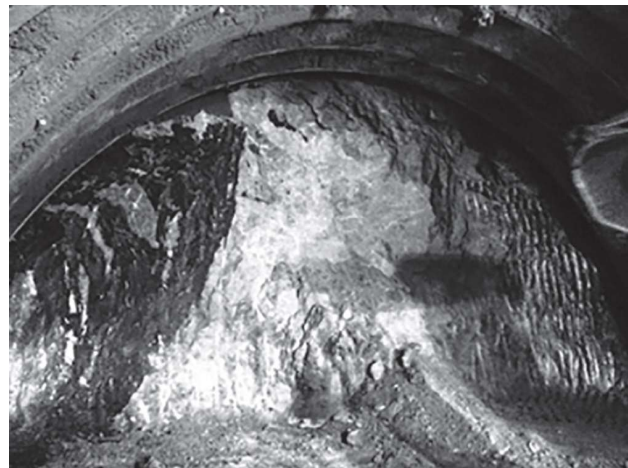
Figure 1: MT is exposed on the left in phyllite of Robang Formation at right

the Jhikhu carbonate band, was also encountered. The compressive strength of rock mass in exit tunnel was calculated 2 in the RMR in most of the cases. In schist of exit left tunnel, value of rock mass ranged from 35 to 60MPa measured with Schmidt hammer. As a result, the RMR was calculated as 4 for this rock type. In exit tunnel, MT was encountered from LK29+236.8 to LK29+216.5 (See figure 1). The overall thickness of MT was 20.3m. The MT was dark black, easily crushable by hand, and haphazardly jointed. Some quartz lenses and deformed material were also present. Ground water was shower in this area. The RMR values ranged from 17 to 22, with most cases falling between 17 and 19. In the right exit tunnel, we anticipate encountering it at chainage RK29+180, which has not yet been excavated.

In the Mahadevtar tunnel, the main fault is MT. It has already been encountered in the exit left tunnel but has not yet been encountered in the right tunnel. It is expected to be encountered approximately 20 meters from the existing face. Numerous shear bands and zones have been found in both the entrance and exit of the Mahadevtar tunnel. Local displacements of the rock mass are frequently observed in the entrance tunnel. The thickness of these shear bands ranges from 2 cm to 50 cm. They

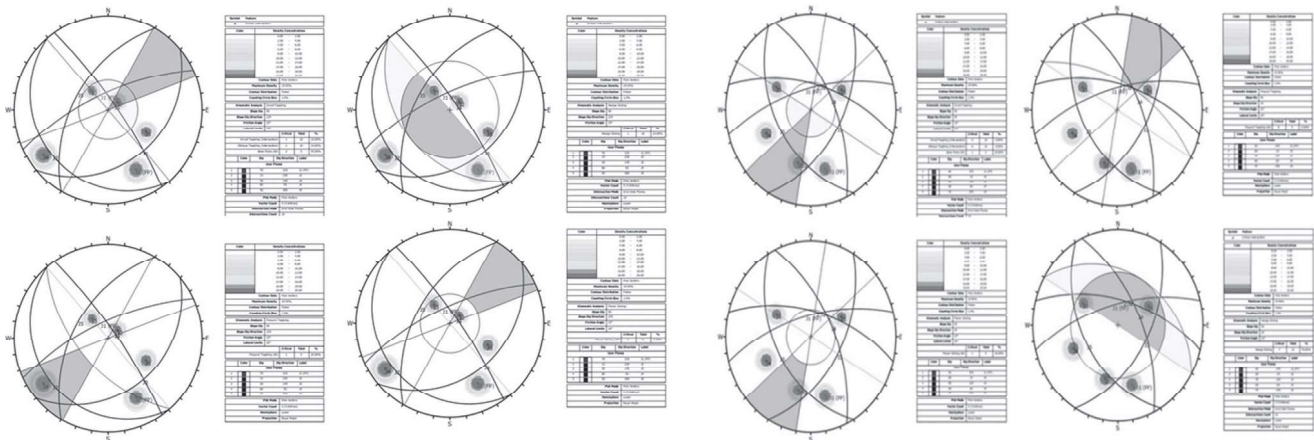
Figure 2: Kinematic analysis of entrance (left figure) and exit (right figure)

In the table 4, a range of joints is provided. Most of the failures were due to wedge and toppling. After conducting a kinematic analysis, it is also evident that the occurrence of plane failure is non-existent. In most cases, the rock mass has experienced wedge and toppling failure (See figure 2).

Trend	Entrance	Exit	Remarks
Tunnel Axis	Portal- 190° Curve- 203° Straight- 229°	30°	In entrance 3 types of sections are present
Foliation/Bedding	335-360°/50-80°	345-020°/60-70°	
Joint	220-270°/35-85° 110-190°/20-80° 55-80°/20-85° 295-310°/45-75°	07-18°/40-60° 120-170°/35-65° 30-60°/40-70° 210-240°/20-65°	Wedge failure is dominant in both tunnels.

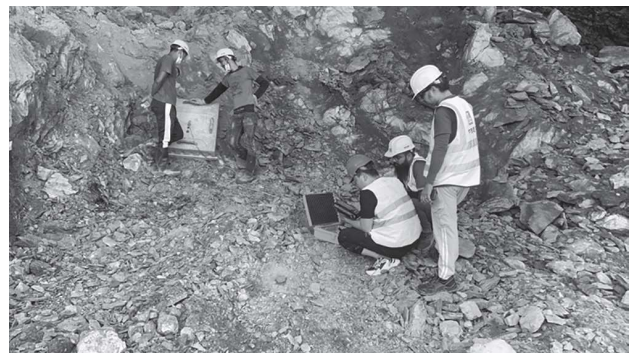
Figure 3: Conducting GPR survey in Mahadevtar tunnel

The underground geological conditions are unpredictable and may lead to various anomalies, creating challenges during excavation. To better investigate the geological and hydrogeological conditions ahead of the tunnel excavation working face, we aim to enhance the accuracy of our geological exploration data. For this purpose, we utilize ground-penetrating radar (GPR) to forecast the alignment of the unexcavated tunnel. GPR effectively detects the surrounding rock geology, including cavities, karst formations, and water-rich areas behind the face (See figure 3). It provides information on rock conditions up to 30 meters from the tunnel face.

After ensuring that there will be no problem in further excavation and that the collapsed area is fully supported and stable, the previously dumped muck must be removed. Before full excavation, a Ground Penetrating Radar (GPR) survey should be conducted. If any anomalies are detected, it is not advisable to excavate the full face. A breaker is recommended for full excavation; if that is not possible, then a smooth blast should be done. However, excavation should begin with single ribs until the collapse area becomes stable. The number of ribs can be gradually increased after some time.
