# Injuries and Complications Management with Forsus Appliance

**Introduction:** Forsus is a useful appliance for non-compliant Class II problems, however various problems can occur when using them.

**Objective:** To demonstrate a comprehensive series of critical situations that can occur using the Forsus device and to provide the possible solutions of each complication.

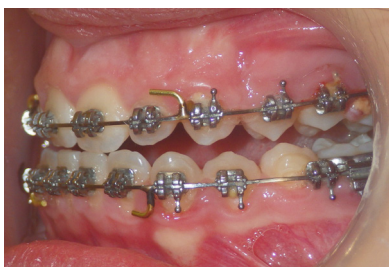
Lower bracket failure is the most common emergency associated with the Forsus (27%). The use of a fully compressed Forsus and/or repetitive cycles of opening/closing of the mouth can occasionally cause canine/premolar bracket bond failure (Figure 1).

Figure 1: Bracket of second premolar debonded

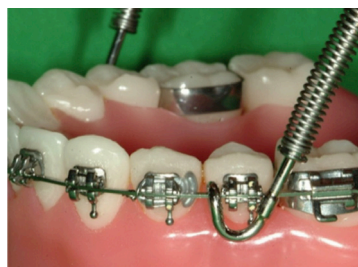
Elastomeric ligatures with a bite guard (3M Unitek, Monrovia, CA, US) were originally conceived to prevent debonding of the lower incisor brackets caused by premature contact of the upper against the lower incisors in deep bite patients (Figure 2a-b). They can be placed under the main working wire (commonly .019x.025 SS wire) around the premolar/canine bracket. The signet part should lean toward the distal side of the bracket to cushion the contact between the Forsus push rod and the canine/premolar bracket.

Figure 2a-b: Bite guard to prevent debonding of the lower incisor brackets

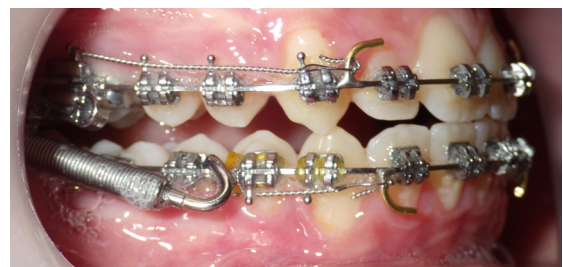
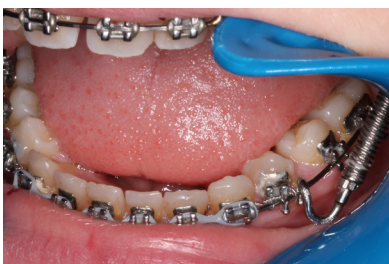
If the bracket is a passive self-ligating type with a self-locking door, the retention of the .019x.0125 SS wire will be assured by the door itself. If the bracket is a standard one or an active self-ligating bracket, it is better to tighten a .010 metallic ligature around the bracket to prevent mesial rotation of the tooth (Figure 2a). Mesial rotation may be caused by the distal push on the bracket together with a failure of a standard elastic ligature or opening of the self-ligating active door (Figure 3).

Figure 3: Mesial rotation of first premolar due to failure of standard elastic ligature

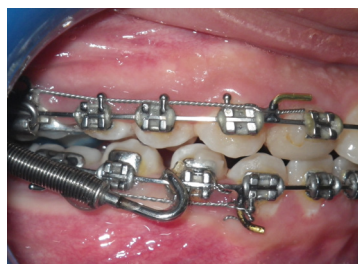
Figure 4: Thick composite build-up to rebond first premolar "on the wire" during active Forsus therapy

A reinforced adhesion of the target bracket may be obtained by etching the mesial and occlusal surfaces of the canine/premolar bracket and adding a thin extra layer of flowable composite around the base of the bracket (Figure 4). This will make failure of the target bracket a rare event.

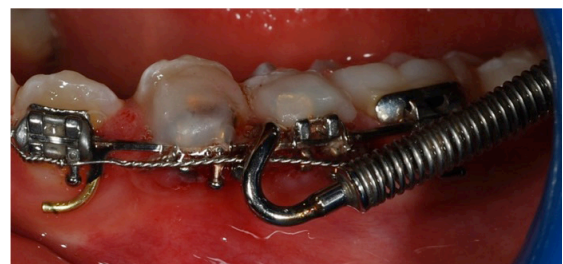
Figure 5: Build-up of flowable composite on the occlusal and mesial surface of the bracket

Immediate reparation is needed when a lower bracket fails, otherwise the lower push rod will push mesially the debonded bracket against the adjoining mesial. The effectiveness of the spring will thus be reduced. We advise re-bonding on the wire because the wire setup of the lower arch is quite complex and time consuming (metallic ligatures, cushioned elastic ligatures, composite build-up). The debonded bracket is embedded in a thick layer of flowable composite that extends around the bracket base (Figure 5).

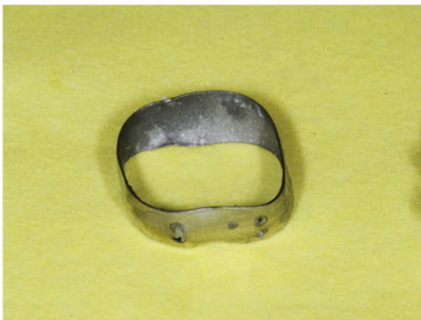
The tube of the upper first molars may also fail in the case of "Forsus on the wire" or the headgear tube of the band may break in the welding area (3%) in case of E22 or L-pin insertion of the spring module (Figure 6).

Figure 6: Breaking of band tube in the welding area

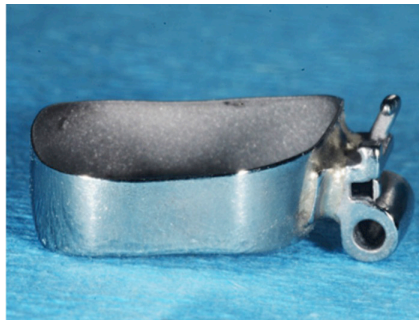
Figure 7: Welding of the tube reinforced

The headgear tube welding on the band (laser welding) can be reinforced by consolidating the auxiliary tube for the headgear (Figure 7).

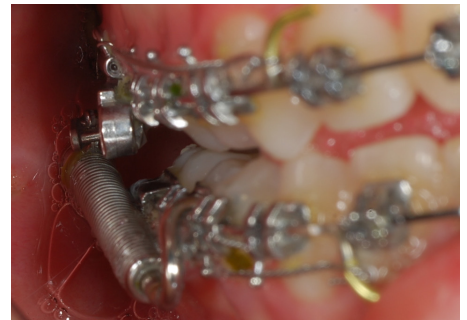
Rubbing of the orthodontic appliance against the cheeks may cause irritation of the cheek mucosa (13%) (Figure 8-11). In four cases, it was necessary to temporarily remove the appliance from the mouth to allow healing.

Figure 8: Lesion on the rear cheek mucosa (due to the back part of the spring)

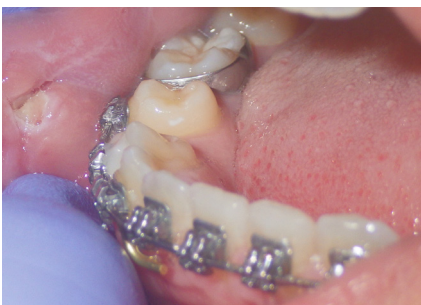
Figure 9: Lesion on the cheek mucosa (due to the middle part of the spring)

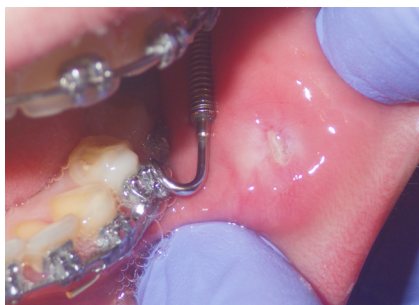
Figure 10: Lesion on the cheek mucosa (due to the middle part of the spring)

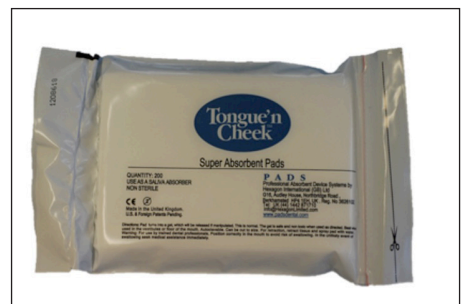
Figure 14: Tongue'n Cheek dental pads™

provide the patient with a set of cotton rolls that should be placed in the vestibular fornix beneath the spring. Cotton rolls keep the cheek mucosa away from the push rod and the spring, thus allowing an initial strengthening of the mucosa, analogous to what happens with wax and standard brackets. Patients are instructed to use the cotton rolls at night (not during the day because they would give a hamster-like appearance) for the first 7-10 days. Cotton rolls are very effective, but are also slightly uncomfortable because they are rigid. We found Tongue'n Cheek Super Absorbent Pads (Hexagon International (GB) Ltd., UK) to be a better alternative (Figure 14). They are soft cotton pads that gain volume when they absorb saliva (Figure 15). They are more comfortable than standard cotton rolls as they are softer. They can also be used to relieve an injured mucosa.

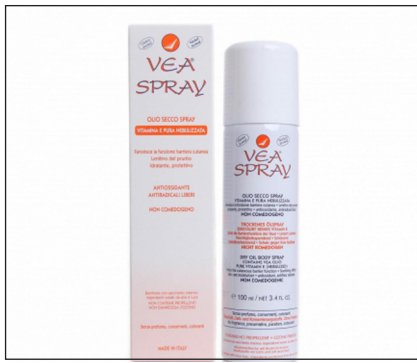
**Figure 16: Vitamin E prophylaxis to increases the turnover of epithelial cells and to act as a lubricant**

Vitamin E prophylaxis should begin a month before inserting the Forsus and continue during treatment to increase the turnover of epithelial cells and to act as a lubricant<sup>7,8</sup> (Figure 16). Consumers have a choice among gels or sprays.

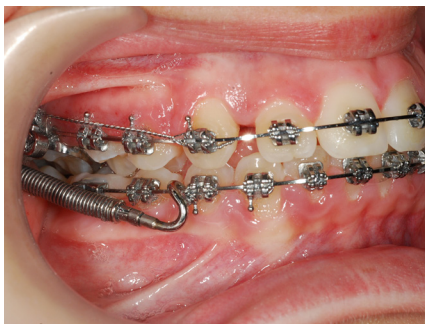
**Figure 18: First molar intrusion**

The Forsus activation generates a force vector that produces intrusion and distalization of upper first molar. The intrusion of the first molar (23%) may sometimes be impressive (Figure 18-19). As the intrusion force is vestibular to the center of resistance of the first molar, it can indirectly induce a torque augmentation, which is caused by the moment generated by the intrusive force.

It is advisable to engage the second upper molars from the beginning of the treatment to avoid or minimize this condition. With the second molar connected to .019x.025 SS wire, the force is evenly distributed on the molars and specific side effects on

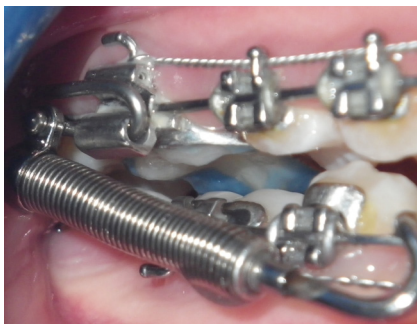
**Figure 19: First molar intrusion**

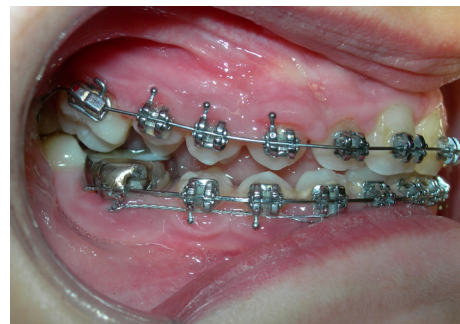
**Figure 20: Second molar bonded to extrude the first molar**

the teeth supporting the spring occurs only rarely. If the upper second molars were not included in the initial bonding, some intrusion on the upper first molars may appear, and it will be more intense for greater duration of Forsus use. If intrusion or flaring happens, the orthodontist should finally include the second molars after Forsus removal and use a thin NiTi/CuNiTi wire to allow the upper molars to extrude (Figure 20).

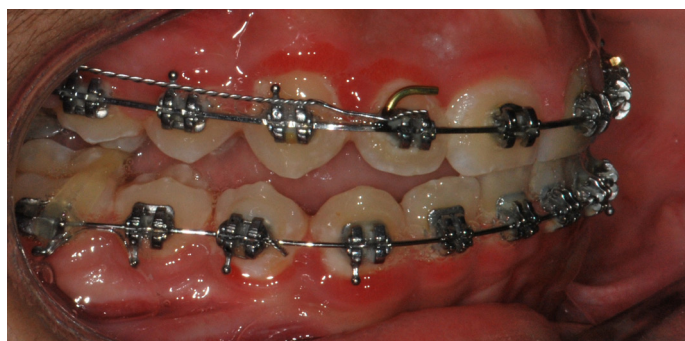
Figure 21: Vestibularization of the lower molars

This is a very rare situation (2%). It is hypothetically due to a convergent inclination of the spring that pushes forward the dental elements against the cortical bone, which opposes resistance to the mesial/forward force. The right and left forces exerted by the pushrods act posteriorly in the lateral side of the arch pushing from backward to forward on the wire, behind the first premolars. The wire is connected to the teeth and they cannot really advance forward as incisor root are embedded into the alveolar bone (they can eventually procline as a consequence of forward forces). The wire is affected by these forces that tend to widen its end, thus causing vestibularization of the lower molars. As a consequence a cross bite in the molar area may be seen (Figure 21).

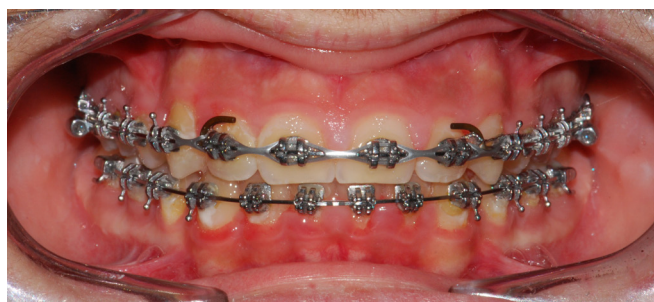
Figure 22a-b: Criss-cross elastics to resolve the vestibularization of the lateral sides of the lower arch

The use of crossbite elastic is the solution to decrease the excessive vestibularization of the lower molars and to achieve a correct intercuspation (Figure 22a-b).
