Geological and Geotechnical State of the Nisane Khola Landslide, Dharan, Sunsari, Nepal - A Case Study

Abstract

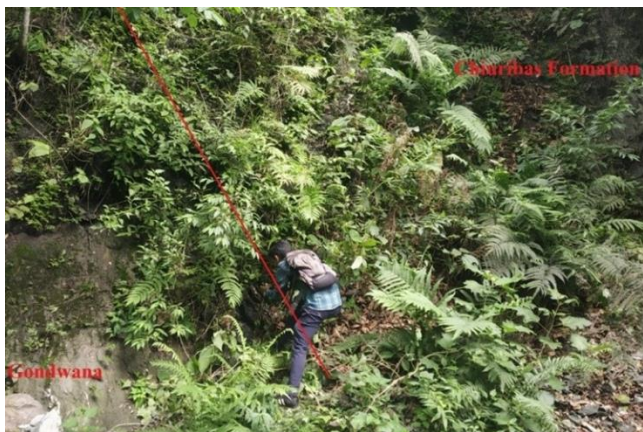
The lithology comprises of greenish to dark grey 10-45 cm thick beds of quartzite and metasandstone alternating with green to grey phyllite. Occasional metabasic intrusions can also be observed. The metasedimentary sequence is separated from the rocks of the Gondwana sequence by the Dharapani Thrust (Fig. 3).

Fig. 3: Exposure photo showing boundary zone between rocks of the Chiriabas Formation and Gondwana rocks about 200 m upstream along the Nisane Khola from the Nisane Bridge over the Koshi Highway

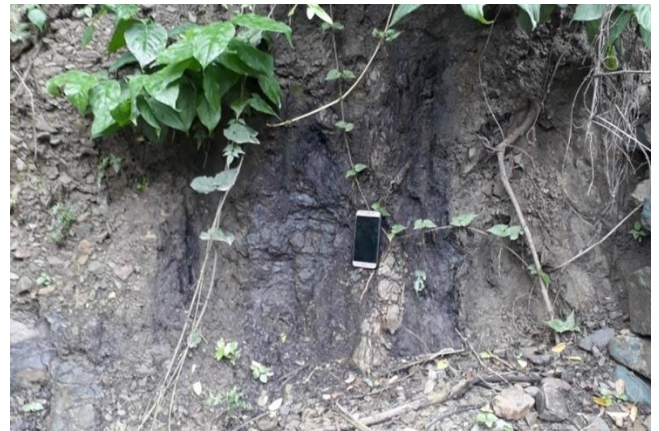
The Gondwana rocks can be observed upstream along the Nisane Khola from the Nisane Bridge on the Koshi Highway. This sequence consists of grey to black shale alternating with greenish to bluish grey, thick sandstone beds. This unit resembles with the Tamrang Formation of Barahakshetra section (Dhital 2015) which is separated from the Siwalik by Main Boundary Thrust (Fig. 4).

Fig. 4: Exposure Photo showing the boundary between the rocks of the Siwalik and Gondwana Sequences at the left bank of Nisane Khola at the Nisane Bridge on Koshi Highway

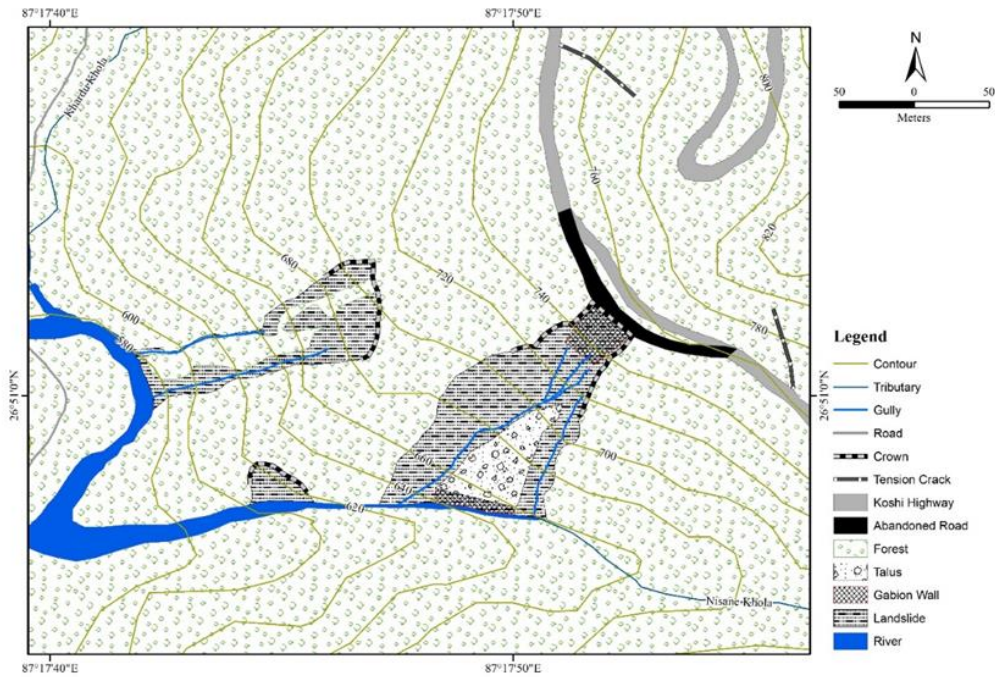
An attempt was made to prepare the landslide map and cross-section (Fig. 5 and 6) in order to delineate the area affected by landslide. Altogether, three major scarps of landslides can be observed on the area (Fig. 5). The major emphasis has been given to the slide, which has obstructed the Koshi Highway. Some tension cracks (Fig. 7) and sign of creeping (bent trees stem) indicates ongoing deep-seated movement on the landmass added by the subsidence of some section of highway. Presently, gabion-benching structure has

been installed to stabilize the slope at the crown of the slide, which seems to be insufficient in near future.

From the landslide map, surficial examination of ground movement and examination of landslide materials, some results have been drawn. All three scarps are the parts of single creeping mass bounded by tension cracks at the top. High precipitation rate of Dharan and high gradient of the Nisane Khola seems to be main reason that prohibited the accumulation of landslide material at its toe part. This toe scouring has lead major scarp to extend its area and it seems to continue further. On the other hand, the low gradient of

Fig. 5: Map representing landslide and landuse of the site

the Sardu Khola and little gentler slope may be the reason for other scarps not to increase as rapid as the major slide.

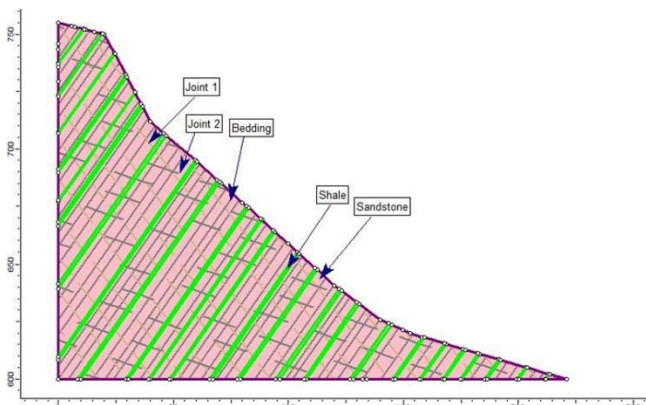
Fig. 6: Map representing cross-section view of the landslide

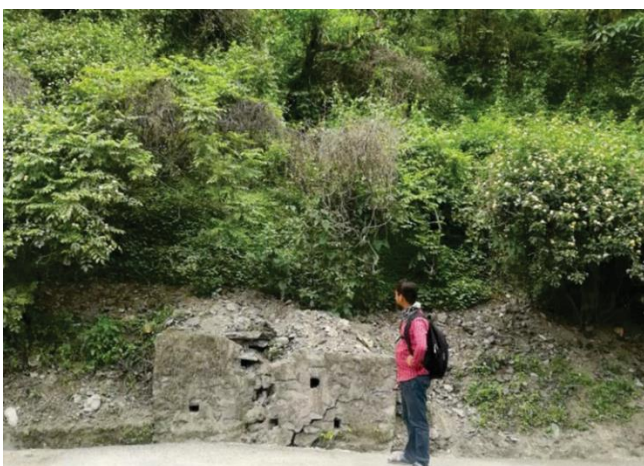
Fig. 7: Development of the tension crack destroys the wall installed for slope stabilization along the Koshi Highway

the prominent mode of failure. The toppling possibility exists on location 1 (crown part) and 8, whereas, at location 2 and 3 the wedge failure is accompanied with plane failure. From the RMR_{basic} analysis, majority of rock mass falls within Class C or the fair class. The SMR analysis shows most of the slopes are only partially stable to unstable and needs support for stabilization. The result of SMR suggested that the slopes of location 2, 3 and 4 of main scarp require special attention and the shotcrete along with rock bolting are recommended for slope stabilization.

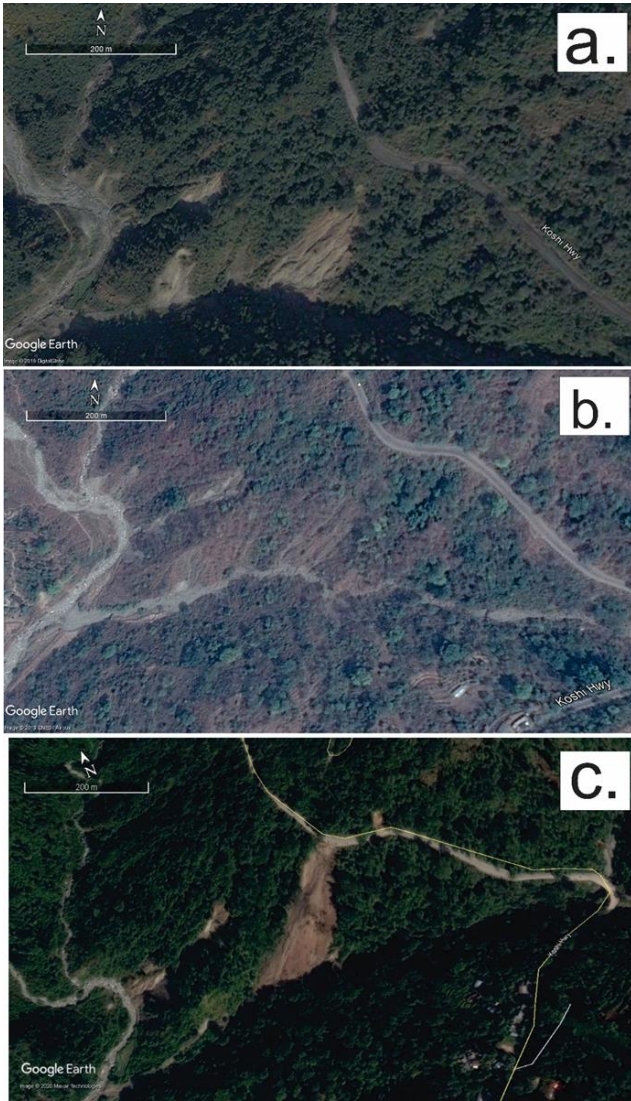
For this purpose, the satellite images from Google Earth Pro (Fig. 8 and 9) of different time interval was studied and analyzed. The topographical map 2687 02C of Dharan area published by Department of Survey, Government of Nepal in 1995 A.D. represents markings of landslides in the present study area. This concludes landslide to be older one. The Google image of 2004 A.D. represents intense scars on the Koshi Highway side of the Nisane Khola. The slides seem passive till 2009 A.D. with developing vegetation cover. Whereas, in the image of 2014 A.D., no real trace of landslide can be observed as the site has been covered by vegetation. In early 2015 A.D., slight scouring of the slope can be observed. The sliding intensified after the series of earthquake and aftershocks of Gorkha Earthquake 2015 A.D. The image of 2016 A.D. shows the slide has reached up to the Koshi Highway. Some mitigation measures applied on the toe portion by installing gabion wall, which caused the slide to disperse in its periphery and is evident by the imagery of 2018 A.D. showing deep gullies on the western and eastern section of the main landslide.

Fig. 8: Temporal images of Nisane Landslide from Google Earth Pro (a) 2004 A.D. (b) 2014 A.D. and (c) 2016 A.D.

Nisane Landslide itself is an old one but its activeness has varied through time. The recent slide activity has initiated after the Gorkha Earthquake, 2015 (Fig. 8 b and c) and it is continuing. Some damaged structures due to ground displacement and bent stem of trees indicate the ground is moving downslope slowly. The high precipitation rate and the toe scouring of Nisane Khola may further intensify the failure in due time.

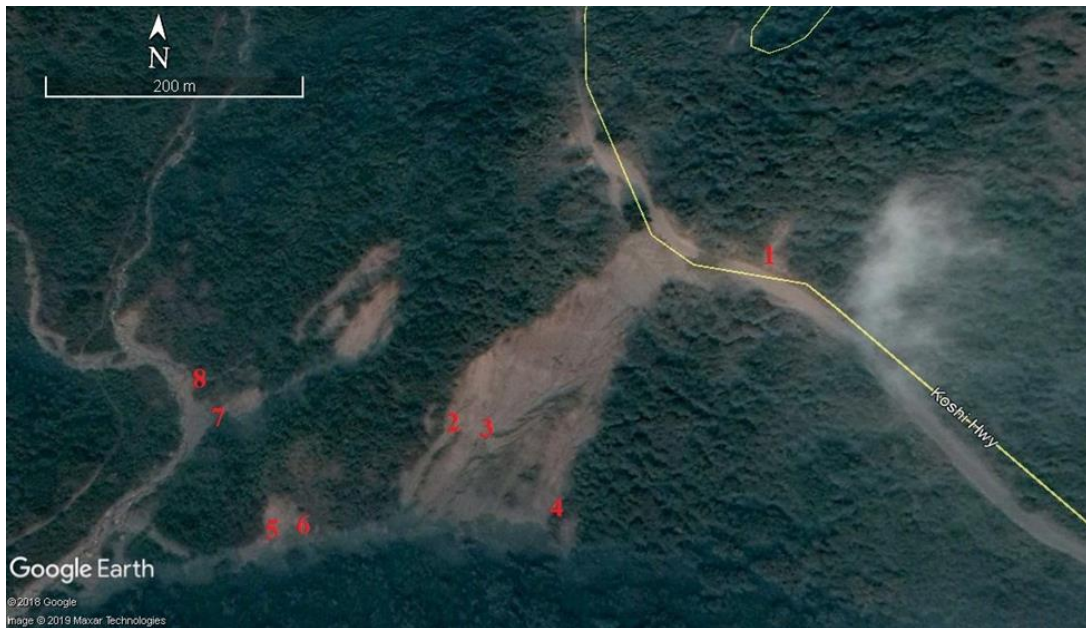
The kinematic analysis, RMR_{basic} and SMR were carried out at eight different slope faces of landslides as indicated in Fig. 9. The data related with joints sets and friction angle were analyzed, and the stereographs are as shown in the Fig. 10. The area consists alternating beds of sandstone and shale dipping

Fig. 9: Aerial image of 2018 A.D. from Google Earth Pro showing the locations (Numbers 1-8) chosen for slope stability analysis
