Water Quality Assessment Using Water Quality Index (WQI): A Case Study of Karmanasha River, Lalitpur, Nepal

The research analyzes the water quality of Karmanasha River which functions as a primary water source for domestic and agriculture needs in Lalitpur area. This investigation examines the environmental well-being of the river through the analysis of measurements for pH, Electrical Conductivity (EC), Dissolved Oxygen (DO), Biochemical Oxygen Demand (BOD), Chemical Oxygen Demand (COD), Iron Content, Turbidity (NTU), and Total Coliform Count which were analyzed and then aggregated in the form of WQI. The BOD and COD levels demonstrate substantial human-caused polluting factors. This research highlights the Water Quality Index to indicate the quality of water in the Study area.

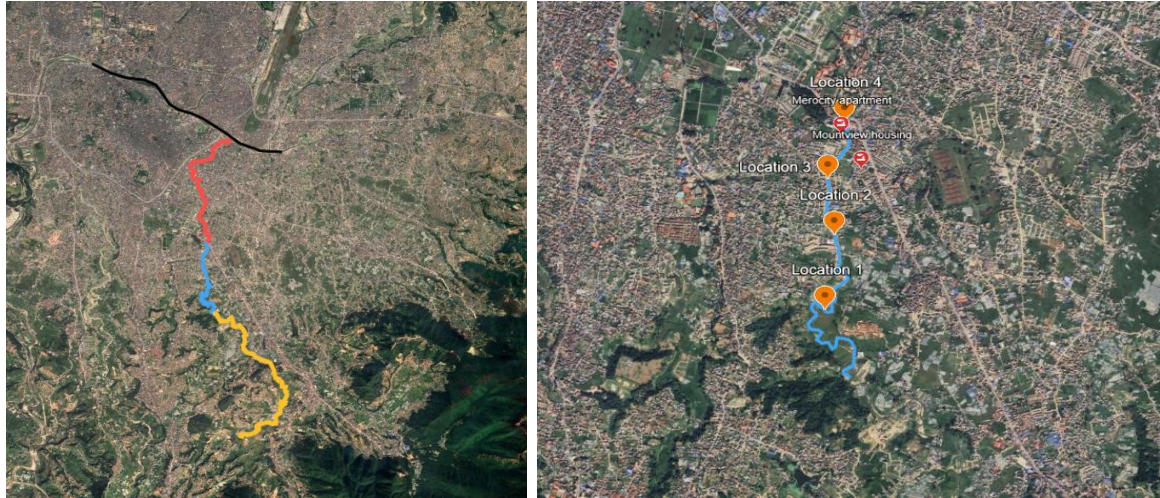
Figure 1. Study Area and Sample Location

The research is conducted in the Kodku Khola River basin, commonly referred to as Karmanasha, as shown in Figure 1. The Guindaha section of Badikhel village is the starting point of this river situated in the Godawari Municipality within the Lalitpur District (Shrestha, 1988). The Kodku Khola falls under a sinuous river with an average slope of 2.58. (Naresh kazi Tamrakar, 2012). The river system is the only waterway flowing north to south across its drainage area. The river flows through Godawari, then Hattiban, and finally Gwarko, before reaching its terminus at the Balkumari Manohara River in Kathmandu. The study area incorporates the territories located above the Hattiban Bridge. The researchers have selected a combination of research methods to evaluate the Karmanasha River's water condition. Water sampling and survey contribute to quantitative data collection, while stakeholder interviews provide qualitative information in this research. The upstream section of Karmanasha River experiences a discharge flow between 17.35 m³/s to 56.94 m³/s. (Acharya *et al.*, 2020). The Khumaltar Station recorded an average annual rainfall of 1238 mm over ten years,

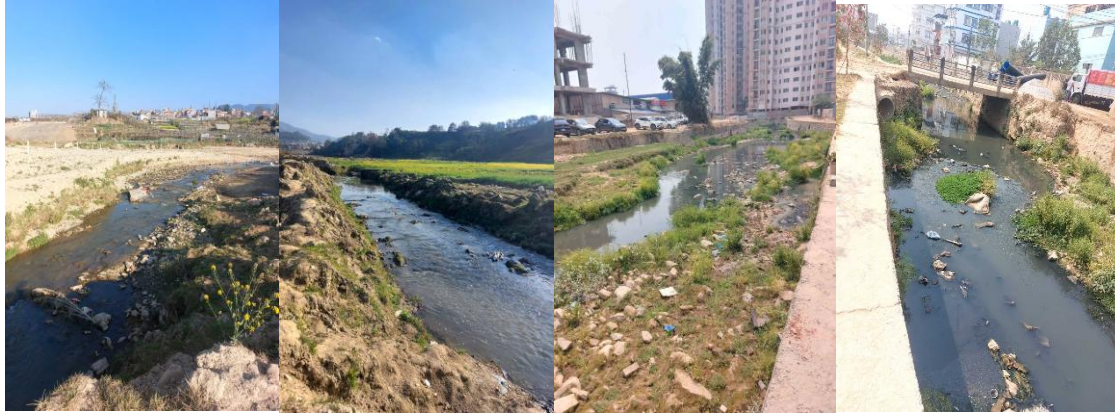
Figure 3. Sampling Location

The sampling was taken in January (dry season) when the flow of river is low and the water is more polluted than other season, upstream of Hattiban Bridge (around 2km). Four water samples, labeled L1, L2, L3, and L4, were selected for physical, chemical, and microbiological analysis. The site was selected due to the presence of a sewage intake channel and the significant environmental changes in the river, which is severely polluted. The Mountain View housing serves as point L3 for sewage discharge and Merocity apartment operates as point L4 for sewage disposal. Location L2 serves as a water intake for tank water services to distribute water throughout the valley through tankers.

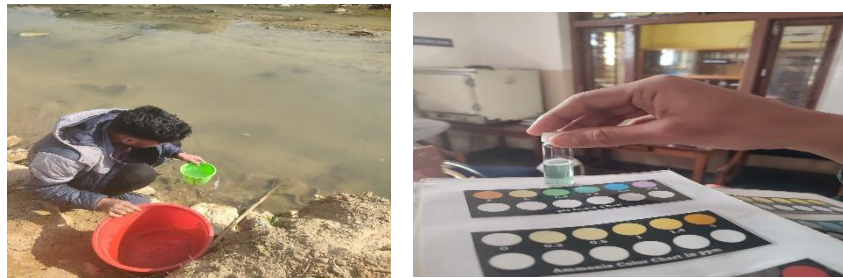
Figure 4. Sample testing

The samples were collected in 2L plastic bottles from all locations. These are taken to NAST (Nepal Academy of Science & Technology) for water analysis report.

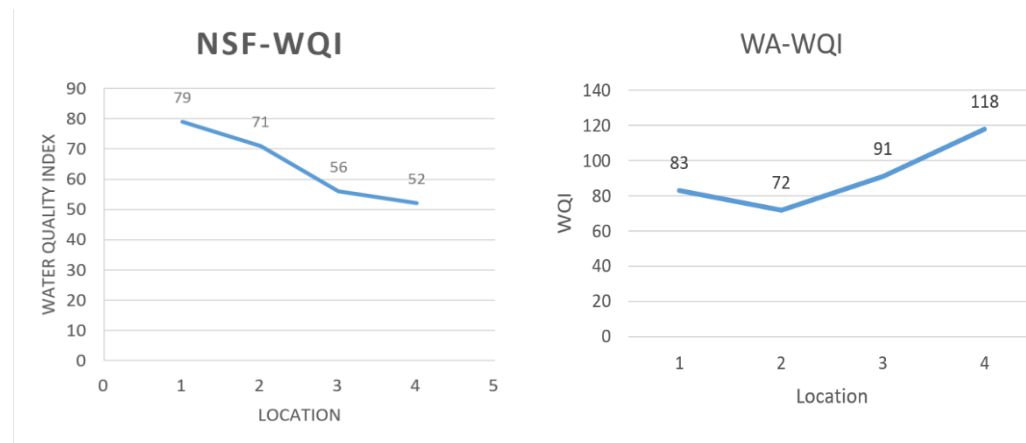
Figure 4. Water Quality Index Graph

The analysis implemented NSF-WQI and WA-WQI as dual assessment tools to reveal additional information about the quality decline in Karmanasha River's waters. Both evaluation systems demonstrated diminished water quality along the watercourse, yet their pollutant detection abilities and calculation procedures led to unique results during assessment.

Sn	Location	WA-WQI	
1	L1	83	Very Poor
2	L2	72	Poor
3	L3	91	Very Poor
4	L4	118	Unfit

SN	Location	WQI	
1	L1	79	Acceptable
2	L2	71	Acceptable
3	L3	56	Little Contaminated
4	L4	52	Little Contaminated

The dual-index methodology showed that clean water conditions prevail in the upper parts of the Karmanasha River but pollution caused by urbanization produces severe contamination throughout its lower stretches. NSF-WQI assigned a "Poor" rating to L4 while WA-WQI classified this point as "Unsuitable" thus emphasizing the immediate need for wastewater treatment systems and measures to control soil erosion along with public awareness initiatives.

The research conducted on the water quality of the Karmanasha River in Lalitpur, Nepal, demonstrates that the WQI values clearly indicate a deterioration in water quality from the upstream location, L1, to the downstream location, L4. The water quality meets WHO standards at all sampling locations, with all pH measurements falling within the approved parameters for aquatic life. The river water contains minimal minerals since its TDS readings do not exceed NSWQS standards. The decrease in dissolved oxygen (DO) occurs slightly downstream of the measurement point but remains above the necessary threshold, which supports the aquatic ecosystem. The downstream water quality showed deteriorating organic pollution status.
