Evaluating fire-induced structural degradation of RCC buildings: NDT-based evidence from Nepalese case studies

4. Case study: Damage assessment of RC fire-affected building in Kathmandu

In this study case studies from three buildings in Kathmandu valley damaged by fire has been taken.

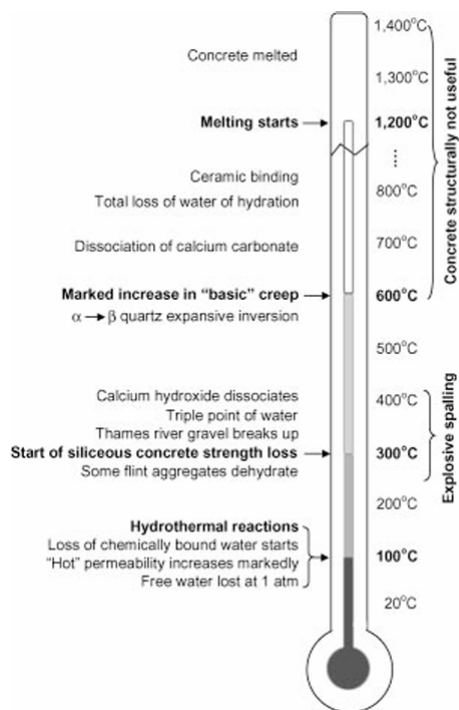
Figure 2: Physicochemical processes in Portland cement concrete during heating [13]

Fire exposure leads to a sequence of temperature-dependent physico-chemical transformations in concrete as shown in Figure 2. Below 100 °C, evaporation of free water occurs. Between 100 and 300 °C, physically bound water is released, resulting in shrinkage and microcracking[19]. At temperatures exceeding 400 °C, dehydration of calcium silicate hydrate (C–S–H) gel and decomposition of calcium hydroxide significantly weaken the cement paste and increase porosity[20].

Aggregate type also influences fire behavior. Siliceous aggregates undergo phase transformation near 573°C, while carbonate aggregates decompose above 700 °C, contributing to cracking and loss of strength[21]. Differential thermal expansion between cement paste and aggregates causes cracking at the interfacial transition zone (ITZ).

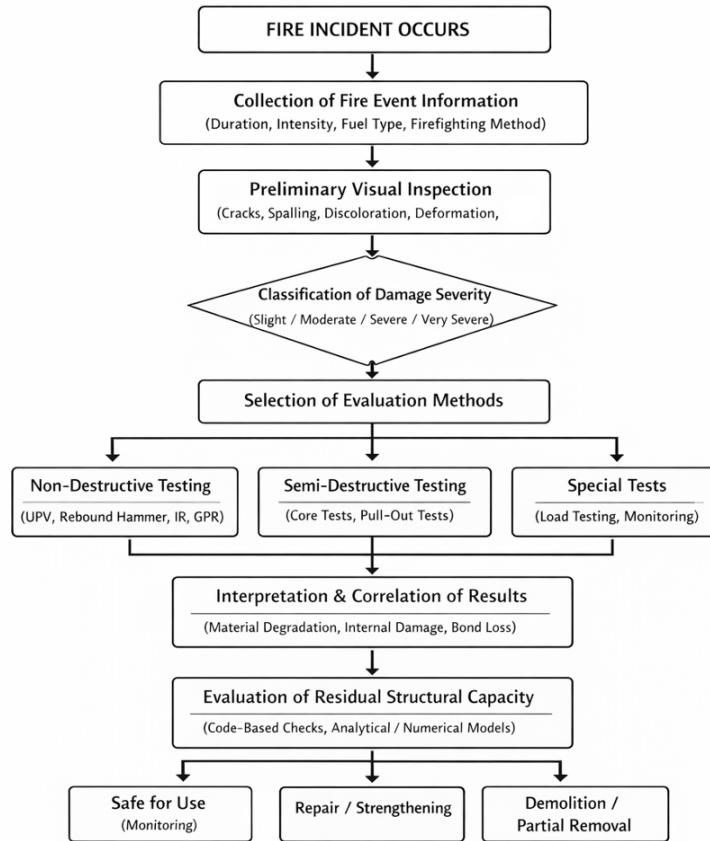
Figure 4: Flowchart for fire damage assessment and evaluation of RC buildings

Fire damage assessment and evaluation of reinforced concrete (RC) structures is done for determining the extent of fire-induced deterioration, residual structural capacity, and suitability for continued use or rehabilitation. A fire damage assessment flowchart for RC structures as shown in Figure 4 typically begins with visual inspection (mapping cracks, spalling, deformation) to gauge fire severity, followed by non-destructive testing (NDT) like rebound hammer and UPV for deeper damage, then potentially destructive testing (cores, lab analysis) for residual strength, and finally analysis & repair planning, deciding if the structure is repairable or needs demolition. The process moves from general observation to detailed material property evaluation, determining the extent of concrete degradation (color changes, spalling depth) and steel integrity to assess load-bearing capacity.

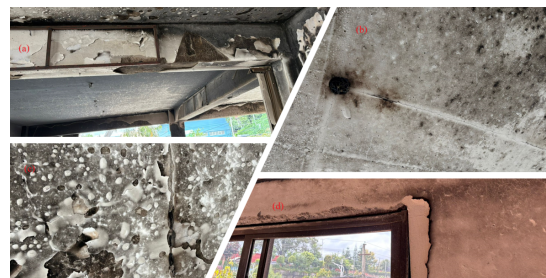
The visual observation of damage in the crucial location of Building A, Building B, and Building C, selected as case study in this research are represented in Figure 6, Figure 7, and Figure 8, respectively. All three of these Reinforced Concrete buildings located in Kathmandu valley were subjected to fire after the Gen Z movement on September 8 and 9, 2025.

Figure 6: Showing damages in various locations of Building A (a) Fire-damaged structural beam showing extensive soot deposition, blistered paint, and heat-induced surface cracking (b) Damage in electrical point and crack propagated in slab along the line of wiring (c) Porous, bubbled surface texture—classic signs of thermal decomposition of cement paste due to high fire temperatures (d) Fire-induced spalling of concrete

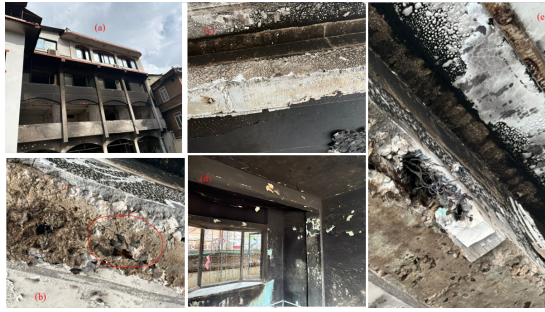
Figure 7: Showing damages in various locations of Building B (a) Discoloration of outer face of building due to fire (b) Fire-induced spalling of concrete with exposed reinforcement in the beam soffit (circled in red) (c) Porous, bubbled surface texture-classic signs of thermal decomposition of cement paste due to high fire temperatures (d) Fire-damaged structural beam showing extensive soot deposition, blistered paint, and heat-induced surface cracking (e) Damage in electrical point

- Cracking of plaster and concrete due to thermal stresses and differential expansion
- Spalling of concrete cover, particularly in slab soffits, beams, and beam–column joints
- Partial or full exposure of reinforcing steel in load-critical elements
- Loss of plaster adhesion and debonding of protective coatings
- Localized severe damage near fire sources, with comparatively minor damage in adjacent regions
- Non-uniform damage distribution indicating steep thermal gradients and asymmetric heating
- Cracking was observed along the alignment of embedded electrical conduits within beam and slab, indicating a localized response of the concrete to thermal and material incompatibility effects during fire exposure.

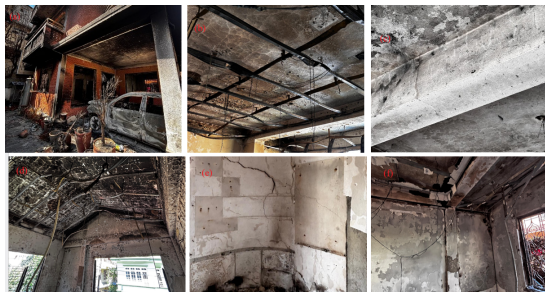
Figure 8: Showing damages in various locations of Building C (a) Exterior view of an RCC building showing fire damage (b) Fire-affected RCC slab soffit with extensive soot accumulation and exposed suspended service lines, indicating prolonged fire duration and elevated ceiling temperatures (c) Close-up view of an RCC beam exhibiting surface discoloration, fine flexural cracking, and localized material degradation due to elevated temperature exposure (d) Damage to slab–beam junction with partial loss of plaster cover, exposed reinforcement, and hanging electrical conduits following intense fire action (e) Interior wall and column surface showing cracking, plaster debonding, and thermal discoloration (f) Beam–column joint with plaster spalling, cracking, and exposed reinforcement, highlighting degradation of load-critical regions under fire exposure

From visual observation of three different buildings assessed after fire, the typical damage pattern observed were:

- Surface discoloration and heavy soot deposition on concrete and plaster surfaces
