## Geological hazards in Pokhara valley, central Nepal: types, distribution, impacts and implications for hazard management

Rajendra Kumar Chettri, Kabi Raj Paudyal & Ram Bahadur Sah

©2026 Journal of Nepal Hydrogeological Association (JNHA), Kathmandu, Nepal

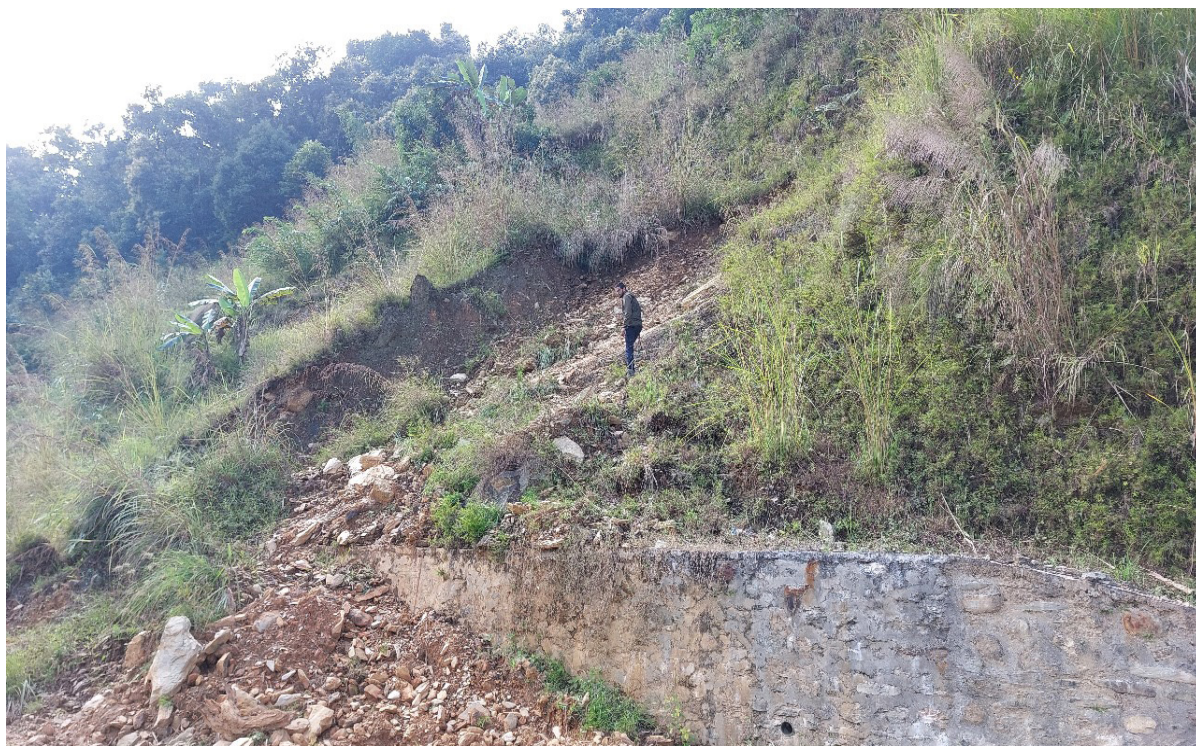
**Fig. 2: Landslide observed along the Pokhara-Syangja road section**

Active and old landslide features are observed along several transportation corridors surrounding Pokhara. The northern part of the valley contains landslide-prone slopes, while road sections toward Syangja (Fig.2) and other surrounding hill regions show evidence of slope failure and localized subsidence. In southern areas, rockfall and localized slope failures are also important.

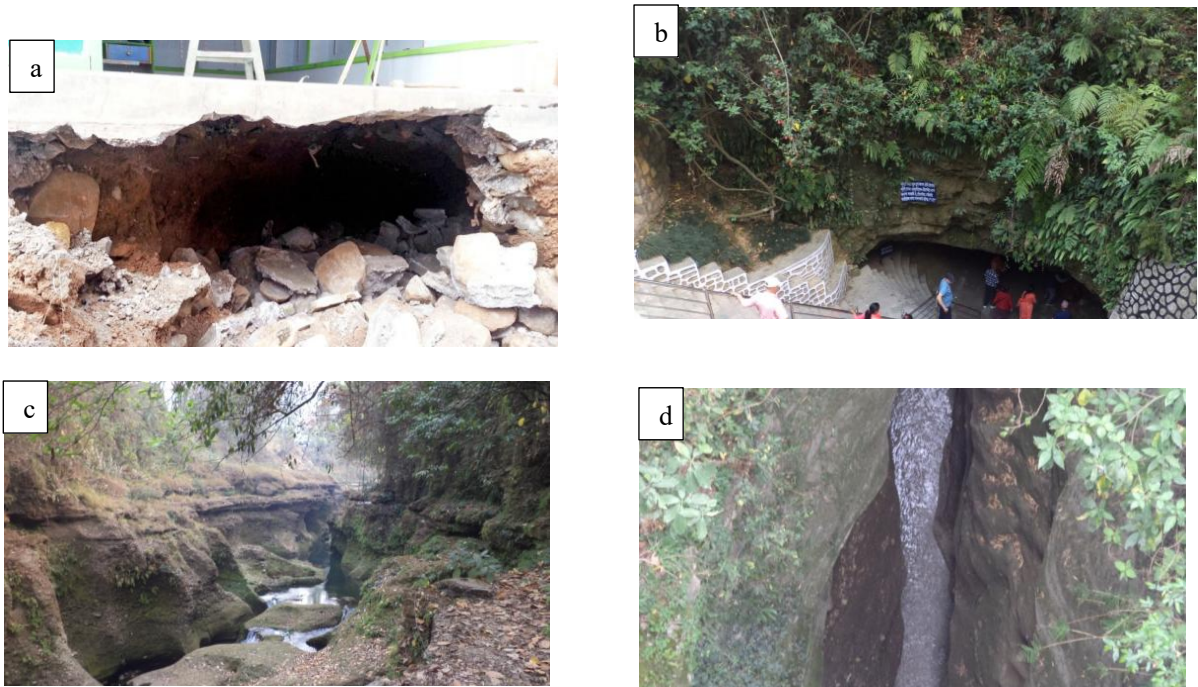
Fig. 5: (a) Sinkhole at Gairapatan, Pokhara (b) Mahendra Gufa revealing the beauty of karst topography (c) Davis Fall at Chorepatan (d) Seti gorge at K.I. Singh Bridge.

The development of underground voids may eventually cause collapse or subsidence at the surface. Sinkholes (Fig.5a) have been reported from several parts of the valley, and the Armala area is particularly notable for the occurrence of numerous sinkholes. Other urban and peri-urban areas may also experience localized ground instability during the rainy season.

The karst hazard is closely associated with the geological nature of the valley-fill sediments. Areas containing highly calcareous and permeable deposits may be particularly susceptible. The presence of gorge (Fig.5d) caves, underground channels, solution features, sinkholes and waterfalls (Fig.5c) indicates that subsurface erosion and dissolution remain active geomorphic processes.

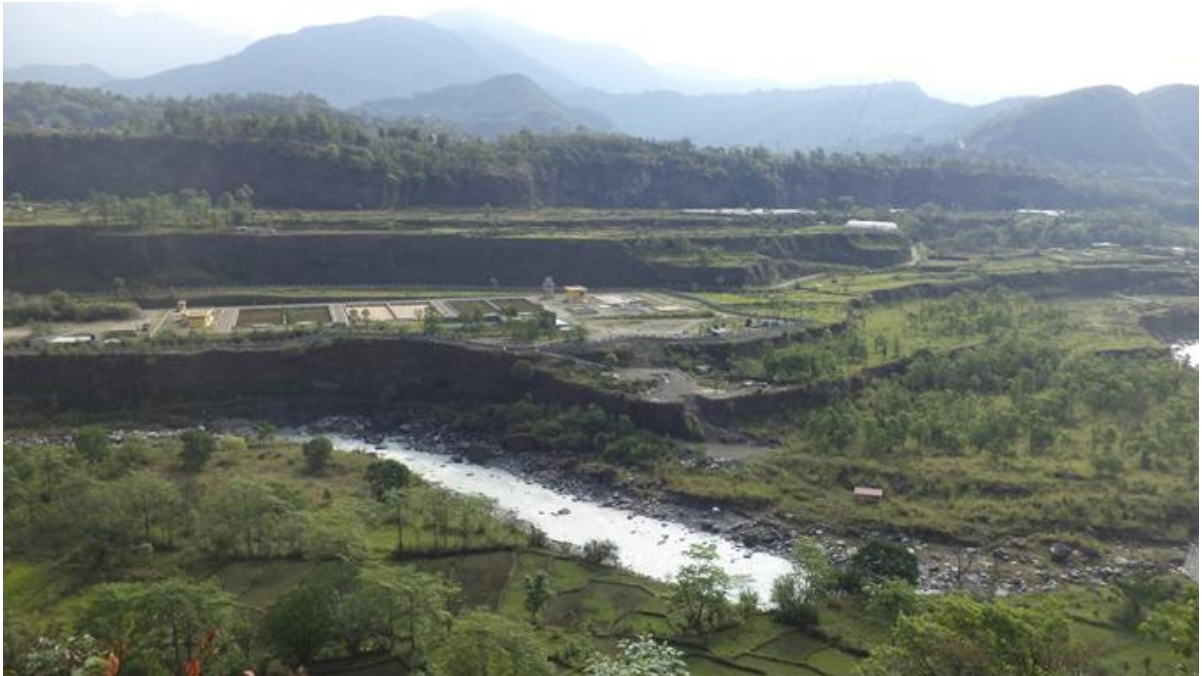
Fig. 7: Debris flow sediment deposited along the bank of Seti River with Terrace topography.

The extensive coarse-grained sediments of Pokhara Valley provide evidence of major debris-flow and catastrophic sediment-transport events during the geological past (Fig.7). Previous studies have recognized several phases of large-scale sediment accumulation and suggested that some deposits were emplaced during exceptional geomorphic events (Yamanaka et al., 1982; Fort, 1984, 1987, 2010). More recent investigations have related repeated catastrophic valley infill to large Himalayan earthquakes and associated mass movements (Schwanghart et al., 2016; Stolle et al., 2017).
