## Seismic response of random rubble stone masonry buildings from mid-hills of central Nepal

Rubble stone masonry in mud mortar is the most prevalent stone masonry buildings in the mid-hills accounting for more than 70% of Nepali building stock. However, these types of construction are relatively more vulnerable to seismic events. Interestingly, some of these masonry buildings performed very well while many others collapsed. For a detailed understanding of performance of these masonry at component level during earthquake excitation, this paper presents the gradual failure mechanism for a typical stone masonry from mid-hills of central Nepal. The analysis was carried out by first linear analysis of Finite Element macro-model, followed by non-linear push-over analysis using finite element method and equivalent frame method. Performance was assessed under different levels of earthquake. Linear analysis results showed that these masonry buildings satisfy the drift requirements as per Nepal building code with adequate margin but are susceptible to heavy damages, especially in shear along with significant compression crushing and tensile cracks, under design level earthquake. Detailed n

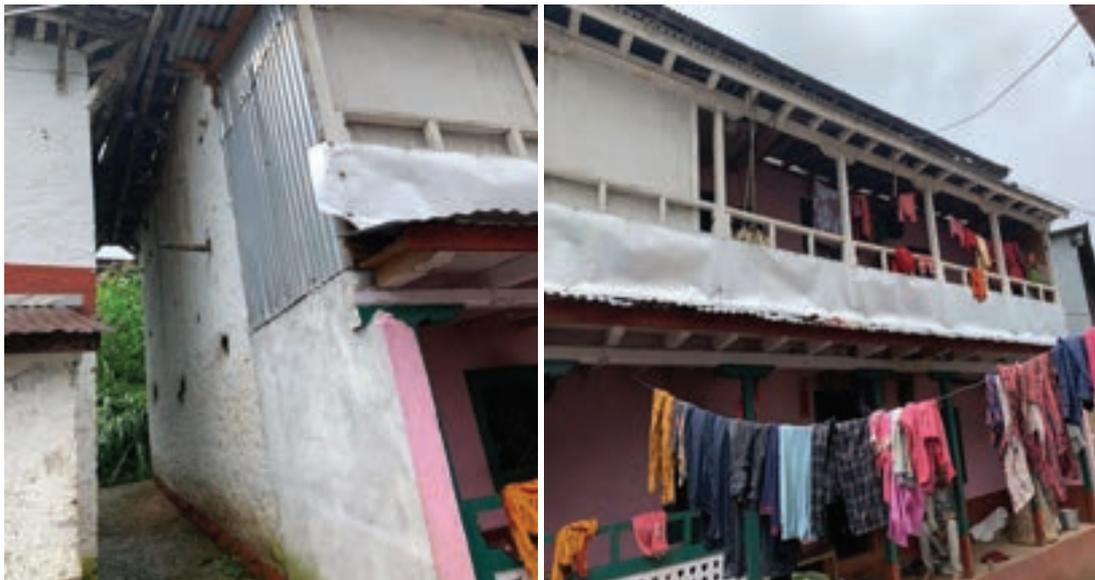
**Figure 2:** Left side-view (left) and front-view (right) of the study building

The field visit was made to Dhunkharkha, Bethanchowk of Kavre district (Figure 1), which is about 12.9 km from Panauti Buspark, in December 2023, to record the construction system, damage pattern, and dynamic properties of a few mud-mortar stone masonry buildings of the site. A typical stone masonry building, which has a floor area of 39.40 square meters, made of mud mortar as shown in Figure 2 was selected and studied in detail. The total height of the building up to attic level is 6.90 m. Height of the first storey is 2.14 m, height of the second storey is 2.230 m, and that of the attic is 2.53 m (including 1.23 m height of rectangular part and 1.30 m height of triangular or gable).

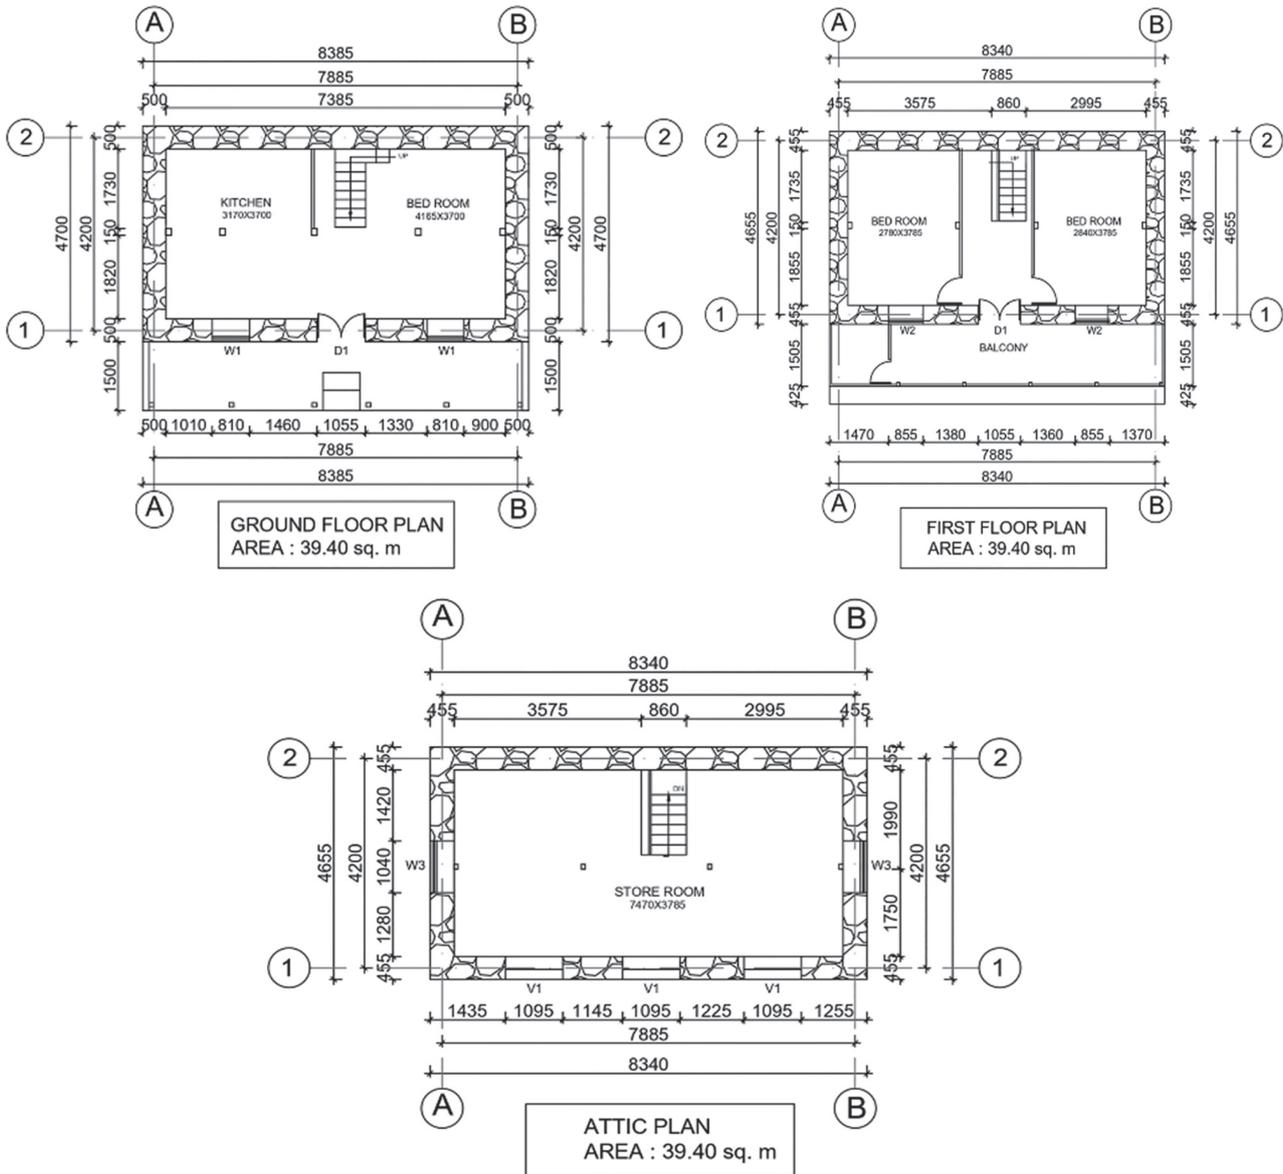
Figure 3: Plan of the study building

Figure 3 shows the plan of the building and Figure 4 shows the elevations of the building. From our observation at site, most of the buildings at Bethanchowk have no opening at back, and rare openings at the sides on the ground floor and attic. Most of the openings were observed in the front side. In Hilly terrain, such types of buildings are mostly observed in significant numbers. This building is free from attachment to soil on either side.

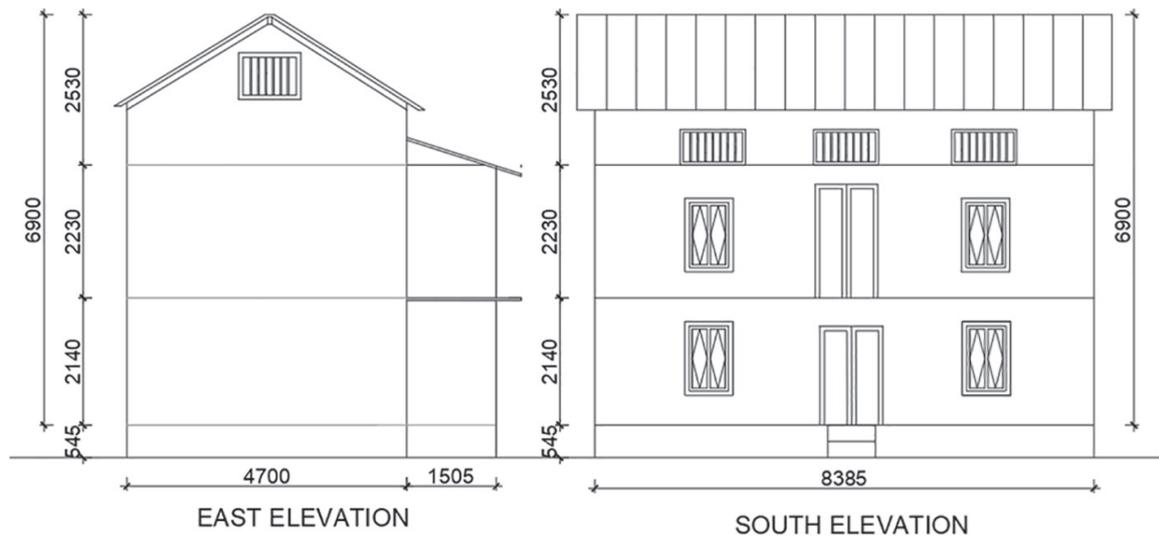
**Figure 4:** Left (left) and front (right) elevation of the study building

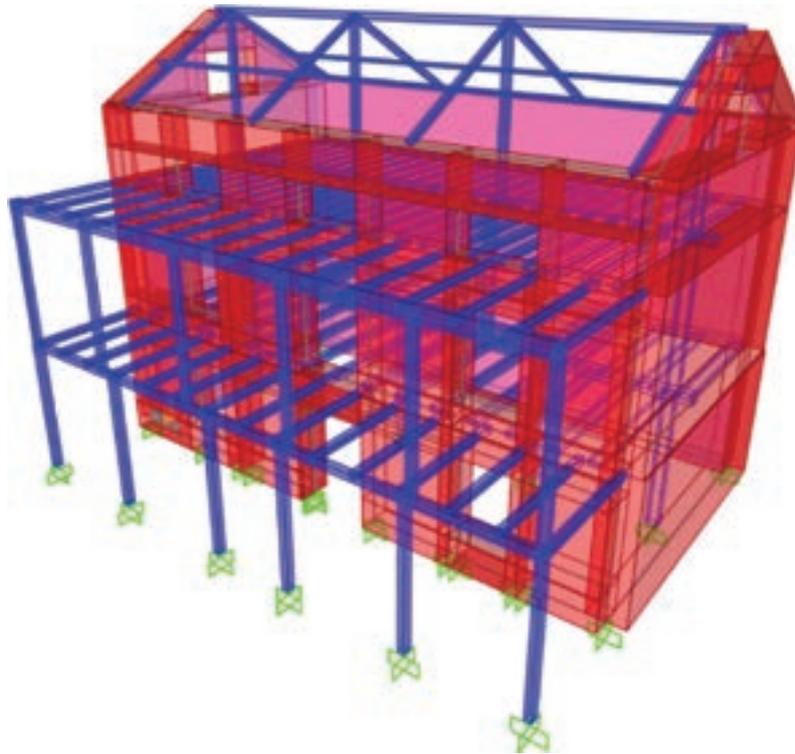
**Figure 5:** FEM model of the building in SAP2000

The detailed numerical analysis was conducted using two approaches. In the first approach, a finite element model was prepared in SAP2000v24. A three-dimensional finite element model (FEM) is shown in Figure 5. The structure was assumed to be fixed at support. The walls were idealized as shell elements whereas the flexible timber and mud floor slabs were not modeled. Instead, the loads on the floor were calculated and applied to the Dalins (timber beams). Similarly, load on the roof including the roofing sheets were calculated

and applied on the purlins. Linear elements such as Nidals (large timber girder supporting Dalins), Dalins, Tham (vertical timber posts), Dada (roof-rafters), and Bhatas (roof-purlins) were idealized as frame elements.

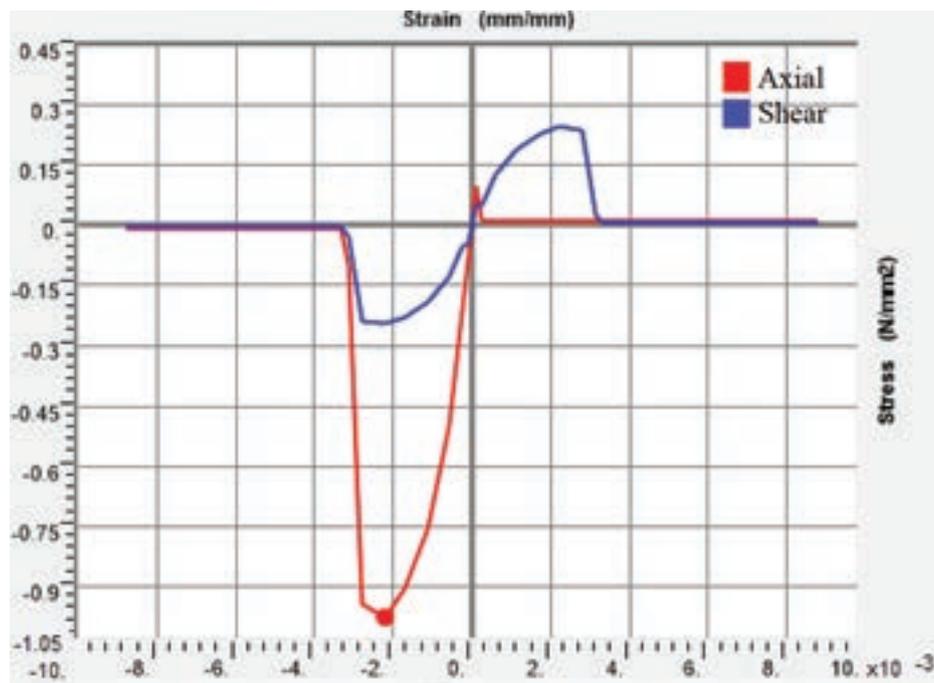
**Figure 6:** Stress strain curve of stone masonry adopted in the study

To further understand the post-elastic behaviour of the building, non-linear analysis was conducted using the same FEM in SAP2000 using non-linear stress-strain model of the masonry as presented by (Adhikari & D'Ayala, 2019). However, to account for poor quality of construction and low strength of commonly built masonry, the presented stress-strain is scaled to match the peak strength of masonry to be 1 MPa, and peak tensile strength is considered as 10% of compressive strength as presented in Figure 6.

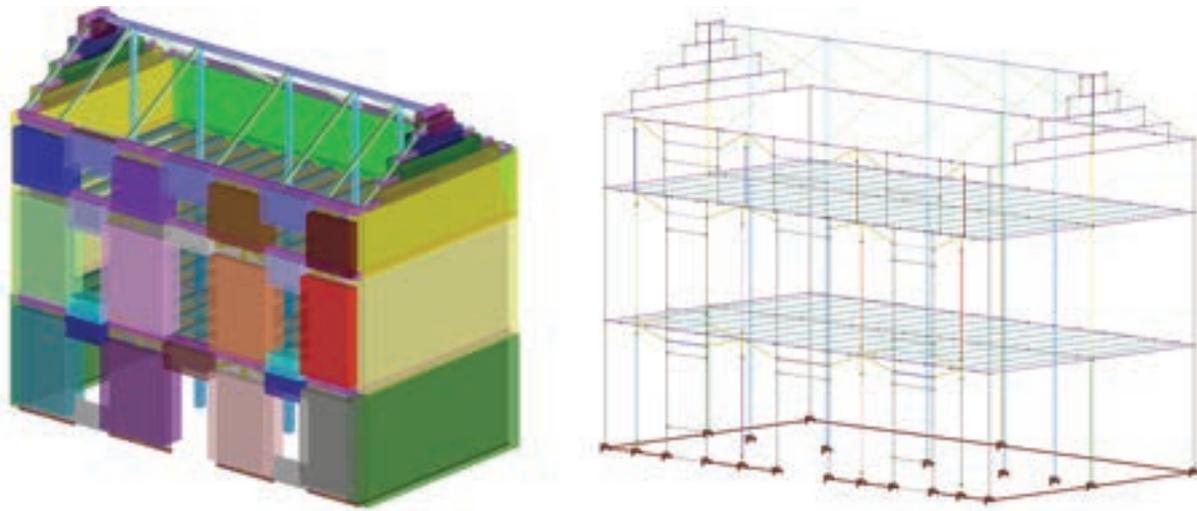
**Figure 7:** EFM model of the building (Solid view (left) and Equivalent frame view (right))

In the second approach, equivalent frame model was prepared using a professional Italian software PRO\_SAP with PRO\_SAM Plug-in. A three-dimensional Equivalent Frame Model (EFM) is shown in Figure 7. The walls are modeled as a SAM wall element fundamentally used for non-linear static pushover analysis. The SAM wall element is further divided into spandrels and piers. The intersecting area of piers and spandrels are commonly considered rigid in the EFM and are defined as a rigid element. The linear elements such as timber joists, Nidal, Dalin, Thams, roof-rafters, and roof-purlins were modeled as SAM-D2 elements (frame elements).

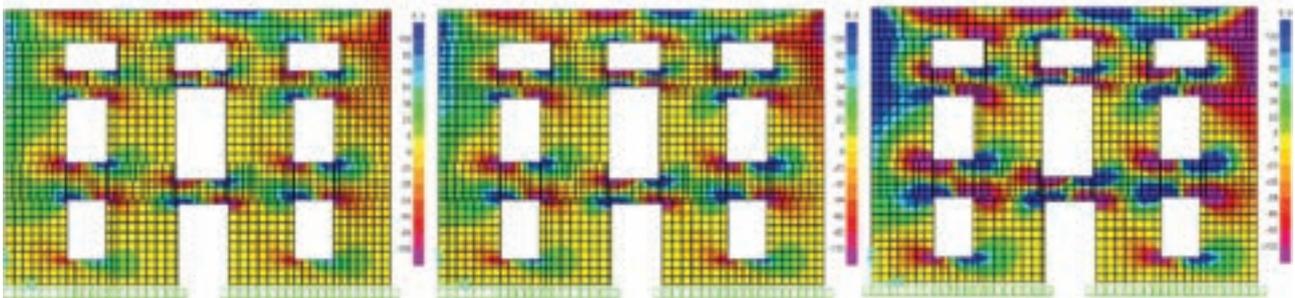
**Figure 8:** Horizontal stresses ( $S_{11}$ ) observed in the front face of the building corresponding to different PGAs of 0.15 g, 0.19 g, 0.35 g (left to right)

Various stresses observed for the study building is shown in Figure 8 to Figure 10. Figure 8 shows the horizontal stresses ( $S_{11}$ ) observed in the front face of the building corresponding to different PGAs of 0.15g, 0.19g and 0.35g respectively. Similarly, Figure 9 shows the vertical stresses ( $S_{22}$ ) and Figure 10 shows the shear stresses ( $S_{12}$ ) observed in the front face of the building corresponding to different PGAs of 0.15 g, 0.19 g and 0.35 g respectively.

In general, in-plane tension are avoided in masonry design, in par with is 1905:1987 (BIS, 1987c) as well. However, the analysis shows tensile stresses especially at corners of doors, windows, and at extreme corners of walls. Hence, some tensile cracks are expected in the masonry, but once cracks are generated, stresses get redistributed in adjacent portion and no significant damage is generally observed due to this tension. The common design practice to cater to this tension is to provide vertical reinforcements such as steel rebar or timber posts that can integrate the wall even in case of these tensions and can significantly improve the resilience of these walls.

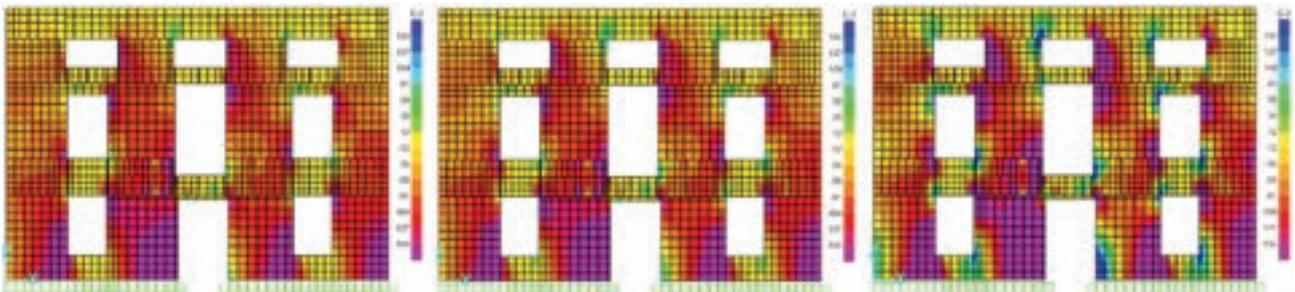
**Figure 9:** Vertical stresses ( $S_{22}$ ) observed in the front face of the building corresponding to different PGAs of 0.15 g, 0.19 g, 0.35 g (left to right)

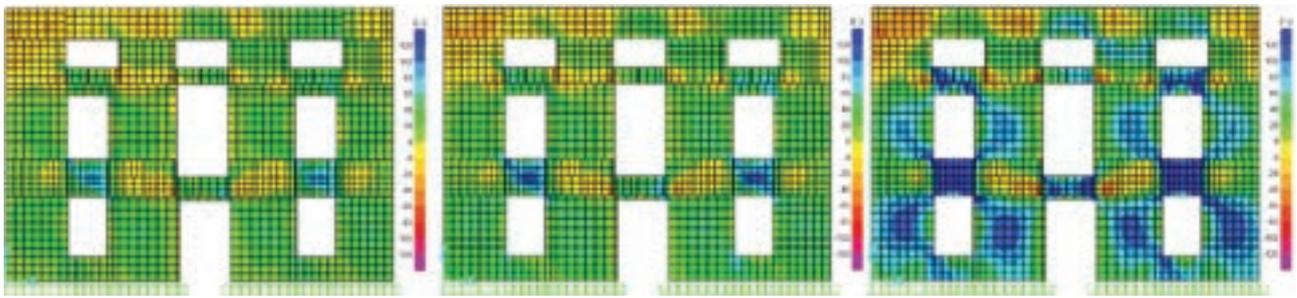
**Figure 10:** Shear stresses ( $S_{12}$ ) observed in the front face of the building corresponding to different PGAs of 0.15g, 0.19g, 0.35g (left to right)

Shear Stresses at piers and spandrels of walls for different combinations of load was determined. Maximum shear is observed to be critical at in-plane loading. The maximum shear stress in wall appeared in the middle portion of the ground floor and the first floor, and the peak stress was about 0.15 MPa, which is higher than commonly specified safe strength of 0.05 MPa for mud-mortared masonry which is in reasonable range if factor of safety is considered to be 2 for the observed shear strength from diagonal test (Kumar Bothara et al., 2023), though within the max shear strength of 0.24 MPa as per the adopted material characteristics as shown in Figure 6. The observed peak stresses are tabulated in Table 3.

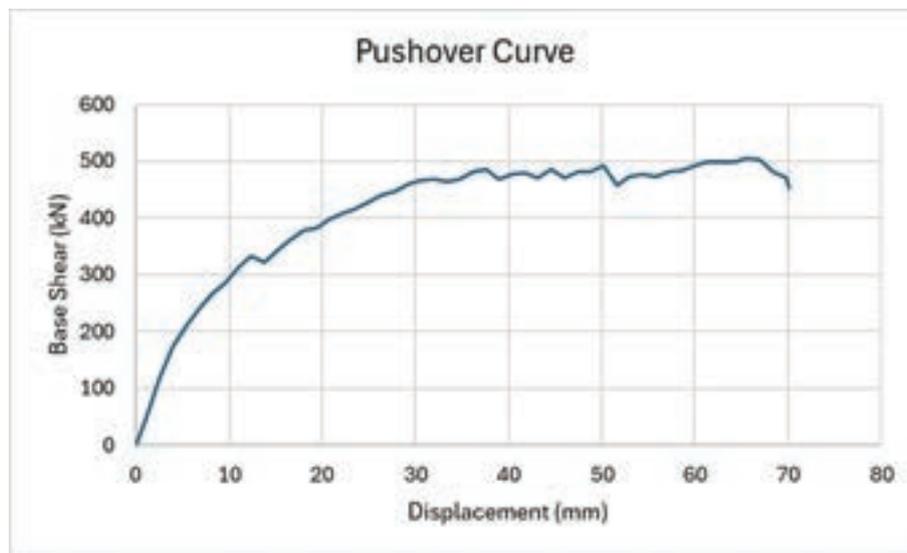
**Figure 11:** Pushover Curve from SAP2000v24

The curve shows significant linearity up to 5 mm displacement of eaves at base shear of about 180 kN. Then, non-linearity was gradually introduced with base shear saturation at about 450 kN with displacement of 30 mm.

The building was modeled using FEM in SAP2000v24 with homogenized non-linear stress-strain characteristics of masonry wall using macro model. A detailed model was developed which could capture all the aspects of non-linearity including material nonlinearity as well as geometric nonlinearity. Nonlinear static pushover analysis was used to evaluate the seismic capacity of the existing structure. Non-Linear pushover load cases were initially defined, and the analysis was run using Event-to-Event only solution scheme. In Event-to-Event stepping, the load steps will automatically be subdivided where changes occur in the stiffness of nonlinear elements. This causes a series of nearly linear steps to be taken, which can minimize deviation from equilibrium (CSI (Computers & Structures INC), 2016). The stress-strain curve adopted for the masonry is as shown in Figure 6. A joint at central part of the building at the eaves level of the building was selected as the control node. The capacity curve thus obtained from the analysis for x-direction is as shown in Figure 11.

While the nature of pushover curve from the two approaches are similar, the displacement parameters are significantly different. This is due to the method of analysis adopted in each approach. In FEM, a non-linear material model is provided, which is gradually loaded, and non-linearity is introduced gradually. Out of plane failure and rocking is not considered in the model thus estimating large non-linear capacity.

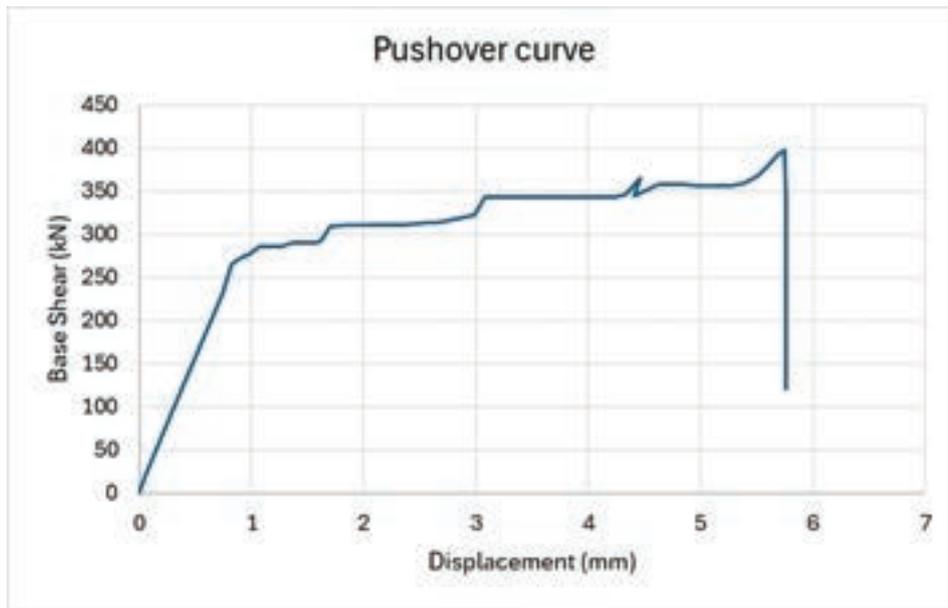
**Figure 12:** Pushover Curve from PRO\_SAP (with PRO\_SAM Plugin)

Similarly, the structure was again modeled in PRO\_SAP (with PRO\_SAM plugin) using the Equivalent Frame Model for the rubble stone masonry. While the strength of the wall was adjusted as per the adopted material model, the strain characteristics were predefined in the software. Non-linear static pushover analysis in PRO\_SAP was executed, and capacity curve was obtained as in accordance with NTC 2018 (MIT, 2018). The base shear (force) distribution was considered to be a triangular distribution as in linear static according to par. 7.3.3.2 (MIT, 2018). The capacity curve thus obtained with the completion of pushover analysis in PRO\_SAP is shown in Figure 12.

However, in EFM, force-based analysis is conducted, and different local failure mode of each wall components (spandrels and piers) are considered in line NTC 2018 (MIT, 2018). The masonry component failure is brittle, and hence, significant loss of strength is captured at small deformation. Iterative analysis is conducted to determine forces in different wall components and to estimate their damage states. Further, these failure criteria are based on design principles which account for large factor of safety, and hence indicate failures at lower values of forces. Hence, this type of curve is useful for the design with margins of safety.

Nonetheless, both curves estimate the peak base shear of nearing 400 KN which is quite reasonable and in agreement with each other, at least for the force-based analysis.

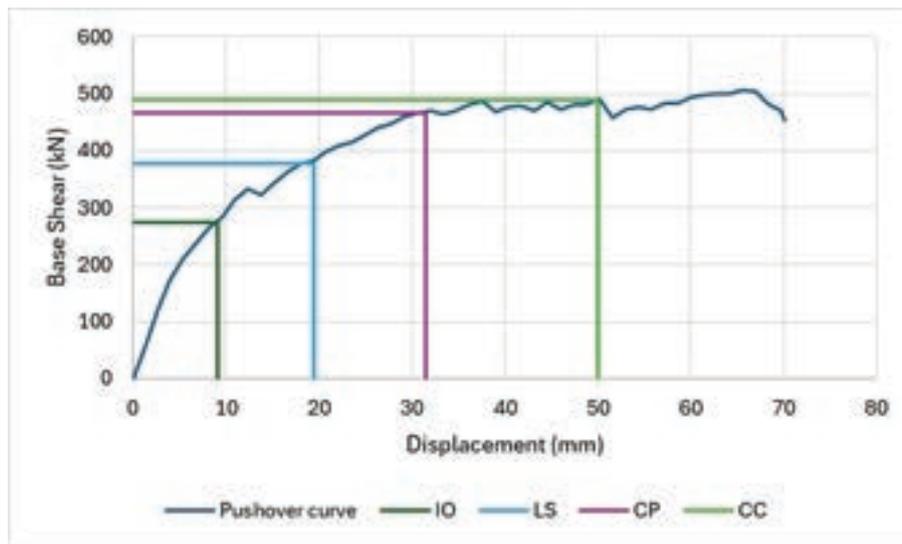
**Figure 13:** Damage states identified on the capacity curve

Based on the capacity curve obtained from FEM, the performance states are defined as shown in Table 4 and Figure 13.

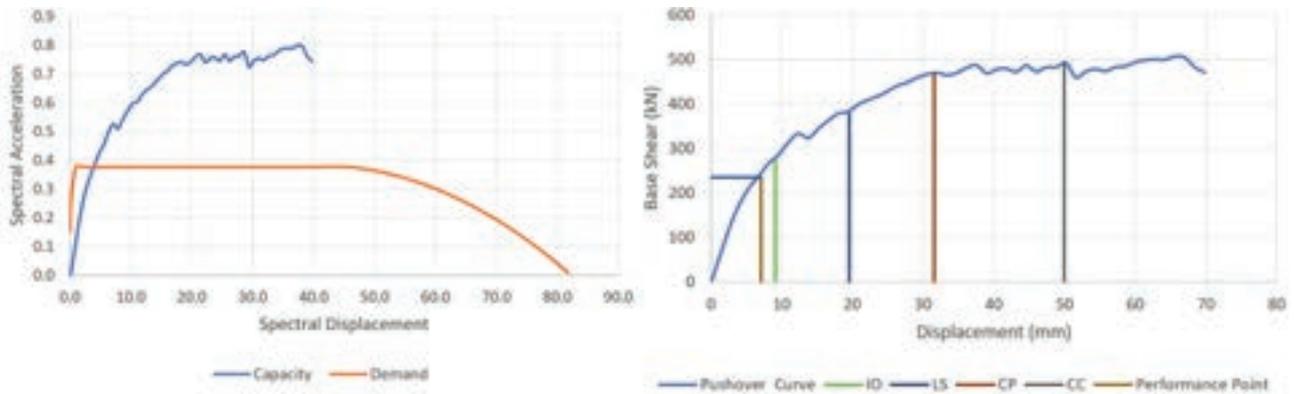
Figure 14: Performance point (left) and performance of the building (right) for 0.15 g PGA

Accordingly, the performance of the building corresponding to various ground motion intensities of 0.15 g, 0.18 g and 0.3 g are depicted in Figure 14, Figure 15, and Figure 16 respectively and in Table 5.

Above figures and table depicts that for 0.15 g PGA, the building imparts immediate occupancy performance level while for 0.18 g PGA, building transit to life safety performance level from immediate occupancy level. Similarly, for 0.3 g PGA performance point lies right of the collapse prevention i.e., building is susceptible to complete collapse at 0.3 g PGA. It also shows that there is rapid increase in damage level when the PGA increases slowly, indicating the relatively brittle failure mode of the building.

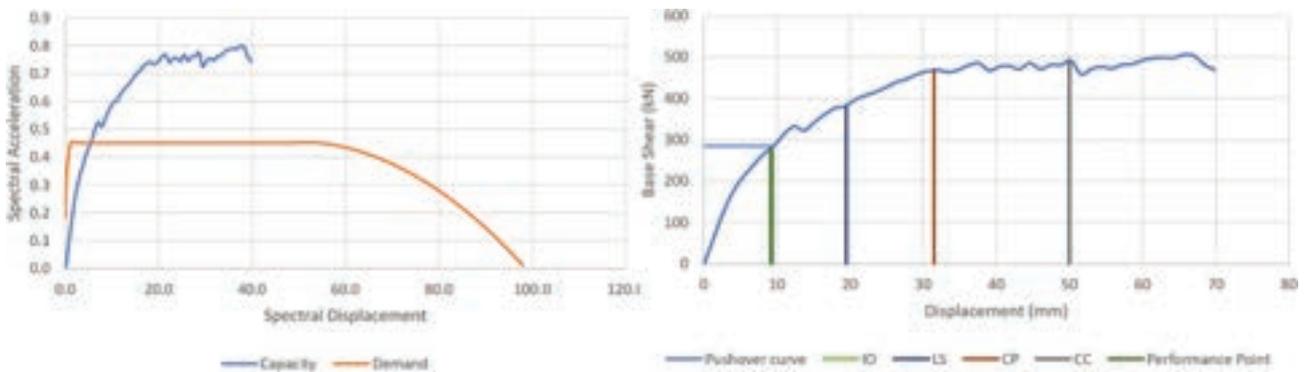
Figure 15: Performance point (left) and performance of the building (right) for 0.18 g PGA

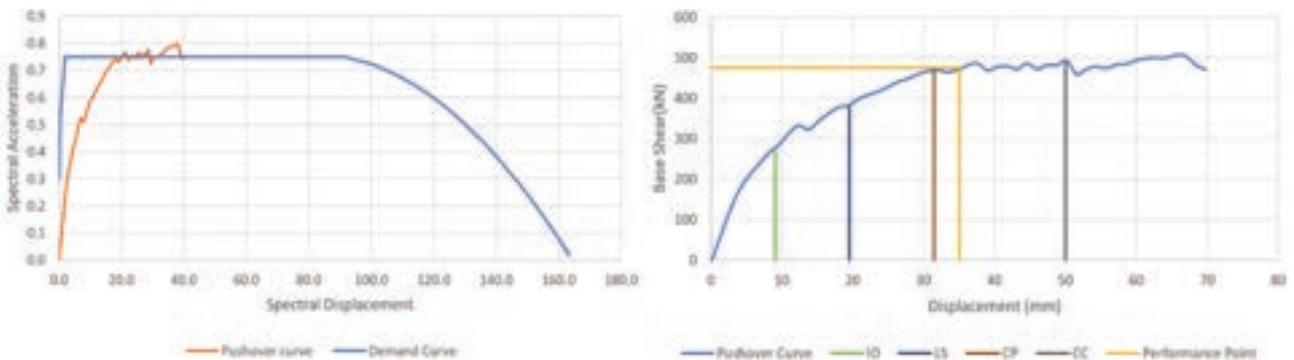
Figure 16: Performance point (left) and performance of the building (right) for 0.3 g PGA

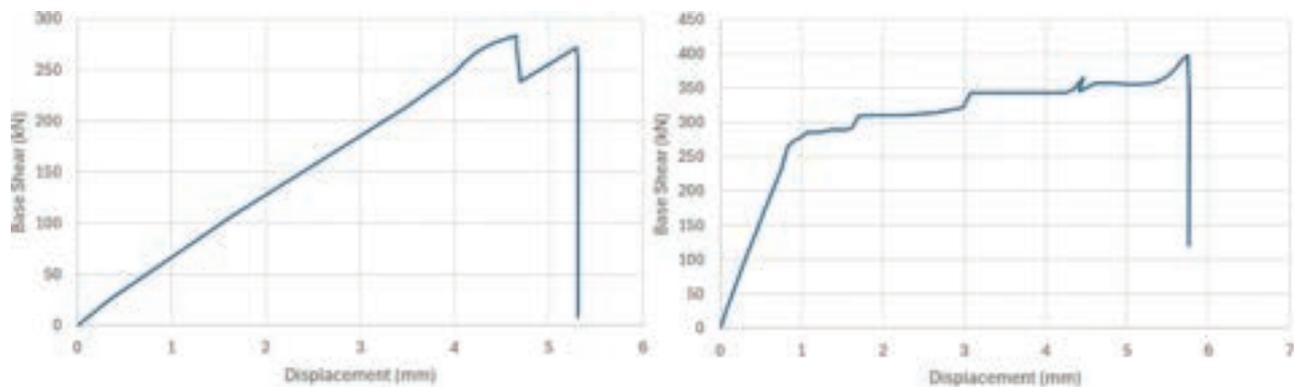
**Figure 17:** Pushover curve of model with gable (left) and without gable (right)

The gable significantly affected the capacity curve. The gable is quite flexible in out of plane loading and thus when the control node was selected at top of gable, the stiffness as depicted by capacity curve significantly reduced. Figure 17 compares the capacity curve with and without gable wall.

As per Figure 17, displacement is contributed significantly by the gable itself rather than bottom two storey as shown in Figure 18. Brittle collapse was observed at a displacement of 4.7 mm, which is due to collapse of gable. To evaluate the performance of the building other than the gable wall, gable walls were removed from the model and reanalyzed under lateral load to find the capacity curve. Consistent with the capacity curve of the model with the gable, the ultimate force was about 356 kN whereas the ultimate force of 300 kN is observed in the capacity curve obtained from the model with gable walls. However, displacement at that value of load observed in the model without gable is only 1.6 mm. This implies the existence of deformation in the gable resulting in much more early failure of the gable as compared to the rest of the wall. At 0.15 g, the failure of the gable is seen in the PRO\_SAP model. It closely resembles the observed gable collapse at the site during the shaking of about 0.15 g from the Gorkha earthquake as per the shake map provided by United States Geological Survey. To understand the failure mode of other components of the building, further analysis was conducted removing the gable.

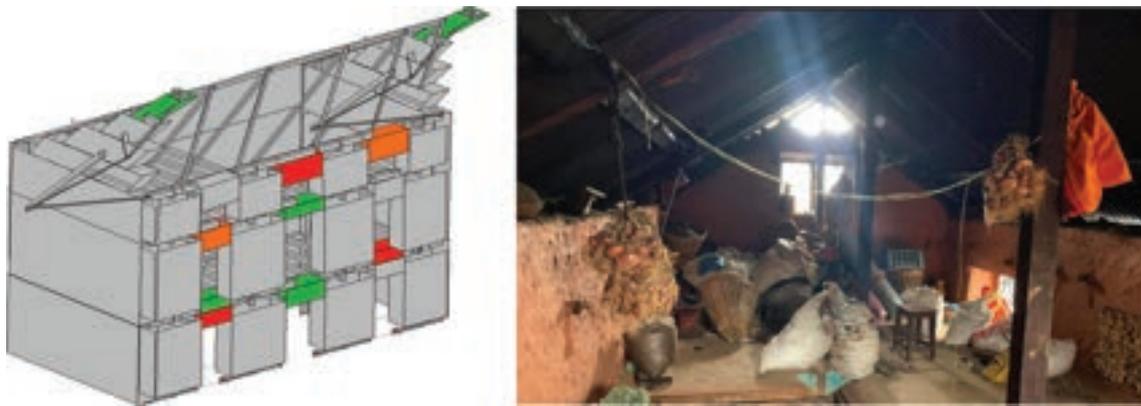
**Figure 18:** Collapse mechanism of Gable wall in EFM (left) and at site (right)

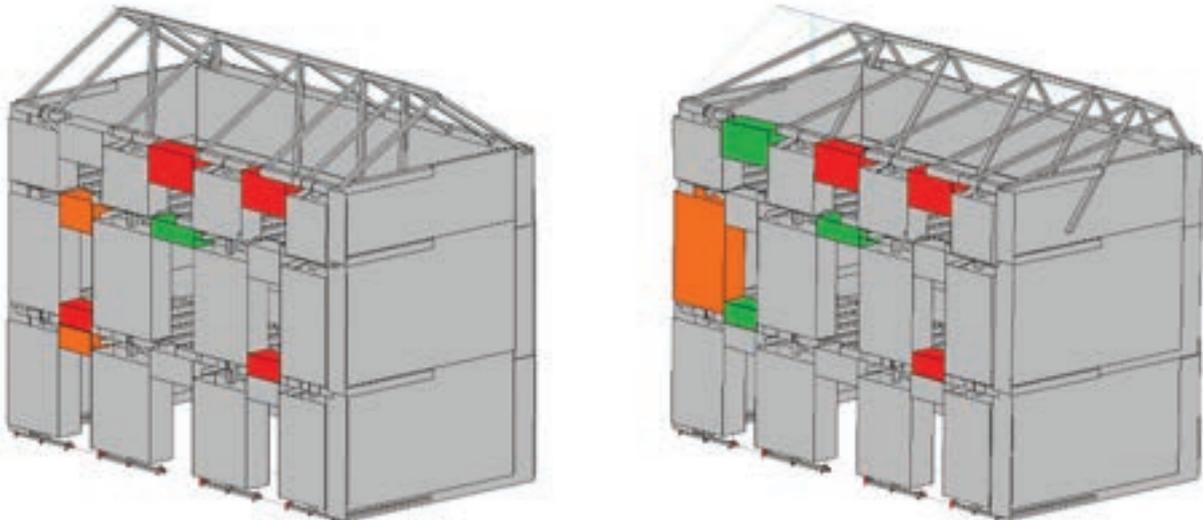
**Figure 19:** Damage pattern at stage1 corresponding to 0.065 g (18.57% of design level shaking) (left) and at stage 2 corresponding to 0.14 g (40% of design level shaking) (right)

The horizontal acceleration in the building gradually increased and the performance at major stages are reported to understand the damage patterns. The performance is reported at PGA of 0.065g, 0.14g, 0.19g and 0.35g which correspond to 18.57%, 40%, 54.28% and 100% of design level shaking (DUDBC, 2020). Figure 19 shows that at stage one, even at a small level of ground shaking of PGA 0.065 g, slight tension cracks can be seen in some of the spandrels which appear red in the figure. The spandrels colored green indicates that the bending moment exceeded the bending capacity in the direction parallel to the plane of the wall and the spandrels colored red indicates that the axial action exceeded the tension capacity of the element. In the spandrels, colored orange, the shear action exceeded shear capacity in the direction parallel to the plane of the wall. It has an insignificant effect on lateral capacity of building as observed by the linear capacity curve. At stage two, analysis is carried out for 0.14 g PGA. As shown in Figure 19, shear failure in one of the piers on the first floor represented by an orange-colored pier was observed along with in-plane moment failure of three spandrels represented by the color green.

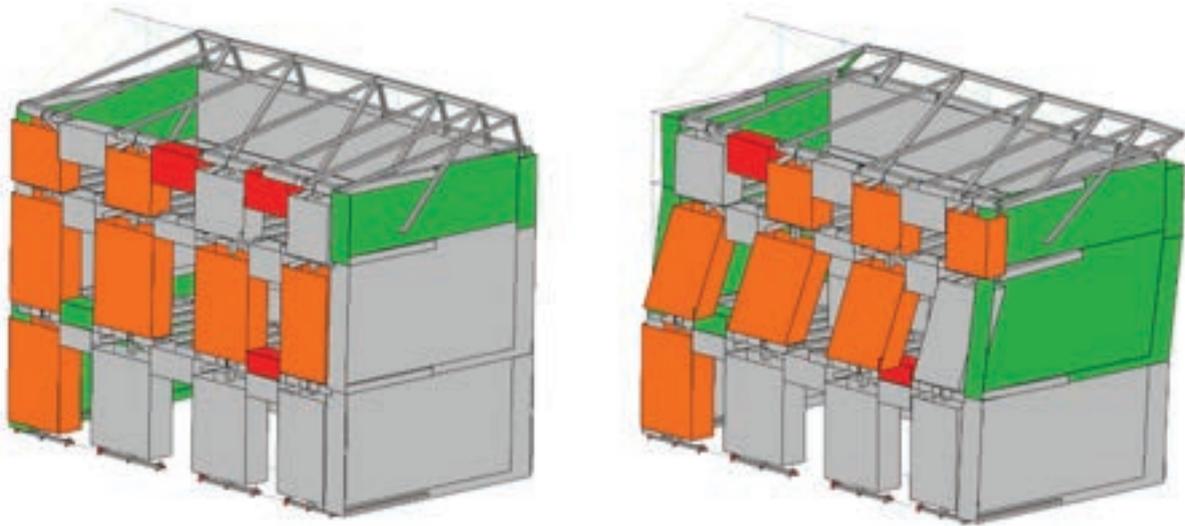
**Figure 20:** Damage pattern at stage3 corresponding to 0.19 g (54.28% of design level shaking) (left) and at stage 4 corresponding to 0.35 g (at design level shaking) (right)

As shown in Figure 20, at stage three, when the PGA is increased to 0.19 g, almost all front pier in first floor fails in shear while only single pier of ground floor fails in shear. The lateral capacity of the building is further reduced as shown by the reduced slope of the capacity curve shown in Figure 12. However, the building was able to sustain further deformation up to 0.32 g (stage four). Ultimately the building collapsed by an out of plane failure of the wall as shown by the piers colored green in Figure 20. It indicated that the bending moment exceeded the bending capacity in the direction perpendicular to the plane of the wall (out of plane failure) whereas the piers colored orange indicates that the shear action exceeded the shear capacity in the direction parallel to the plane of the wall (in plane failure). It is seen that the shear failure of the ground floor pier is less as compared to the shear failure of the first floor and attic. Shear failure is seen more in the upper story than that on the ground floor. It must be due to the shear enhancement of ground floor walls due to higher compressive stresses and horizontal force distribution from floor system. Also, at first failure, the spandrel occurs, and later the pier begins to fail. Lateral strength is compromised when the pier begins to fail in shear.
