Vulnerability assessment of touristic village in Nepal Himalayas: A case study of Lwang village

Pradeep Kafle¹, Magnus Upadhyay¹, Shreedhar Khakurel^{1,*}

¹ Department of Civil Engineering, Pashchimanchal Campus, Institute of Engineering, Pokhara, Nepal

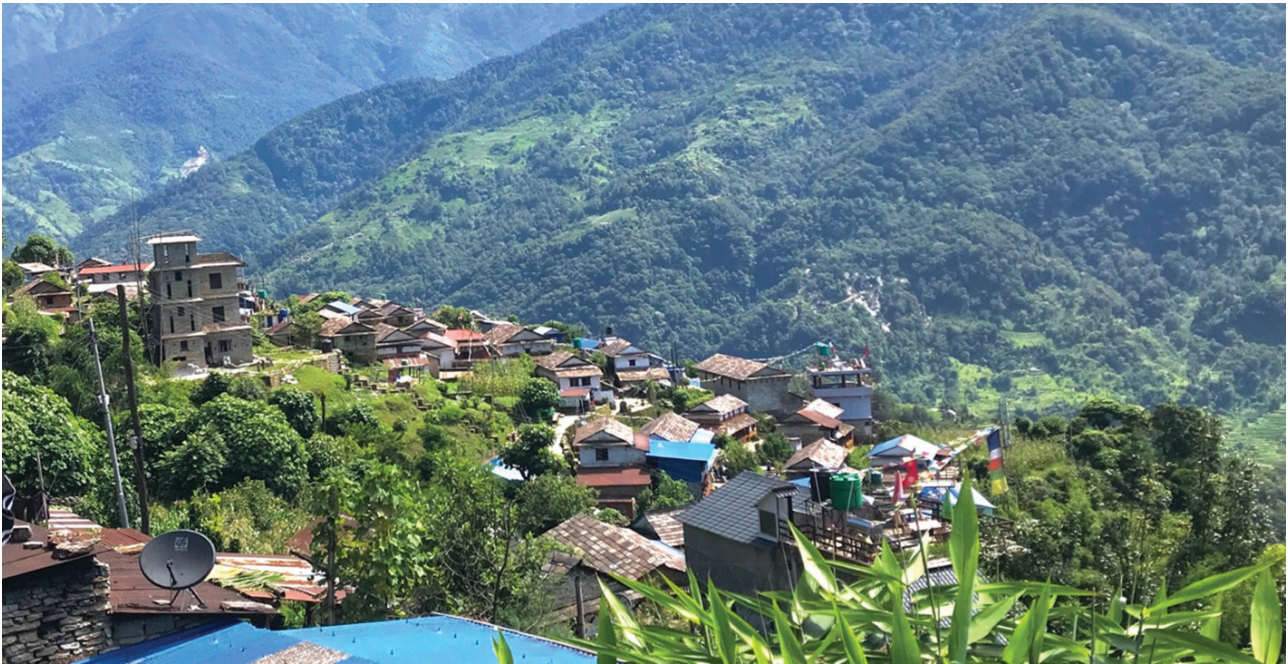
Figure 2: Lwang village with stone masonry houses

The village as shown in Figure 2 is distinguished by its prevalent use of stone masonry construction presenting distinct challenges regarding seismic vulnerability due to the material characteristics and construction methods adopted. Stone masonry constitutes stone as a unit and mud or cement or both as mortar. Due to the presence of these brittle materials and the absence or minimal presence of additional ductile members, they are susceptible to lateral loadings including earthquakes.

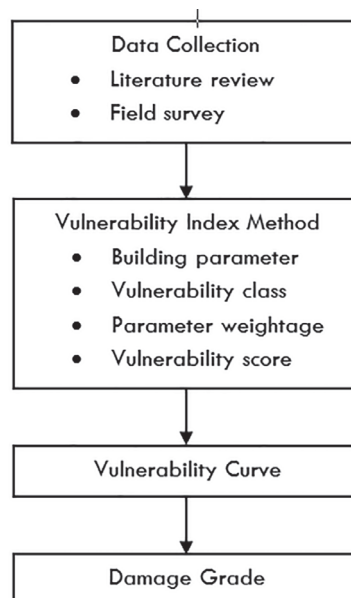
Figure 3: Flowchart of the study methodology

The flowchart of the methodology proposed for this study is presented in Figure 3. The study is initiated from data collection by field visit and literature review. Then, the vulnerability index is calculated from the building parameters, vulnerability class values, and weightage of the parameters. In doing so, parameters are chosen based on past studies to calculate the vulnerability score. From the computed vulnerability index, a vulnerability curve is produced which helps to predict the damage grade of buildings at earthquakes of different intensities.

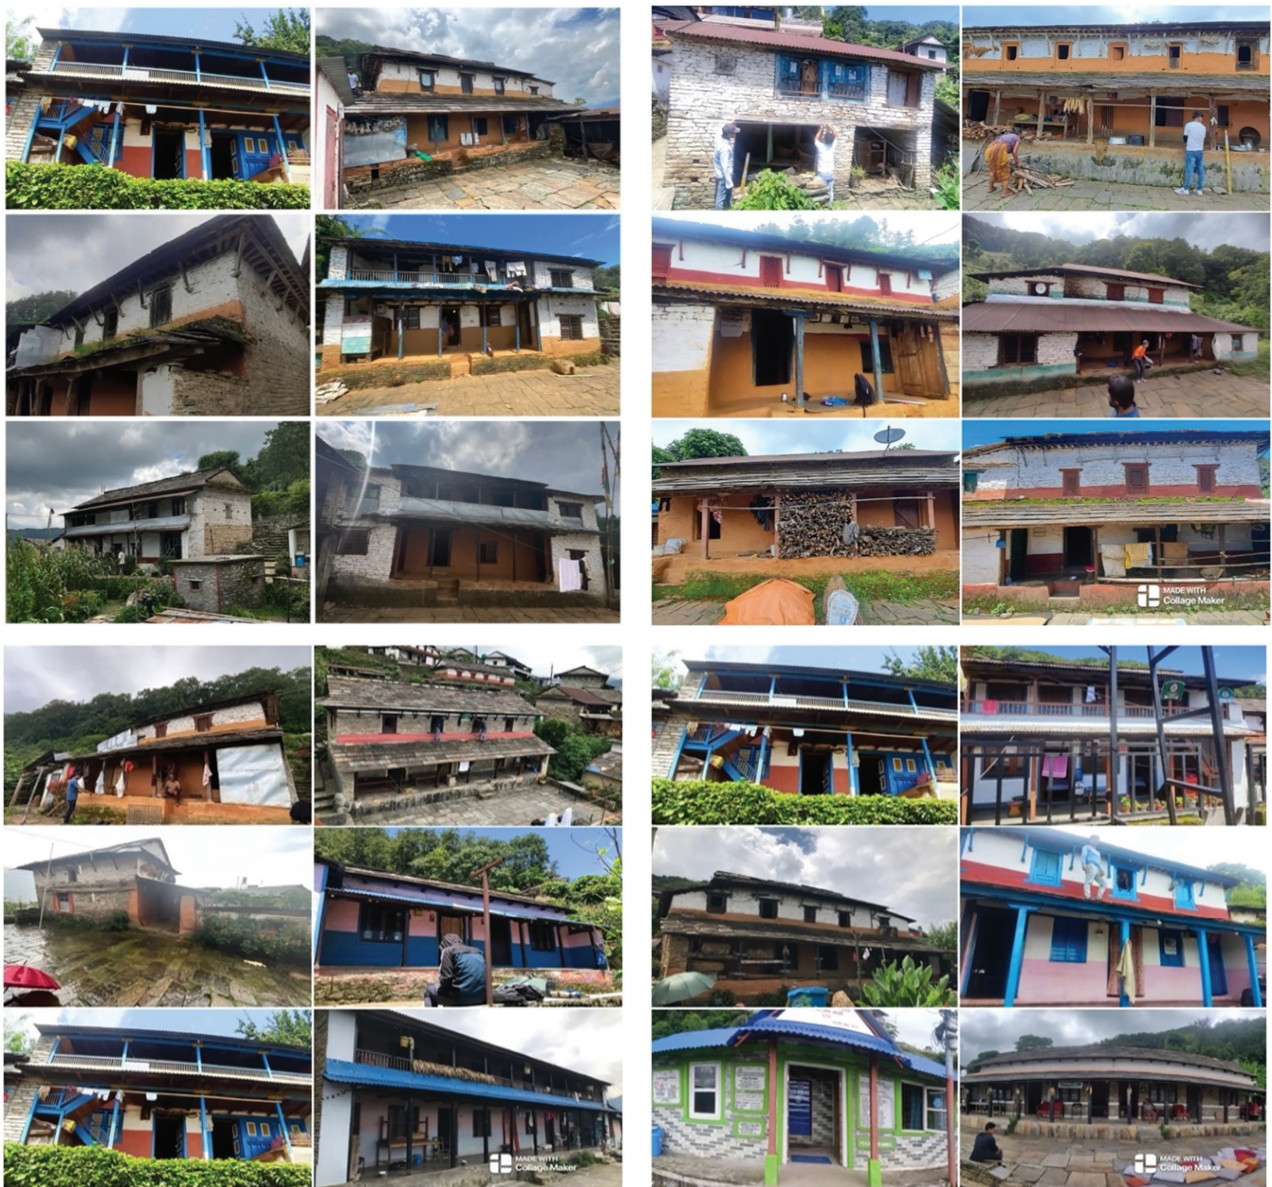
Figure 4. Photos of the studied buildings

Field survey is conducted in Lwang village to identify the buildings for the study. 24 buildings were studied consisting mostly of stone masonry structures and a few brick masonry structures as shown in Figure 4. Most of these buildings use mud mortar while a few use cement mortar. The study considered various parameters including building usage, number of storeys, type of mortar, type of stone, type of roof, seismic resistance elements, plan area, and crack patterns. Additionally, verbal conversations with homeowners provided details about the foundations and the construction years of the buildings. Field observations and conversations revealed that the majority of buildings were constructed as non-engineered structures. However, there has been a shift from non-engineered construction to pre-engineered and engineered housing construction post-2015.

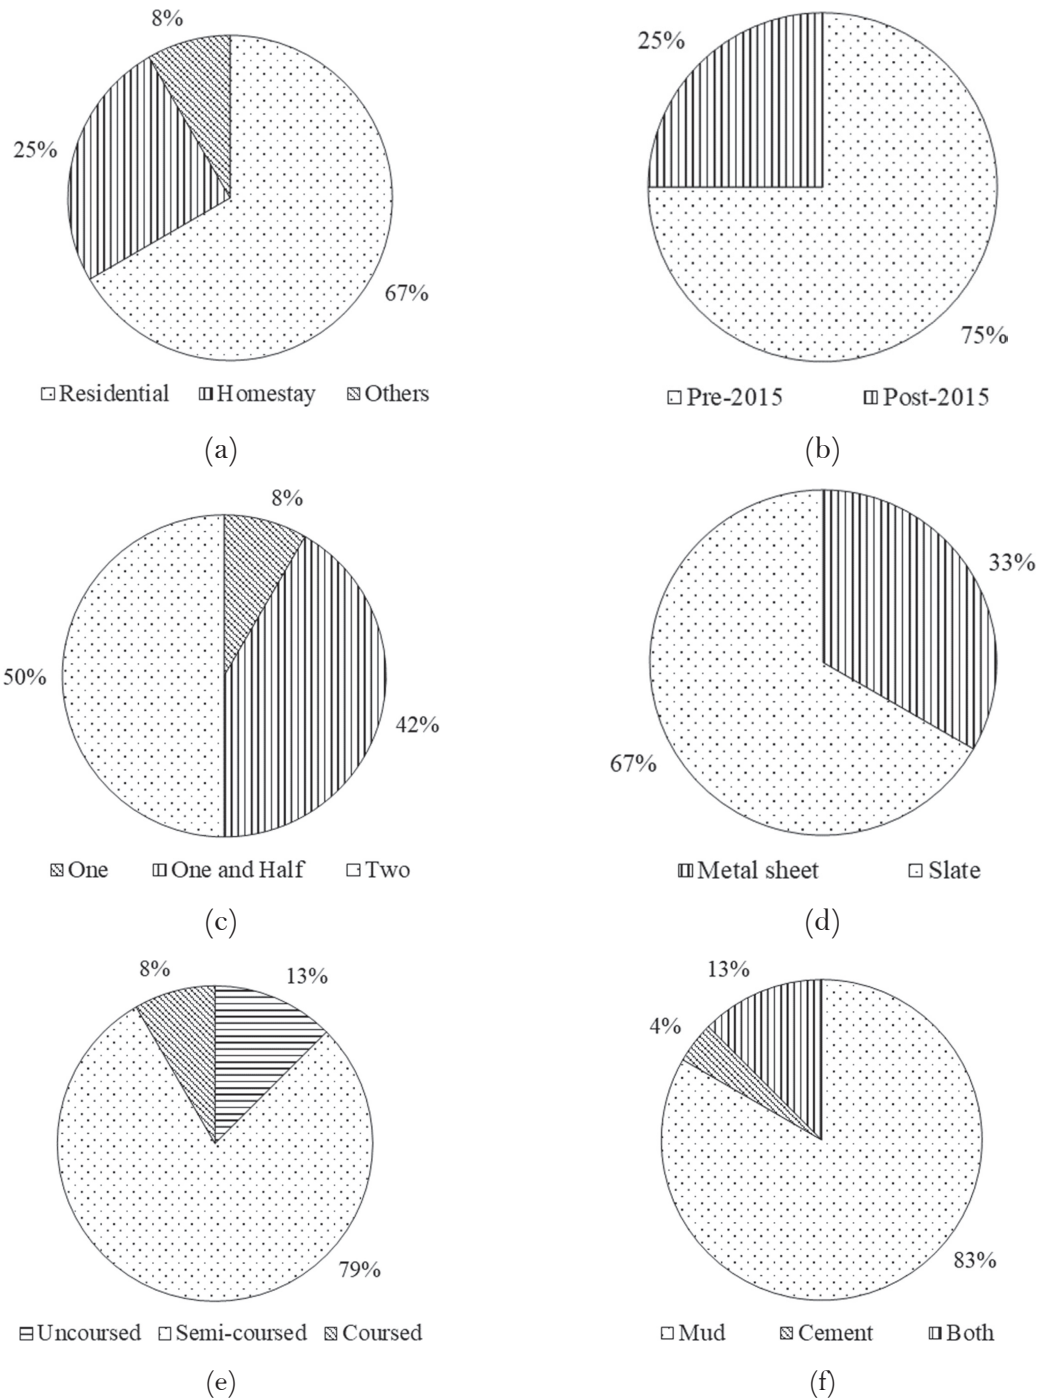
Figure 5: Percentage households based on (a) building usage, (b) built year w.r.t. the 2015 Gorkha earthquake, (c) number of storey, (d) type of roof, (e) type of stone, and (f) type of mortar

The data collected from the Lwang village is analysed and plotted in Figure 5. Based on the building usage, two-thirds of the buildings are residential (16), one-fourth are homestay, and the others are used for store, and public health. Three-fourths of the buildings (18) were constructed before the 2015 Gorkha earthquake while one-fourth of them were constructed after the earthquake. Based on the number of storeys, half of the buildings (12) are two-storey, 10 buildings are one and a half storey and the rest are single-storey. Among the studied 24 buildings, two-thirds of buildings (16) have slate roofs while one-third have metal sheets.

Based on the unit used, about four-fifths of the stone masonry buildings (19) have semi-coursed stone, 3 buildings use uncoursed stone, while the rest have coursed stone. Finally, five-sixths of the buildings used mud mortar while the rest buildings either used cement mortar or mixed one.

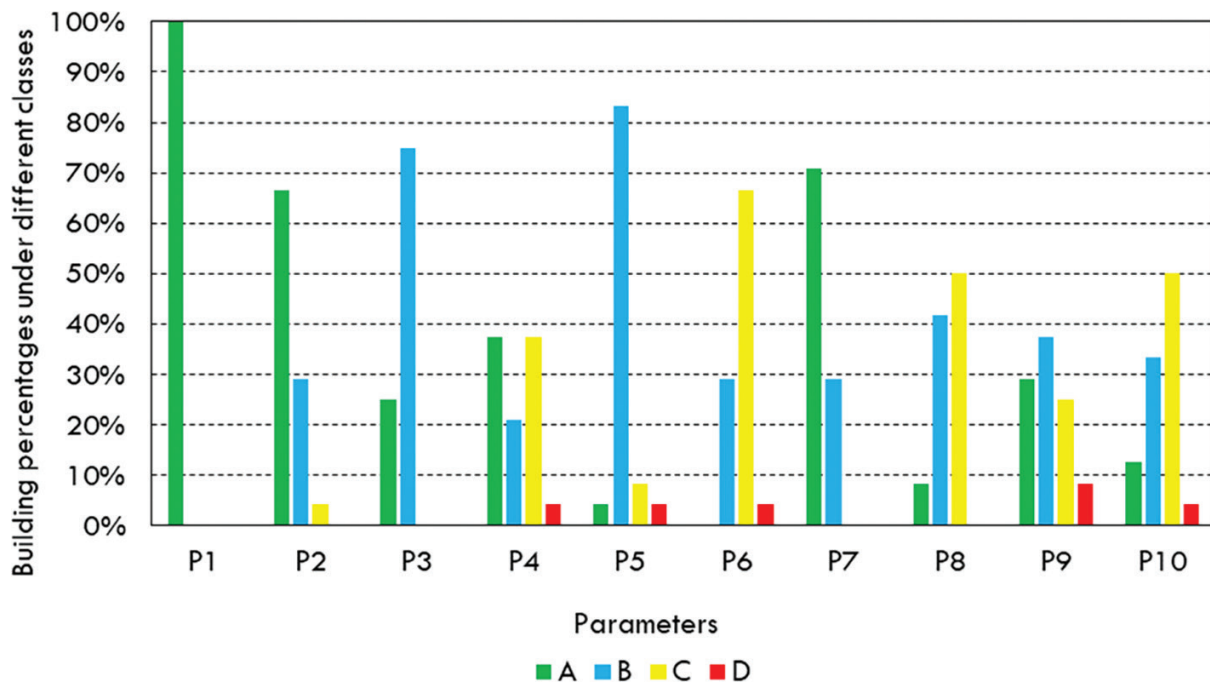
Figure 6: Percentages of buildings under different class for ten parameters

In Lwang village, the vulnerability assessment of masonry structures reveals distinct characteristics across ten parameters. The village predominantly features masonry walls with favourable slenderness ratios (100% in Class A), as shown in Table 2, reducing susceptibility to out-of-plane failure. Most walls exhibit moderate maximum spans relative to thickness (66.66% in Class A, 29.17% in Class B), promoting structural stability. Stone masonry with mud is prominently used (75% in Class B), enhancing resilience compared to other materials (eg. Clay and adobe). Wall-to-wall connections vary, with a significant portion showing strong interconnections (37.50% in Class A) and others moderate (20.83% in Class B and 37.50% in Class C). Timber diaphragms are effectively employed (83.33% in Class B), which is crucial for distributing lateral forces. Roof systems often exert lateral thrust due to stone roofing (66.67% in Class C), impacting wall stability. Despite prevalent wall openings compromising in-plane strength (70.83% in Class A), most structures (made primarily for homestay) had a higher number of openings in a lengthwise portion of the building. Consequently, the percentage of openings in such portion exceeded 25% and compromised structures' ability to withstand lateral loads. Additionally, the openings also lacked reinforcements to compensate for the reduced capacity resulting in the low-inplane index (50% in Class C and 33.33% in Class B). Further, structural heights (50% and 41.67% with multiple floors in Class C and Class B, respectively) slightly increase vulnerability to overturning. Conservation states vary, with 37.50% in acceptable condition (Class B), demanding maintenance for resilience. Moreover, none of the houses had undergone a retrofitting process and seemed to rely on cosmetic repairs. Structural irregularities in shear strength ratios (50% in Class C and 33.33% in Class B) highlight areas for improvement in seismic performance strategies tailored to local conditions. Percentage of studied buildings resembling different class for the ten parameter is shown in Figure 6.

The majority of the parameters were not problematic; however, parameters such as roof thrust, in-plane index, and horizontal diaphragm were areas of concern. Most buildings had slate stone roofs, which increased the seismic weight of the structures. Additionally, the dead load in the first-floor slab further increased the seismic weight. Parameters like the horizontal diaphragm and in-plane index indicated that the buildings had limited capability to resist seismic forces. The absence of other lateral load-resisting elements, such as corner stitches, rebar at corner joints, lintel bands, sill bands, gable bands, and inadequate cross walls, also contributed to the buildings' low capability in responding to seismic forces. Moreover, the majority of houses (made primarily for homestay) had a higher number of openings in a lengthwise portion of the building. Consequently, the percentage of openings in such portion exceeded 25% and compromised structures' ability to withstand lateral loads. Additionally, the openings also lacked reinforcements to compensate for the reduced capacity. Both factors, the percentage of openings and reinforcement in openings, do not satisfy the guidelines for masonry structures.

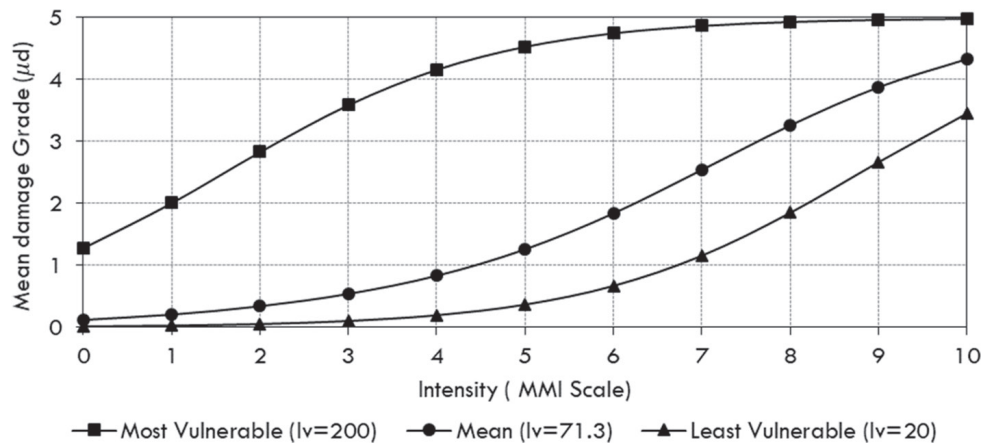
Figure 7. Vulnerability curve for the buildings in Lwang village

The vulnerability Index (I_v) was calculated for all 24 buildings whose values varied from 20 to 200 with a mean of 71.3 and a standard deviation of 38.95. This indicates significant variation in vulnerability levels among the buildings. Vulnerability curves were generated for all buildings using Equation (3), showing expected damage grade under earthquakes of different intensities, for the most vulnerable building ($I_v = 200$), the least vulnerable building ($I_v = 20$), and the mean value of all buildings ($I_v = 71.3$), as shown in Figure 7. The curve highlights priority areas for intervention, suggesting that buildings with higher I_v values require urgent mitigation measures.

After plotting vulnerability curves of each building, the expected damage grades (as per EMS-98) for two earthquakes: 2023 Jajarkot earthquake (intensity VII) and 2015 Gorkha earthquake (intensity X) were determined. The expected percentage of buildings under the epicentral intensity of these two earthquakes are presented in Table 3. Results showed that during an earthquake of intensity comparable to the Jajarkot event, a significant proportion of buildings would experience moderate (37.5%) to heavy damage (45.84%). Since the intensity of 2015 Gorkha earthquake is higher i.e., X, 45.83% of the buildings are expected to suffer heavy damage and 50% could face near-collapse.

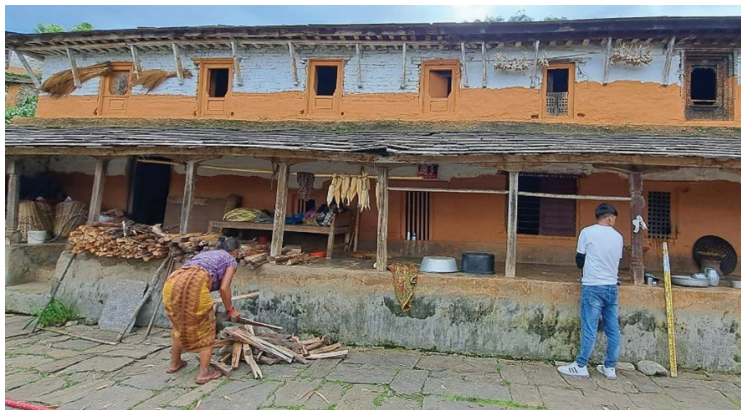
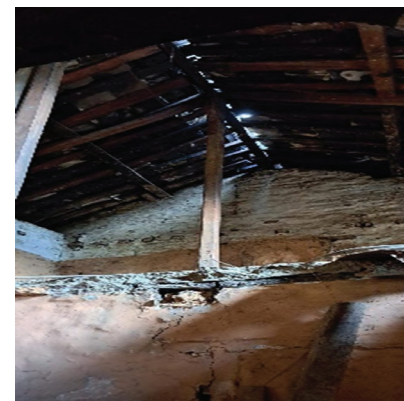
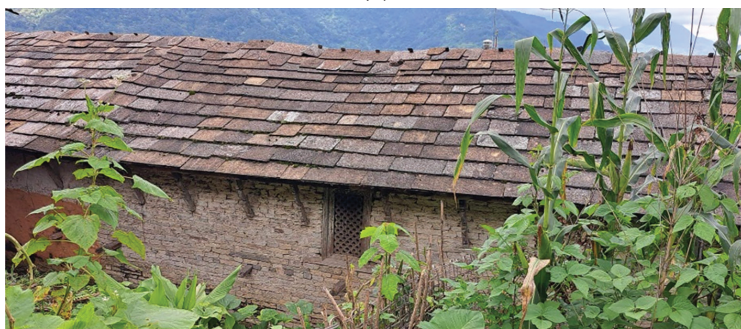
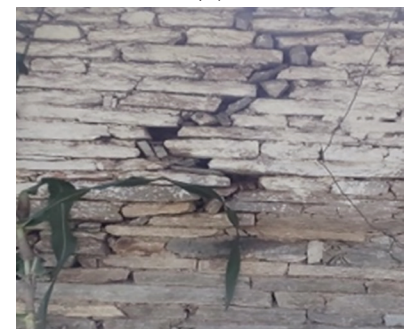
Figure 8: Most Vulnerable Building

The vulnerability curve for the most vulnerable structure showed damage grade at zero intensity earthquake is greater than 1, primarily due to existing damage in the structure, such as roof damage and wall cracks. These existing damages are visible in Figure 8. Figure 8(a) shows the front view of the most vulnerable structure. The building seems to be in good condition from this picture. Figure 8(b) reveals the damaged roof and floor slab, with the roof precariously supported by a strut. Figure 8(c) shows the damaged roof from outside the structure. During the field investigation, numerous cracks were found in the building. Herein, one of the major cracks is shown in Figure 8(d).

The least vulnerable building ($I_v = 20$) in Lwang village is constructed from brick with cement mortar, with well-executed wall-to-wall connections and steel lintel and sill bands, built after the Gorkha earthquake with no visible signs of weakening. Conversely, the most vulnerable building ($I_v = 200$) is made of stone with mud mortar, shows significant deficiencies in wall connections, and has severe cracks from the Gorkha earthquake. Most average houses, made of stone with mud mortar, have proper wall connections and minor cracks from the Gorkha earthquake, and feature fewer openings and cross walls, rendering them less vulnerable.

These findings highlight the urgent need for targeted strengthening measures to enhance the seismic resilience of buildings in Lwang village, thereby safeguarding both the local community and the area's touristic value. The insights gained from this study can be applied to other regions with similar building typologies thereby contributing to mitigate the seismic vulnerability.
