## Study on the Quality of Walkable Streets in Dhapakhel Neighborhood, Lalitpur District, Nepal

To examine the current street network and pedestrian infrastructure in Dhapakhel, Lalitpur, and identify deficiencies in walkability, accessibility, safety, and related facilities such as sidewalks, footpaths, and crossings.

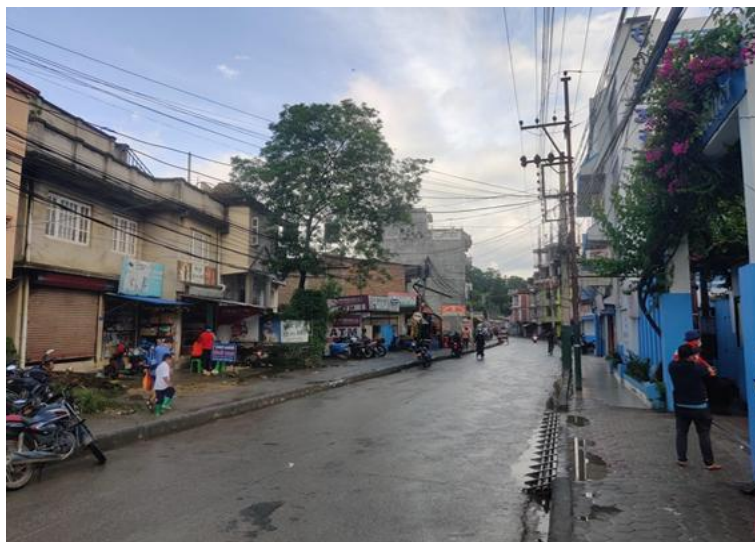
The road network in the area is primarily composed of two types of roads: the Main Collector Road and the Local Street Road. The Main Collector Road has an average width of 11 meters and is designed to accommodate higher activity levels with features such as commercial sub-zoning for adjacent parcels, availability of bus transit, a 2-meter setback from the road edge, a 1.5-meter-wide footpath, and a two-sided slope for effective drainage. In contrast, the Local Street Road is narrower, with a width of about 4 meters, and functions as a shared street space. These roads typically have a 1.5-meter setback from the road edge, a 1-meter right-of-way, and lack dedicated footpaths in most sections. Drainage on local streets is managed through a one-sided slope, reflecting their smaller scale and primarily residential or low-traffic character.

*Fig 1: Local street*

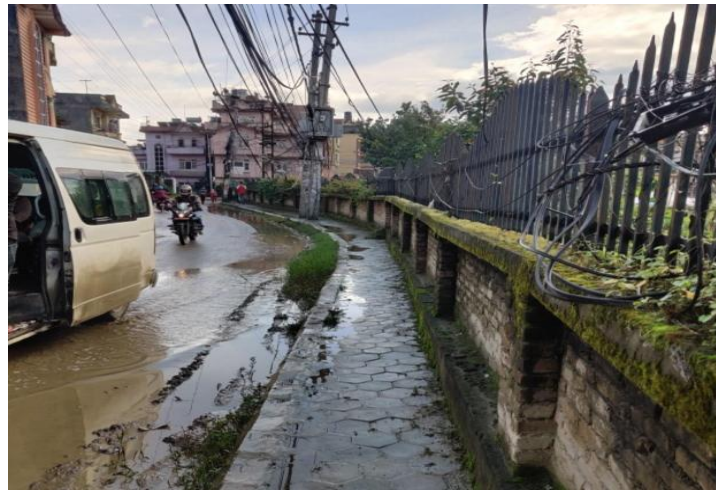
A comprehensive analysis of the footpaths in the study area revealed multiple deficiencies in their design and construction. Many footpaths were found to be poorly constructed, with uneven surfaces and structural issues that hinder pedestrian movement. In addition, the width of several footpaths was insufficient to accommodate pedestrian flow comfortably, particularly during peak hours. Greenery, street furniture, and other infrastructure elements often encroached upon the walking space, further limiting usability. Moreover, a significant number of footpaths were not designed to be accessible for people with disabilities, lacking ramps, tactile indicators, and other necessary features. These findings underscore the urgent need for a holistic redesign of the pedestrian network, prioritizing safety, accessibility, and overall functionality for all users.

*Fig 5: Narrow footpath*

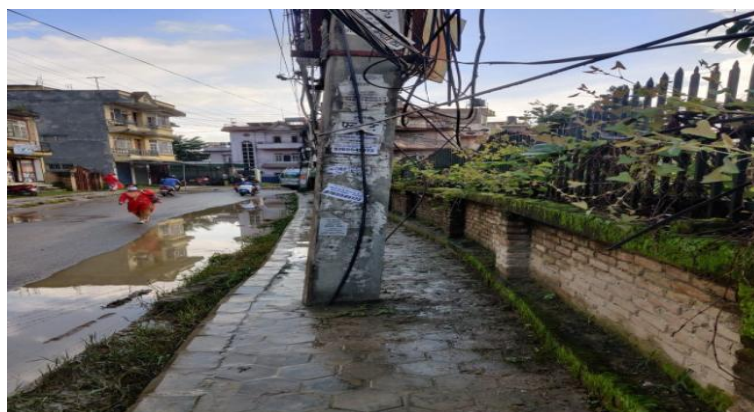
*Fig 6: Electric pole in the middle of footpath*

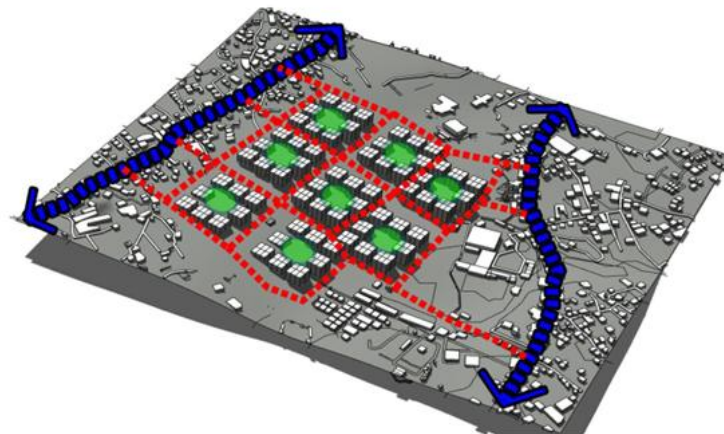
Fig 7: Illustration of Dhapakhel area with compact settlement

Safe and accessible pedestrian infrastructure is extremely important to improve the mobility system of cities. There are no comprehensive policies, plans and infrastructure development programs that ensure the pedestrian's right for safe and easy mobility. Focusing on vehicular mobility while ignoring the needs of pedestrians achieves the opposite of development. Integrated road design that includes standard footpaths, cycling lanes and dedicated public transit routes is more sustainable. It is important to change the trend towards focusing on pedestrian mobility rather than vehicular mobility. This will cause an increase in traffic congestion and also increases in air and noise pollution. The Dhapakhel area can be improved as a pedestrian friendly street only if the strict policy is made and implemented prioritizing pedestrians first and vehicles second. There is also the need for Improvement of infrastructures as the streets are not pedestrian friendly enough and can be improved a lot. As for the new development projects, urban planning, the authorities are recommend to plan as per compact planning. Building a compact city which is more connected and inclusive is far better than the urban sprawl that is continuing in the Dhapakhel area. It will emphasize streets for pedestrians and control the city within. The layout and accessibility of the city should be changed into integrated and inclusive neighborhood planning. This will encourage "Higher Density Multi Family Housing" which will solve the problem of land for housing and population growth. It will also incorporate the Community Open Space/Greenery Parks in the Neighborhood Center of the Dhapakhel area. Improved street networks make areas more walkable and pedestrian-oriented, simultaneously enhancing the physical health and well-being of residents. Another good trend of Compact Development will bring the neighborhood close and healthy and also put all the infrastructures within walking distance within the city.
