LOCAL BUILDING CULTURES IN RECONSTRUCTION

Pawan K. Shrestha^{1*}, Salena Sangachhe¹

¹ Architecture Sans Frontières (ASF) Nepal

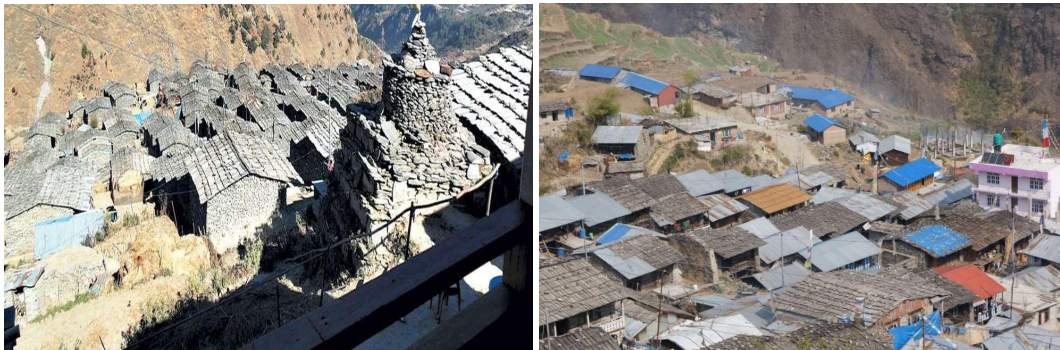
Figure 1: Pre- and Post- 2015 Gorkha earthquake condition of Gatlang, Rasuwa- Black slate roofs of pre-earthquake (Photo: Umesh Pokharel, The Kathmandu Post) and CGI roofs of post-earthquake (Photo: ASF Nepal)

5.1. Post-earthquake Reconstruction in Gatlang, Rasuwa (Figure 1)

Moreover, people clearly expressed their will to preserve their old Tamang heritage: an architecture built out of dry-stone masonry wall combined with wooden structures, wooden carved façades, and black wooden roofs. Hence, it is imperative to adopt repair and retrofit solutions for these specific situations but these need to be validated scientifically so that they can be endorsed by NRA and included in the National Building Code. Then, guidelines could also be developed to benefit to many more HHs in Nepal. Repair and retrofit practices have already been identified and tested based on experiences and started to be applied at a small scale, focusing on affordable solutions such as:

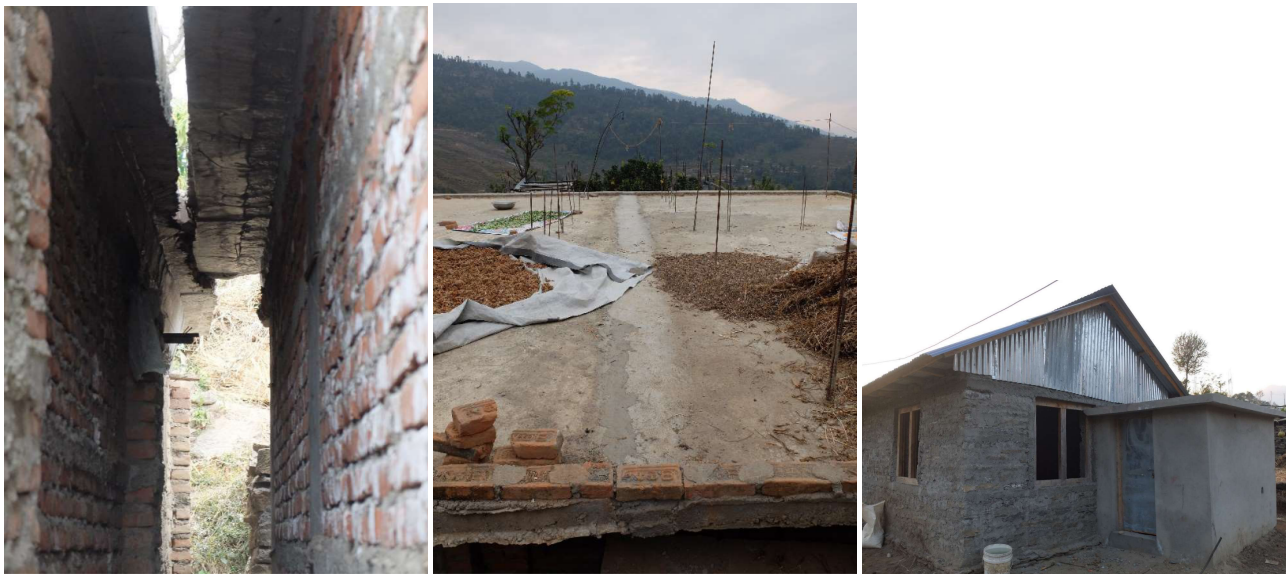
Figure 2: Dangerous adaptations and extensions after reconstruction, Sindhupalchowk (Photo: CRAterre)

(a) Two dwellings merged without an appropriate technical solution (b) Reinforcing bars exposed to corrosion for future vertical extension (c) Risk of damage to the newly built house unit due to the addition of toilet without recommended gap/technical solution

5.2. Post-earthquake Reconstruction in Panchpokhari Thangpal Rural Municipality, Sindhupalchowk (Figure 2)

In addition, it was observed that after the reconstruction of housing units following building catalogs and built according to the necessary quality, these houses turned out to be inadequate such that HHs extended the construction, to respond to their housing and livelihood needs. In many cases, they have mixed technologies without proper connections nor considering the construction as a whole. This results in unstable constructions in seismic prone areas.

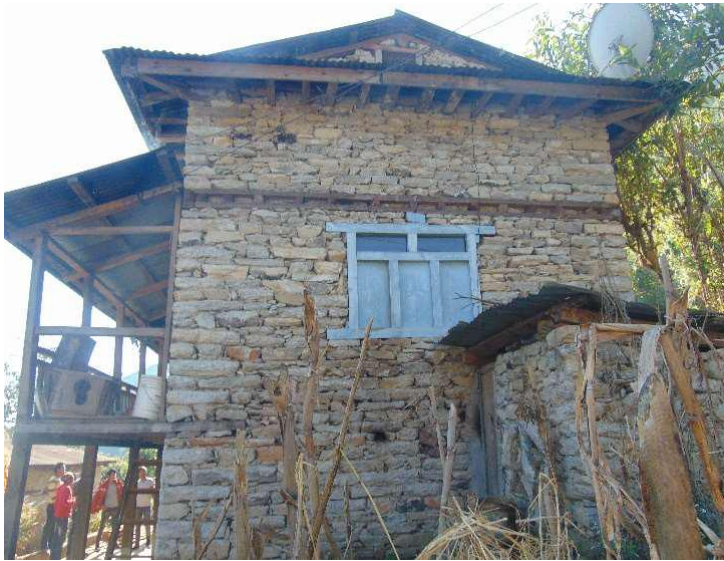
(a) Pre-Earthquake house, Magapauwa, Dolakha (Photo: ASF Nepal)

These distinctive features of these buildings are mud floor, four pitched thatched roof (now almost replaced by CGI sheets) and diagonal struts (tudal) supporting the roof projection on all four sides. Nearly half of the houses had roofs made of tile or slate, 36% had houses made of galvanized iron according to CBS (2011). All these were damaged by the earthquake and in need of reconstruction. It was also seen that local masons and carpenters were in need of more awareness, knowledge and skills for disaster resistant construction and repair. Although good local building practices existed, they needed improvement as it was observed that recent buildings/houses lacked quality and technological soundness as compared to the older ones.

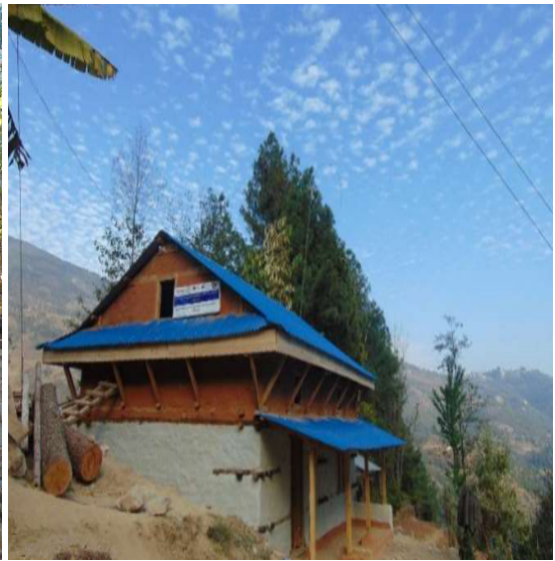
(b) Post-earthquake demo house (Photo: ASF Nepal)

Local builders (masons, carpenters and other building professionals) were thus given Training of trainers for which they underwent OJT by constructing a prototype building. Here, they were able to understand the proposed design and material use, could improve their theoretical and practical knowledge for disaster resistant house construction and repair and were able to supervise on-site construction and train the other local builders and their workers in full capacity. As such, there was increased local capacity enhancement and people began to realize the mistakes that they were making in the construction and agreed not to repeat them. They further learned that the process and technology which was being taught in the training was not completely new but only an improvement of their own old construction practices.

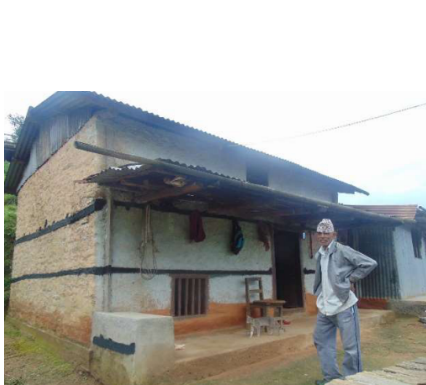
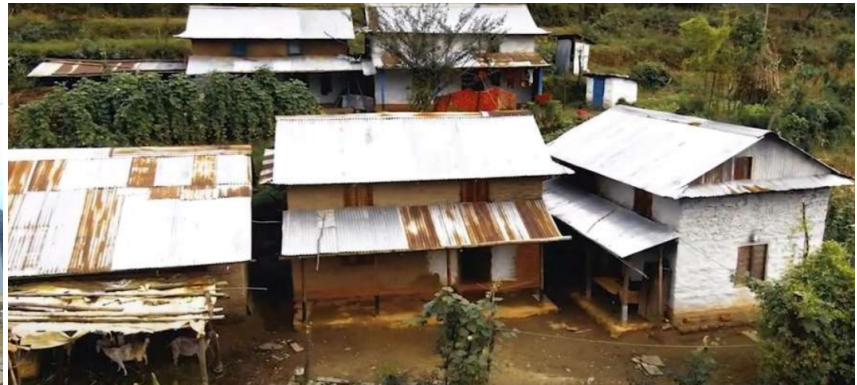
Figure 3: Pre and post-2015 Gorkha earthquake demo houses, Magapauwa, Dolakha

(c) Post-earthquake demo house replication (Source: ASF Nepal)

(d) Post-earthquake demo house replication (Source: ASF Nepal)

Getting to know how some of the earthquake resistant construction technologies were very similar to their traditional construction methods, which was discontinued by the locals, gave them additional confidence to once again adopt those technologies for reconstruction. Replication of the model house design thus extended beyond the project area with 193 households receiving social and technical assistance for reconstruction, 113 houses constructed under technical supervision, 11 households received top up support for house construction, 20 local artisans received On the Job Training and 82 people received vocational training to enhance their skill and livelihood options. As such many constructions in the region were able to benefit from these examples and the skill of the trained builders, who adopted the approach.
