## LOAD RESISTING BEHAVIOR OF NEPALESE REST-HOUSE

### Abstract

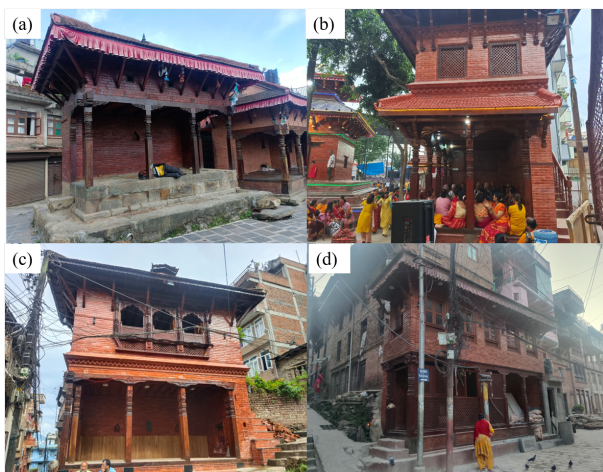
Figure 1. Typical resthouse (sattal/falcha) in Kirtipur showing different wall and frame layout positions at (a) Devdhoka (b) Sundarbasti (c) Kutusagal and (d) Kutujho

Field observations identify several possible ground-storey plan layouts, including parallel wall–frame systems, L-shaped configurations, and U- or C-shaped arrangements similar to the field observations (Figure 1). Based on these observations, four representative plan layouts were selected for analysis: Case I: Masonry wall and timber frame parallel in plan, Case II: L-shaped wall

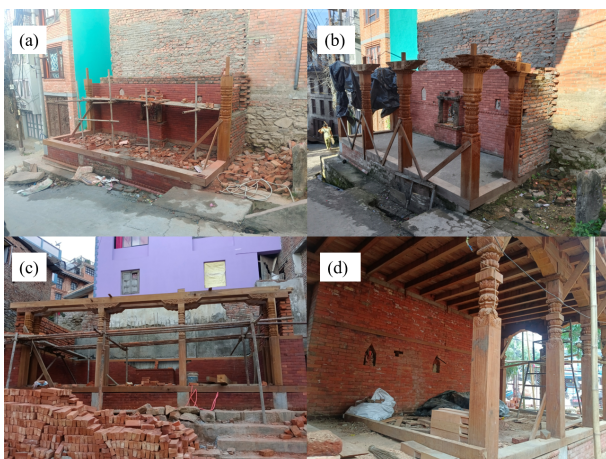
Figure 3. The construction sequence of rest house in Kirtipur. (a) Construction completion of plinth tie and partial completion of side wall., (b) Erection completion of post with corbel, (c) Construction completion of the floor beam and (d) construction of floor joist

The construction sequence adopted in the construction of rest house is depicted in Figure 3. It is observed that the construction technique is similar to the load bearing wall structure construction in other heritage construction. The timber joint is mostly the carpentry with minimal application of other materials like metal plates, bolts etc. In the Figure 4a and b, the connection between the plinth beam and post is shown, the connection type is a mortis and tenon joint. This joint is considered to be flexible joint which does not fully resist moment. The lower tie beam can take axial load from the post and the lateral shear force during the earthquake. The Figure 5a, shows a dove tail joint connection type at plinth level which can only take tensile load and compression load along the axis of the tie member. The Figure 5b shows the cutout prepared for beam to beam connection using scarf connection which can resist partial axial, moment and shear force. Finally, Figure 5a and b show the column to beam connection in which a pedestal is provided below the beam which is used to transfer beam load to the post gradually concentrating at the post ends at top from beam. This type of connection is a unique type which not seen in any other country so far (Figure 6a). For our present work this type of joint is considered as a rigid joint. The load resisting characteristic of different joints can be observed in literature (Sobon, 2002).

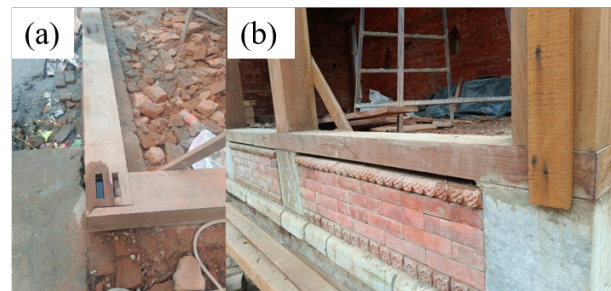
Figure 4. Timber joint (a) Groove in plinth tie for post connection (b) Plint tie beam to post connection

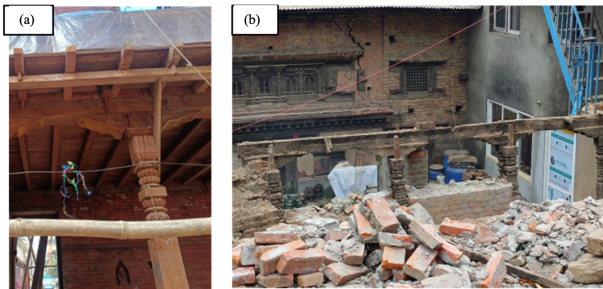
Figure 6. Timber joints (a) Beam post connection using bracket (b) Post dowel end observed in old demolished building

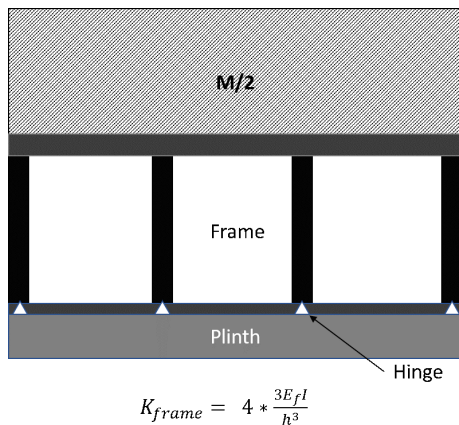
Figure 7. Frame stiffness along the in-plane direction

finite element model, the stiffness distribution of the structural system is evaluated using a simplified analytical approach. The plan dimensions are limited to a length-to-breadth (L/B) ratio not exceeding 2. The first-storey masonry walls are idealized as rigid structure, the timber frames are similarly represented as vertical bending elements connected by a stiff beam at the top, forming a system capable of resisting lateral loads through flexural action of the columns and the diaphragm stiffness of the beam. The base of the timber frame is assumed to be pinned, allowing rotation while restraining horizontal movement, whereas the beam-column connections are modeled as fixed, consistent with the semi-rigid yet continuous nature of traditional timber joinery observed in Nepalese rest houses (Figure 7 and 8).

For this configuration, the lateral stiffness of an individual timber column is determined from classical beam theory as  $k = 3EI/L^3$ , where E denotes the elastic modulus of timber, I represents the second moment of area of the column cross-section, and L corresponds to the storey height. The masonry walls are modeled as planar shear panels, with stiffness expressed as a function of the shear modulus G, cross-sectional area, and wall height (Figure 8 and 9). Depending on the wall aspect ratio, the response
