# RECONSTRUCTION OF THANTHU DURBAR, BHAKTAPUR: A CASE STUDY

<sup>1</sup> Bhaktapur Municipality

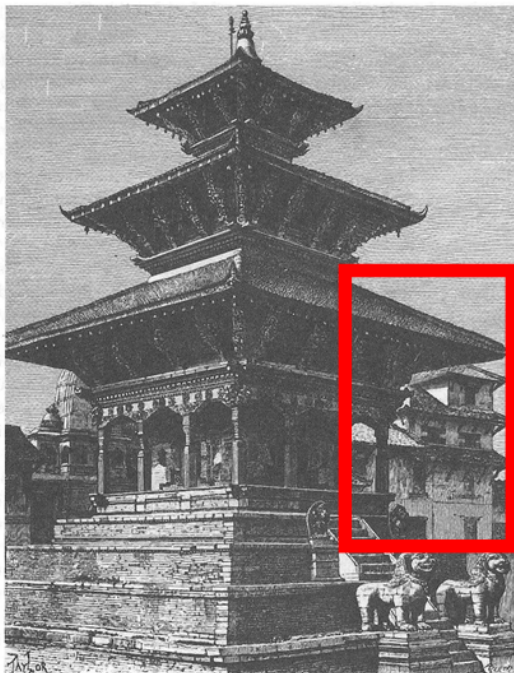
Figure 4. Sketch by Taylor behind the Lapan Dega (Hari-shankar mandir)

The reconstruction proposals were prepared following the detailed documentation of the building. The drawings and design were developed in the Malla architectural style, taking into consideration the Fifty-Five Windows Palace, which is connected to the southern side of Thanthu Durbar. The proposals were based on the research of Prof. Dr. Purushwottam Lochan Shrestha, which indicates that the Fifty-Five Windows Palace and Thanthu Durbar were originally adjoining structures built by King Jita Mitra Malla. Accordingly, the design was prepared to harmonize with the adjoining palace, giving the impression of a single unified structure in the Malla architectural style. The storey of the building was referenced from historical illustrations of the building as Figure 4 in "Voyage to Nepal".

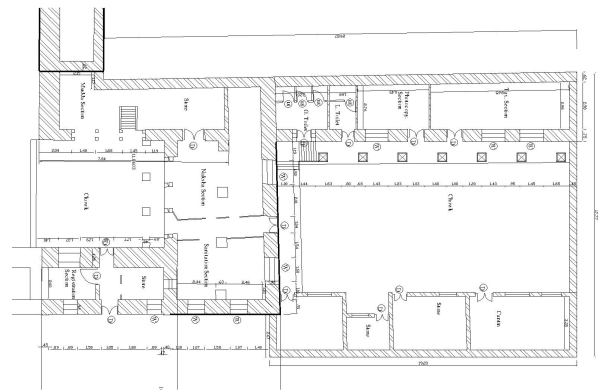
Figure 5. Documentation of building

The existing structure of Thanthu Durbar was measured and documented before commencing on the reconstruction process. The four-storied load-bearing building stood in the main square of Bhaktapur city, characterized by a lime-plastered façade. It comprised two courtyards: the primary entrance courtyard with enclosed bays, and a secondary courtyard formed by a single longitudinal bay. The main entry is accessed from the west. The building features wooden windows, lime-plastered pilasters, decorative cornices on the façade, and a roof covered with jhingati (traditional Newari roofing tiles). The detail survey and documentation was carried through measurements and photographs of existing building.

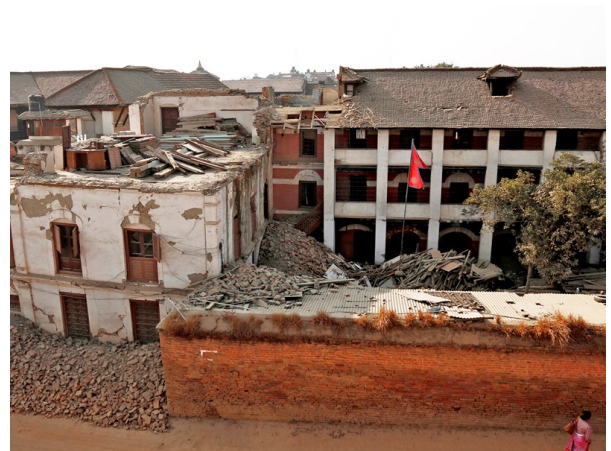
Figure 6. Building damaged by earthquake

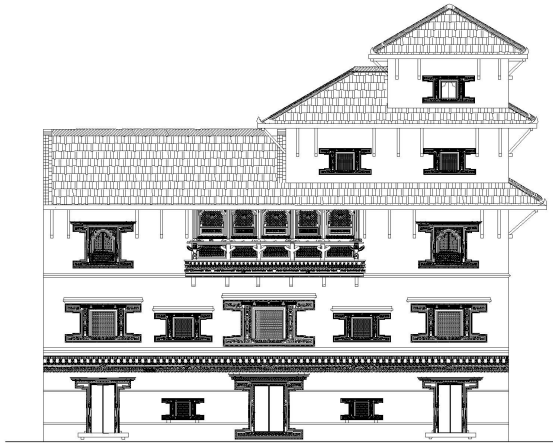
Figure 7. East elevation

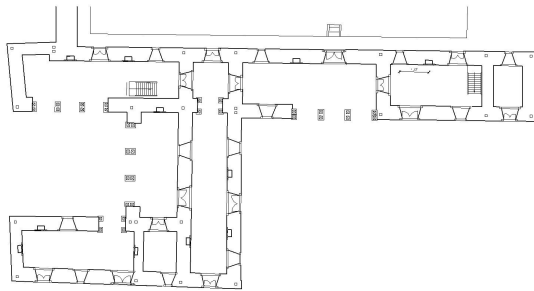
Figure 8. Ground floor plan

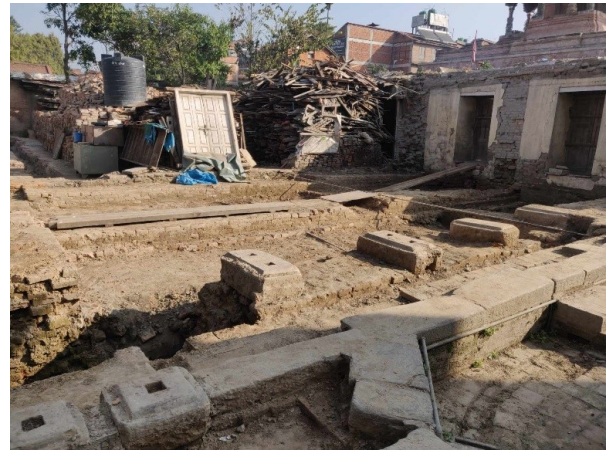
Figure 9. Footprint found during excavation

of the building to study the underlying masonry layers. The primary objective was to determine the approximate age of the structure through the collection of foundation samples and fragments of mud pottery, soil condition, depth of foundation and layout of footprint. Detailed documentation of the foundation was carried out, along with a thorough study of its condition. The proposed drawings were revised based on the actual footprint and evidences revealed during the excavation process.

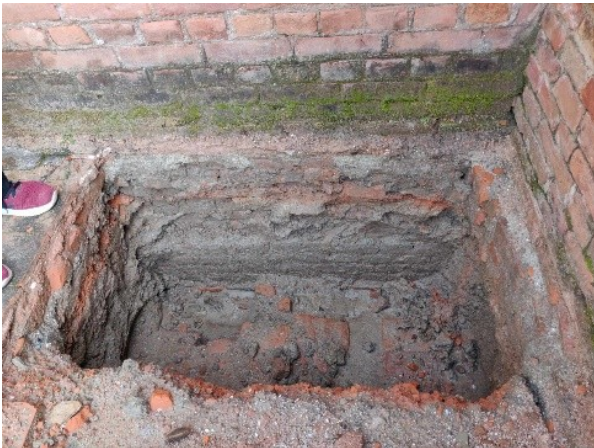
Figure 12. Pit excavation for foundation study 01

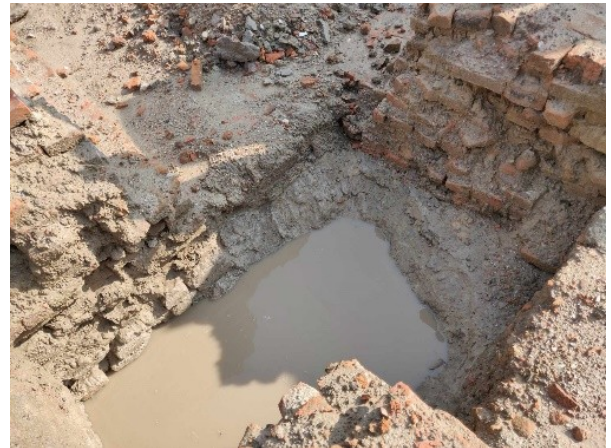
Figure 14. Pit excavation for foundation study 03

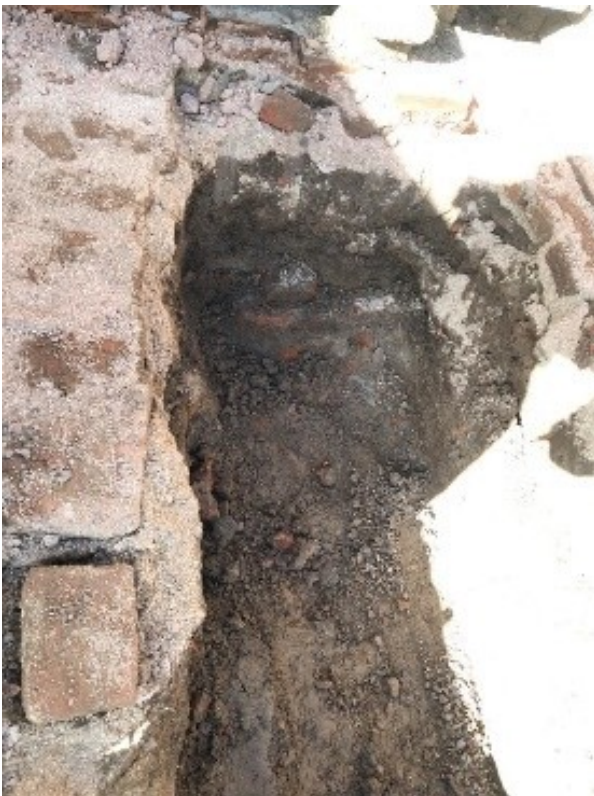
Figure 13. Pit excavation for foundation study 02

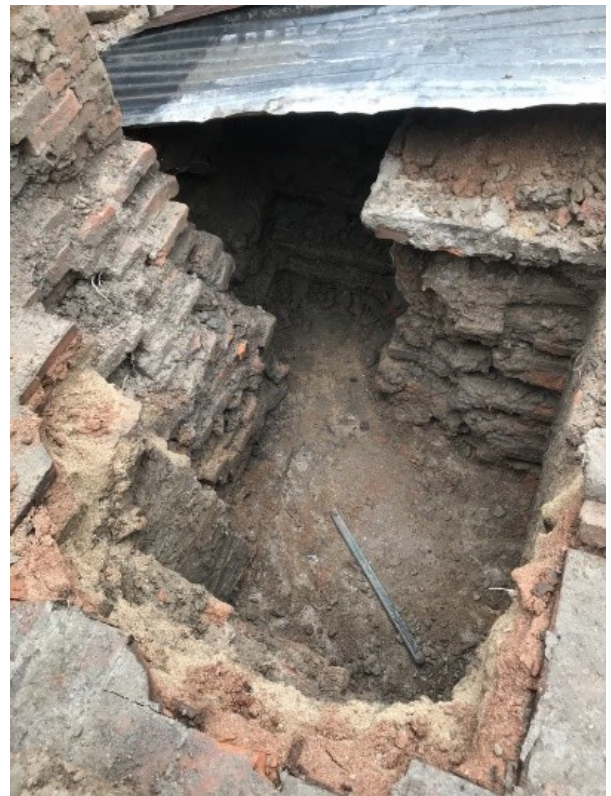
Figure 15. Pit excavation for foundation study 04

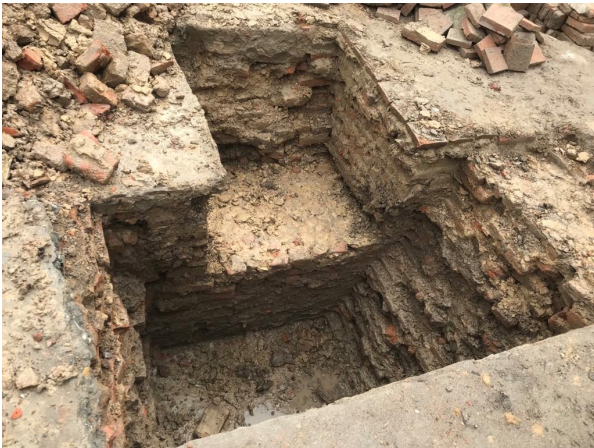
Figure 16. Pit excavation for foundation study 05

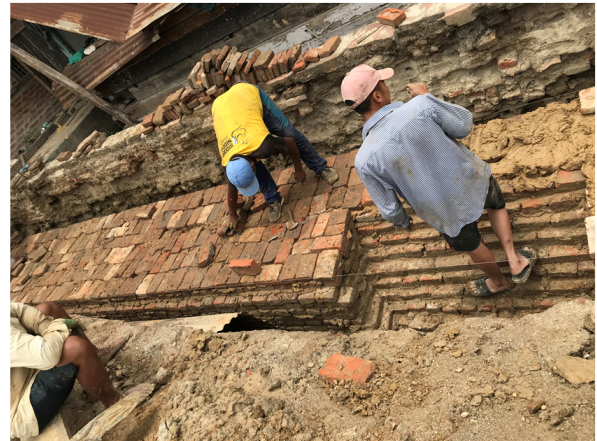
Figure 18. Foundation brick works

of the colonnade. The foundation was excavated up to a depth of 6' from the ground level until stone soling was encountered. Initially, a stone was laid on the foundation to prevent water seepage. The mud mortar was used for reconstruction to preserve the traditional use of material. The maa-apaa bricks were assessed for their strength and used in the internal walls, while dachhi-apaa bricks were applied on the outer façade with mud mortar. These bricks were laid in a header and stretcher pattern in alternating layers to enhance the foundation's stability. A trench plan was devised for the precise placement of walls, with widths of 900mm. Corner timber posts were erected at all corners of the load-bearing walls and secured with Lakashi, forming a chauka structure, to reinforce the load-bearing structure. These posts transferred the weight of the superstructure to the ground. Horizontal sill and lintel bands, tie members were installed to distribute structural loads and help bind the wall system together. These bands were connected to the openings and the corner timber posts, enhancing the overall strength of the building and contributing to a more resilient frame structure. The Traditional timber joineries like Geramo san (Dove tail) and бага chhinah san (Half lap) were used to extend timber members and connect different parts. To protect them from decay, all timber members were coated with bitumen. The base stone (Tepu lhon) was laid for the wooden posts (tham) on the ground floor. Wooden beams (nila) were then placed over the posts to support the structural load. The carved wooden doors and windows were installed after the corresponding wall sections had been completed. Niches (gwakhan), inspired by those in the Fifty-Five Windows Palace, were incorporated on the inner side of the walls to enhance the traditional architectural character. The wooden cornices were continued in alignment with the adjoining palace, maintaining visual and structural harmony. Wooden joists were laid to form the floor level above. To date, one story has been completed, and installation of the openings on the first floor is in progress. Throughout the construction process, the technical team from Khwopa Engineering College and the Heritage Section of Bhaktapur Municipality has been diligently supervising the building.

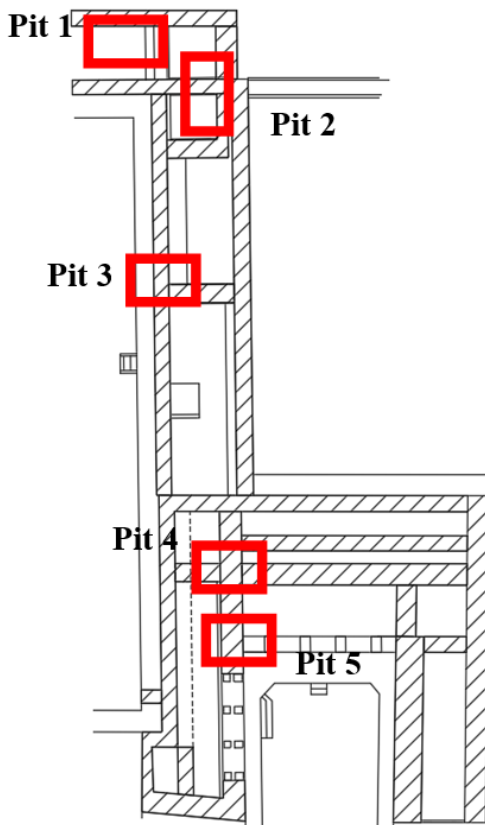
Figure 17. Locations of pit excavation for foundation study

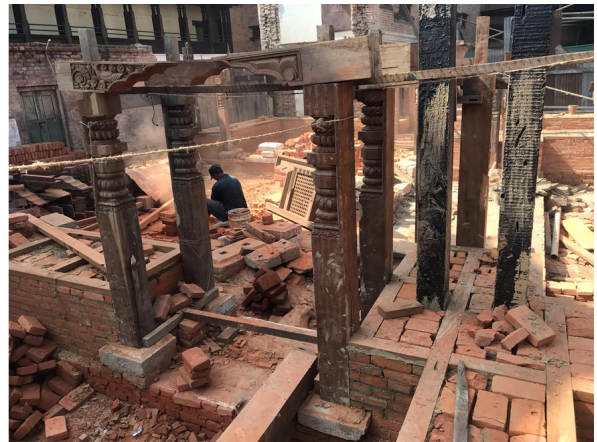
Figure 19. layout of post on base stone

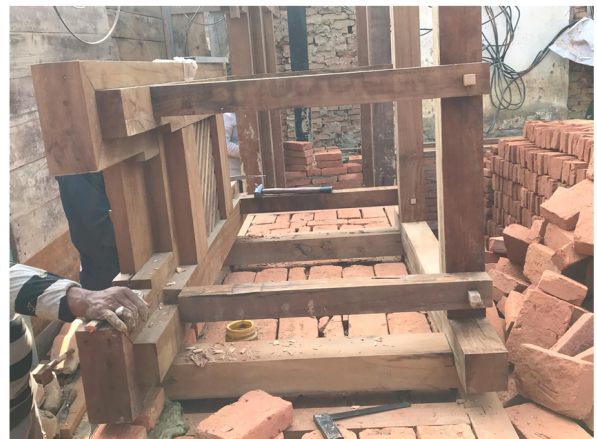
Figure 20. Opening installation with wooden joineries

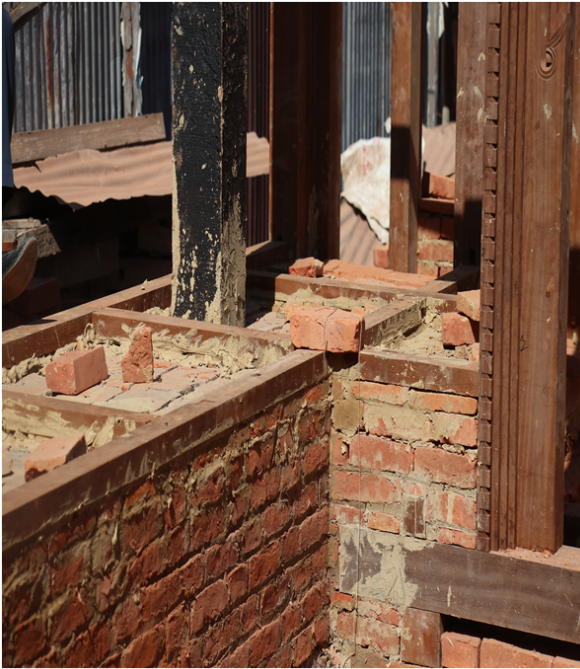
Figure 21. Horizontal sill and lintel band installation

preserve and enhance the historic character of the building. The project also reintroduces traditional techniques for strengthening both the foundation and the superstructure, using horizontal beams (lakashi), timber posts (tham), and traditional joinery. These timber reinforcements provide a degree of ductility to the structure and increase its load-bearing capacity, enhancing the overall resilience of the Durbar while maintaining its authentic architectural integrity. For the reconstruction of heritage structures in Bhaktapur Municipality, mud was used as the primary binding material. High-quality mud was selected based on laboratory tests conducted on samples from three different locations like Jhaukhel, Nalinchowk, and Sipadol, to ensure optimal bonding efficiency in the structure. As result of soil test, Jhaukhel soil was preferred as its binding strength was effective. The reconstruction process has also emphasized the preservation of traditional skills by engaging local artisans and has revived community participation through the active involvement of the user community group.

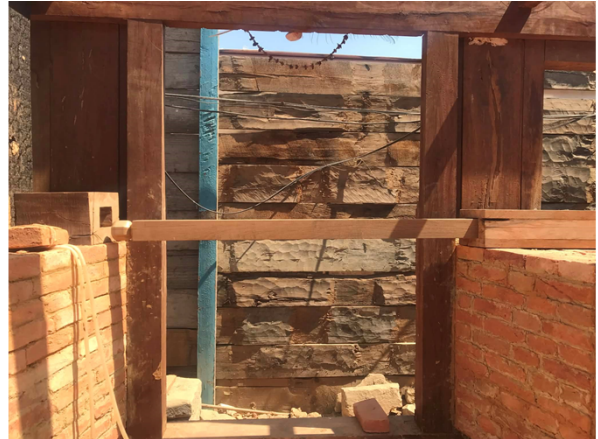
Figure 23. Traditional door lock system (Khaga)

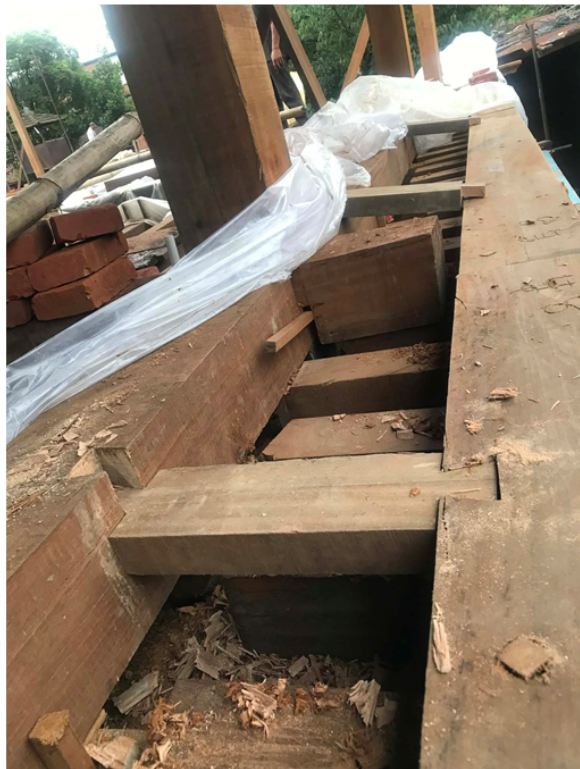
Figure 22. Horizontal sill and lintel band tie up

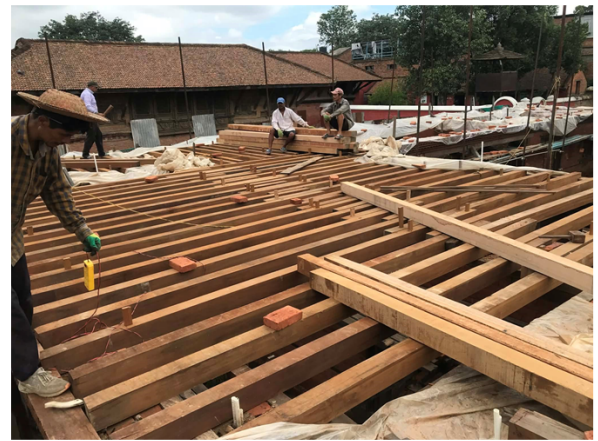
Figure 24. Wooden joists laying in first floor

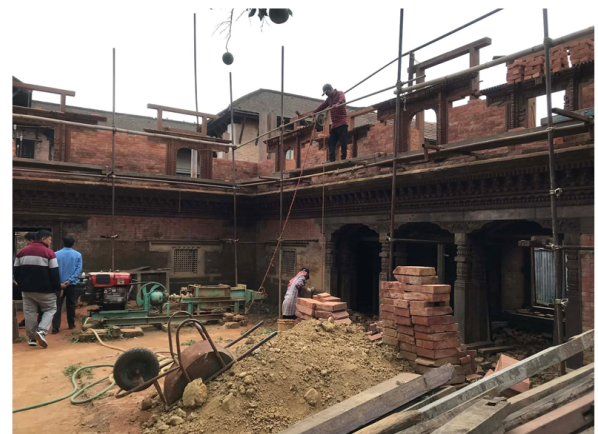
Figure 25. Ongoing reconstruction upto first level
