RELOCATION OF MONUMENTS IN KWELACHHI OF LUBHU

Abstract

Keywords: Relocation; Heritage conservation; Kwelachi; Community involvement

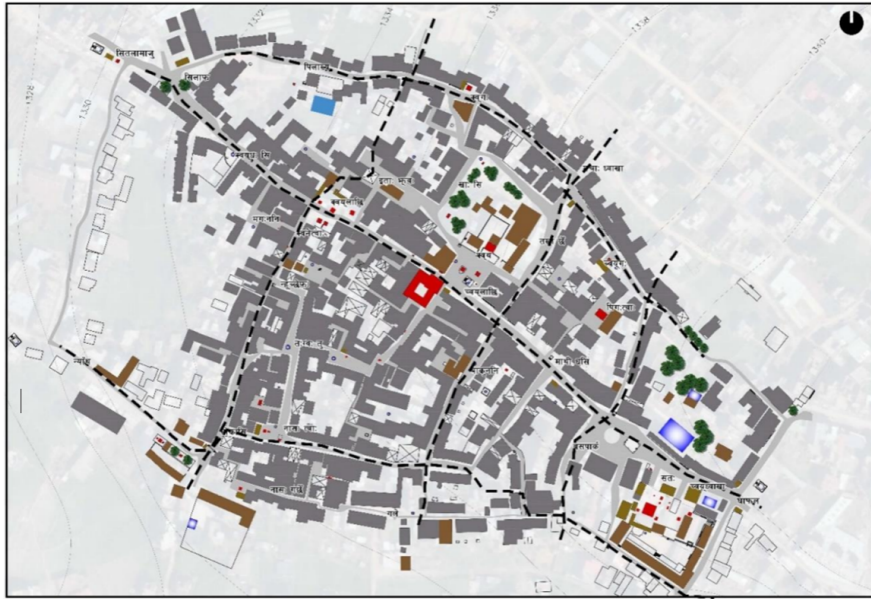
Figure 1. Plan of Lubhu showing settlements and heritage monuments Source: (UN-Habitat & Lumanti Support Group for Shelter, 2021)

Figure 1 shows the settlements and location of monuments. Inscriptions available in Narayan temple and Ganesh temple of Kwelachi area dates back to NS 572 (1481 AD) and NS 741 (1620 AD) (O. Shrestha and Joshi, 2012) indicating neighbourhood's existence for more than 550 years. Plan of Lubhu is shown in Figure 1.

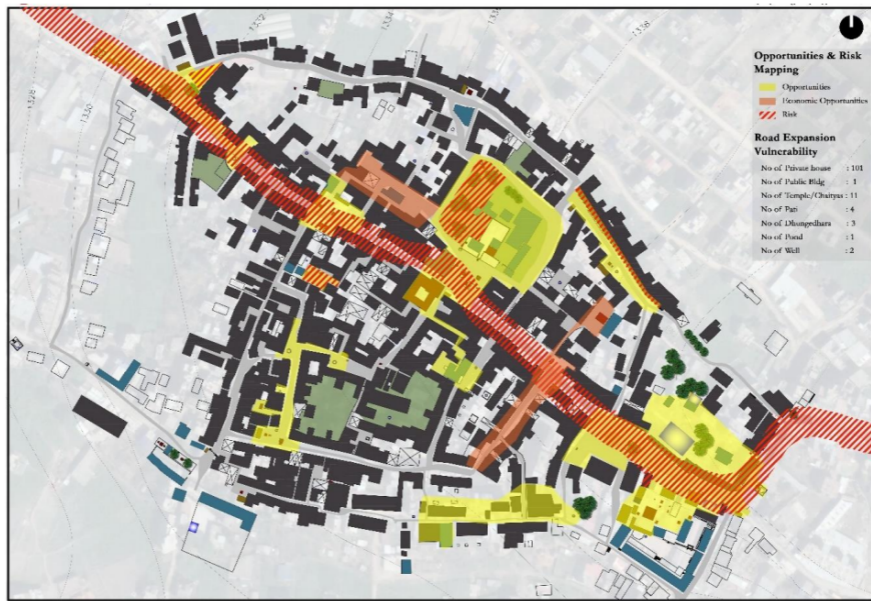
Figure 2. Road expansion proposed by KVDA (UN-Habitat & Lumanti Support Group for Shelter, 2021)

Despite these deep historical facts, the town of Lubhu today faces significant urban planning pressure. Kathmandu Valley Development Authority KVDA has proposed widening of the existing road from its current width of 4.09m - 9.83 m to a 22 m road connecting Kavre and Banepa to the ring road as shown in Figure 2. It is supposed to be a bypass road connecting Lubhu with Banepa and Panauti and also to increase economic

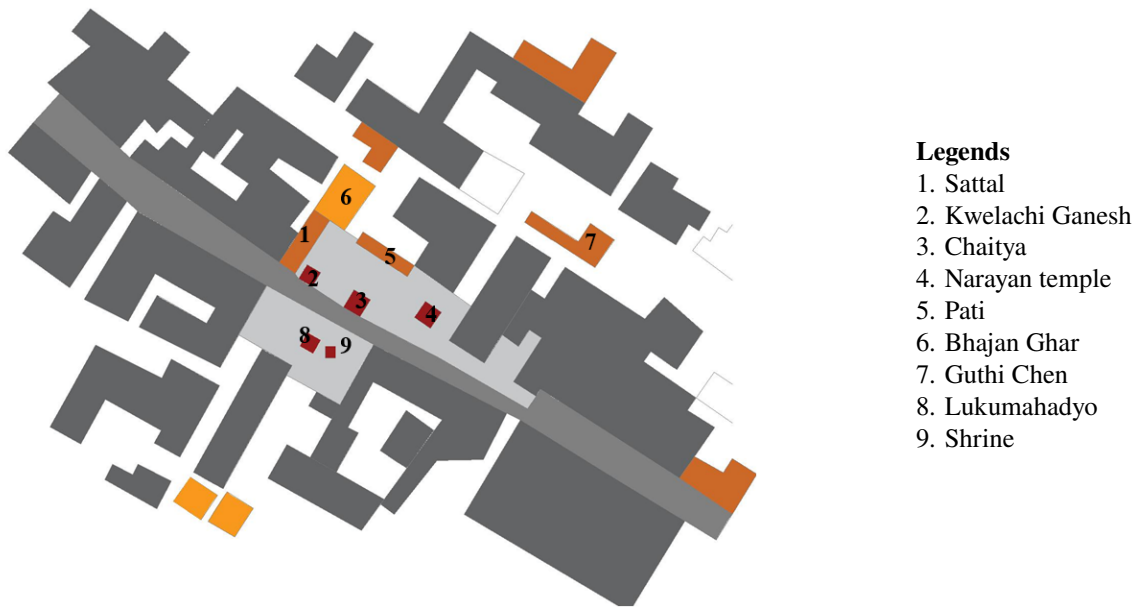
Figure 3. Plan of Kwelachi

Although Kwelachi is comparatively smaller than other open spaces of Lubhu, it holds immense socio-cultural importance. There are altogether 13 monuments at Kwelachi as shown in Figure 3. Among them, Yosin dyo and Khuoo dyo are in the ritual poles erected once annually during Indra jatra. The deceased family members perform puja in the Ganesh temple of this area and distribute sameybaji (beaten rice, soyabean, ginger, garlic, buffalo meat, fish) to the people on the day of Indrajatra. A major puja is also performed in this lachi during Mahalaxmi Mahabhairab jatra. Other temples and shrines in this area serves the locals for daily morning and evening worshipping and performing rituals. The monuments that will be affected by road widening projects is shown in Figure 2 and 4.

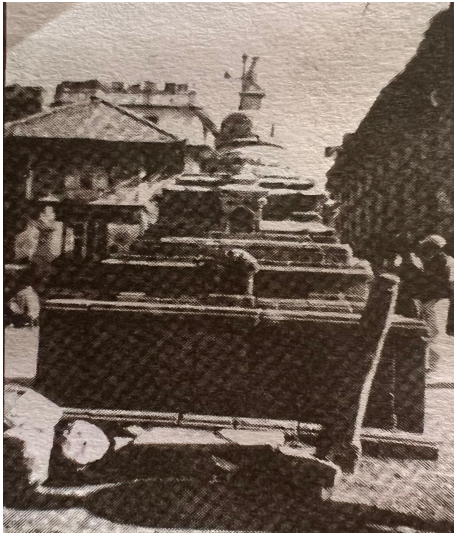
Figure 5. Chaitya before relocation source: Samiti, S. G. (2023)

In 2020, the chaitya at Kwelachhi was relocated approximately three meters from its original site as part of the road expansion project. Figure 5 shows the previous state of chaitya before 2020. The process was contested by heritage activists, who argued that such monuments are not only religiously significant but also vital markers of historical memory. Despite these protests, the relocation was executed quickly by the Department of Archaeology, in collaboration with local residents and representatives of ward No. 8.

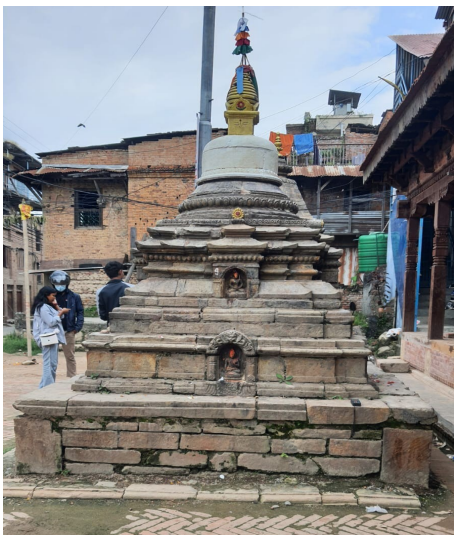
Figure 6. Chaitya after relocation

The plinth height of the chaitya has been reduced significantly in this process as shown in Figure 6 and 7. Some of the existing parts of the chaitya have not been kept in their original position and directions (as shown in Figure 10) due to which size and design is not in proportionally matched as the original one. Also, the position of the plinth and upper structure is not accurately placed (as indicated in Figure 9 and 10) due to which the northern façade of plinth does not consist of nagol while other three sides have more plinth stones and nagol as shown in Figure 8.

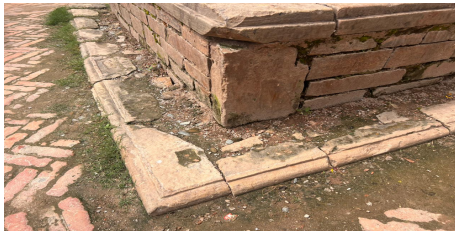
Several construction errors can be found in the newly constructed structure. One of the possible reasons for this could be the reliance on contractors selected through the tender process. Unlike the user-community groups-based constructions, where community members are directly involved and carry a strong sense of ownership and attachment over contractors emphasizing deadlines more

Figure 8. Misplacement of overall superstructure over plinth

over quality. Another contributing factor may be the urgency to complete the structure in speed in an external pressure between the heritage activists and locals leading to poor workmanship, and neglect the traditional construction techniques.

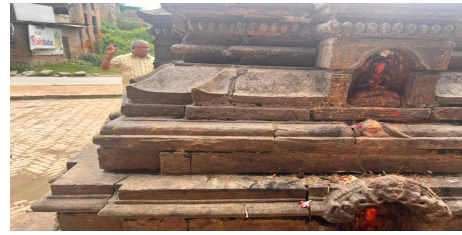
Figure 9. Misplacement of elements during reconstruction

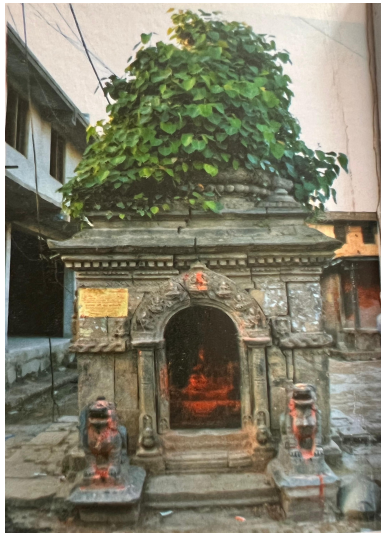
Until 2020, the Ganesh Temple remained in a dilapidated state, further weakened by growth of a peepal tree whose branches and roots enveloped the structure mostly in the upper structure, making it fragile and feeble. The chaitya, positioned close to the road, forces devotees to conduct worship directly from the roadside, exposing them to both traffic hazards and compromised spiritual space. While Narayan Temple and some other shrines stand at a safer distance from the street edge, the temples in immediate proximity—particularly the Ganesh Temple and chaitya—have been repeatedly damaged by passing vehicles. Several structural elements have disintegrated over time due to these collisions. Moreover, the site has witnessed minor accidents and frequent traffic congestion, further causing distress to worshippers and local residents.

Figure 10. Condition of Ganesh temple before 2020 source: annual calender of Lubhu

Ganesh temple at Kwelachi was located near to the main road of Lubhu near an electric pole as shown in Figure 10. The area bounded shows the original position of the temple in Kwelachi. Since it is located very near to road and its main entrance located towards the roadside, the traffic

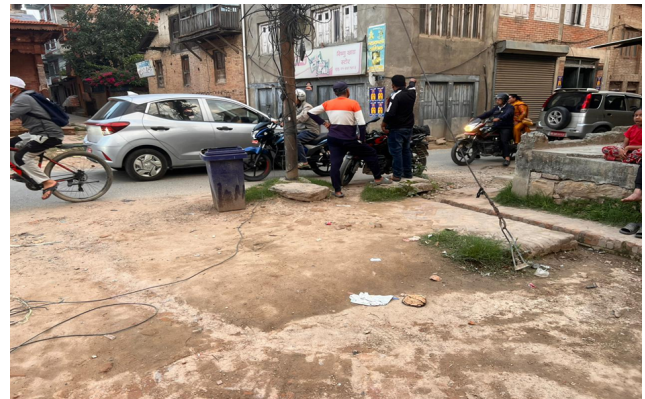
Figure 11. Original position of Ganesh temple in Kwelachi

The reconstruction of the temple was carried out by the ward in 2020. As seen in Figure 11, while reconstructing temple, plinth height has been increased in the newly constructed one. Apart from it, other parts of the structure have been carefully constructed similar to the original one. However, the use of mortar seems to be cement in the newly constructed one. While shifting the structure from its original position (see Figure 11), the foundation works were kept intact. Only superstructure was removed from the original position. Figure 12 shows the reconstruction of the temple after shifting from its original position whereas Figure 13 shows the scenario after relocation of Ganesh temple and Chaitya in Kwelachi.

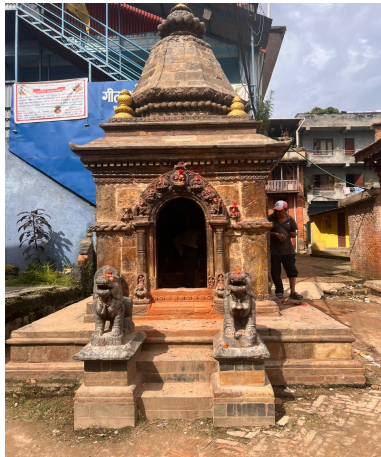
Figure 12. Ganesh temple after relocation

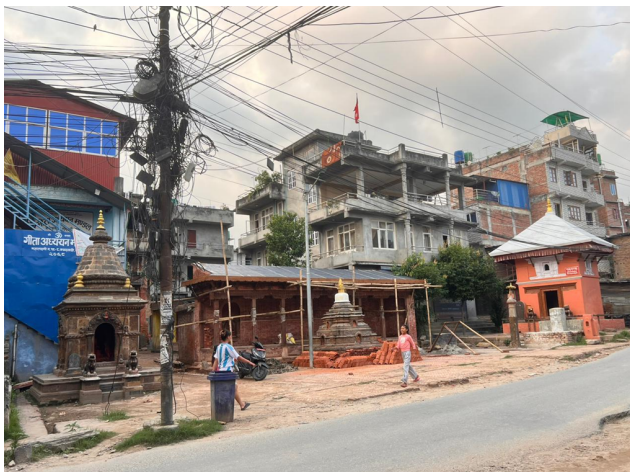
congestion creates problem to its access. As this portion of road acts as a bottleneck of this road (wider to the west and east in the buspark), vehicular movement more often hit the guardian lions and temple parts. So, the locals and the ward initiated to relocate it few metres apart in the square. Figure 13 shows the relocation of Ganesh temple and chaitya being shifted few metres back from the original position. Majorly the upper part of the temple was affected by the growing peepal tree branches and leaves inside the structure which covers upper portion completely. The temple was in verge of reconstruction till 2020 AD as shown in Figure 10.

Figure 13. Kwelachi after relocation of Ganesh temple and chaitya
