# DETERMINATION OF THE DYNAMIC CHARACTERISTIC OF THE MULTI-TIERED BHAIRABNATH TEMPLE IN DAMAGED AND POST-RECONSTRUCTION STATE USING MICROTREMOR

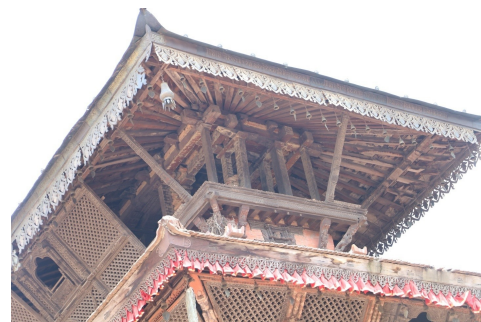
Figure 1. Damaged state after the 2016 Gorkha earthquake

Following the Gorkha earthquake in 2015, a condition assessment was conducted by a team of experts from the Bhaktapur Municipality for detailed documentation of structural damages and assessment before reconstruction efforts (Condition Assessment of Bhairabnath Temple, 2019). The intensive assessment illustrates the floor-wise damage of the structure, and found that the top floor experiences the most severe damage, which tends to collapse. It was slightly tilted due to the seismic forces, and most struts supporting the roof had fallen, as shown in Figure 1. In the lower floor, vertical cracks were observed, likely due to the compression forces exerted by the upper floors. Similarly, shear cracks, wall toe crushing, and corner separation between walls, which are common forms of damage in the masonry structures caused by seismic forces, were also observed in the temple.

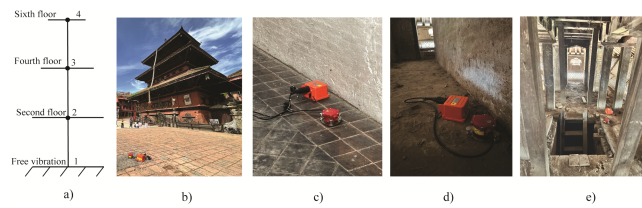
Figure 4. Multiple point measurement a) Illustrative diagram of the measured location, b) free-field, c) second floor, d) fourth floor, and e) sixth floor

After the reconstruction of the structure, the vibration recording was performed with multiple velocity meter sensors, as shown in Figure 4. Later on, date 2024-08-14, a three-component velocity sensor, McSEIS-AT, manufactured by OYO corporation, was deployed. All the sensors were positioned at the center of the ground, second, fourth, and sixth floors. The simultaneous recording of all the sensors was achieved using a built-in GPS sensor that was recorded for 15 min with a sampling frequency rate of 250 Hz. The simultaneous recording enabled the identification of the dynamic parameters of the structure, such as predominant frequency, mode shapes, and damping ratio.

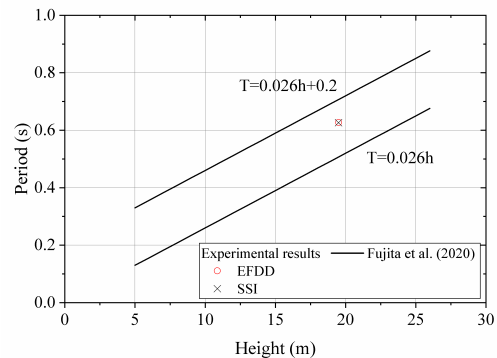
Figure 7. Comparison of experimental (EFDD and SSI) periods with the Fujita et al. (2020) equation.

The experimental results were compared with the fundamental period formulation proposed by Fujita et al., 2020. The formulation was proposed especially for the Nepalese multi-tiered structure; it presents the relation between the fundamental period and height of the structure. The experiment period from the EFDD and SSI techniques was determined from the inverse relation, which is 0.627s for both. As shown in Figure 7, the obtained periods are fitted with the Fujita et al., 2020 formulation, showing proper validation of the test results. It shows that the test results matched the period of the multi-tiered historical structures commonly found in Nepal.
