CULTURAL HERITAGE DAMAGE AND POST-DISASTER RECOVERY UNDER COMPOUND HAZARDS: THE NOTO PENINSULA EARTHQUAKE OF JANUARY 1, 2024 FOLLOWED BY EXTREME RAINFALL

Toshikazu Hanazato^{1*}, Hajime Yokouchi², Eisuke Nishikawa³, Satoshi Nishioka⁴

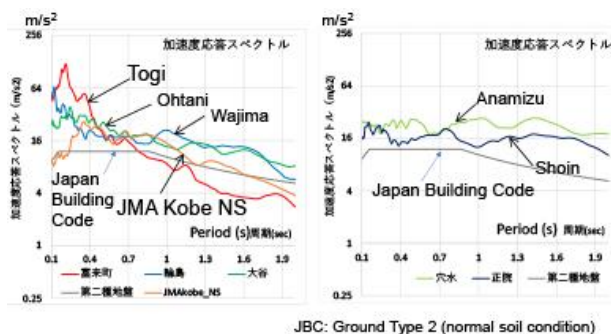
Figure 3: Response spectre of recorded strong motions compared with Japan Building Code & Kobe EQ

and was so strong that it would exceed the intensity of Japan Building Code. Table 2 summarizes the human impact and the damage to the buildings caused by the Noto Peninsula Earthquake as of October 1, 2024.

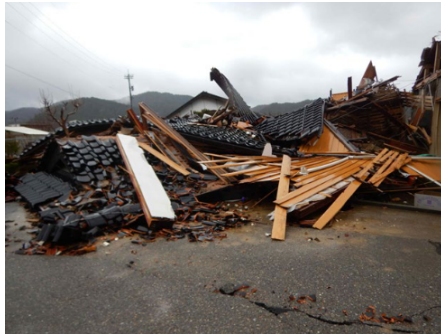
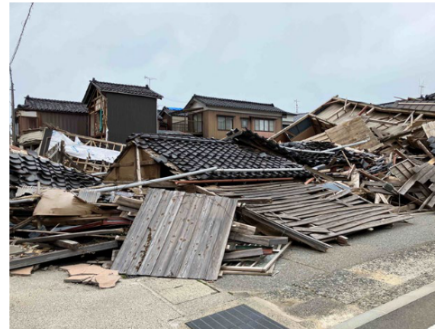
Figure 4: Collapse of traditional wooden houses in the epicentral area (Waima City)

In the Noto Peninsula, most of the houses were of traditional wooden construction characterized by frame structures with roof tiles. Most of those traditional wooden construction houses might be vulnerable to earthquake-induced strong ground motions, therefore, they were severely damaged or collapsed by the Noto Peninsula Earthquake of 2024, exemplified in Figure 4.

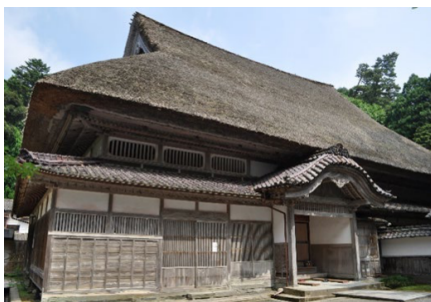
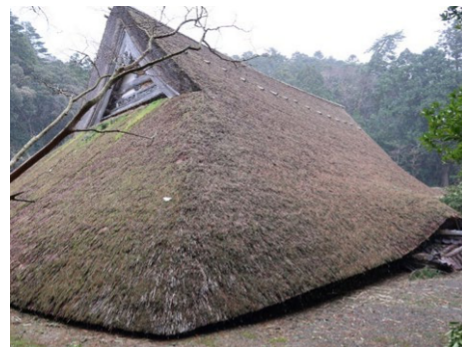
Figure 5: Kamitokikuni Family House

In the Noto Peninsula, there are several traditional construction houses designated as national important cultural properties. Kamitokikuni family house constructed in 1831, one of the important cultural properties, totally collapsed, shown in Figure 5. While survey and discussion were performed for restoration after the disaster, the destructed house and its surrounding historic site were buried by the mudslides caused by extreme rainfall in September, described in Chapter 6.

A number of heritage structures and historic sites, although most of them had not been recovered and restored, suffered the disaster caused by the extremely rainfall. For the case of Kamitokikuni family house that collapsed by the Earthquake (See Chapter 4), the destructed building and the surrounding historic site were buried by the debris flow, shown in Photo 18. There had been historical documents in this important heritage structure, however, those were buried under the mud debris. Afterward, the historical documents designated by the prefecture were rescued, however, an estimated 20,000 documents that have yet to be investigated remain buried.

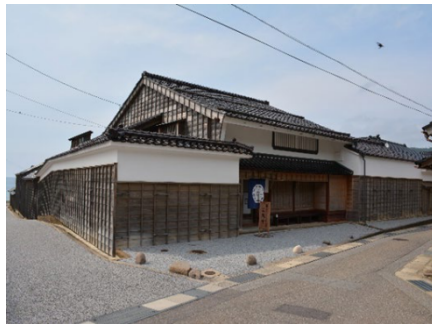
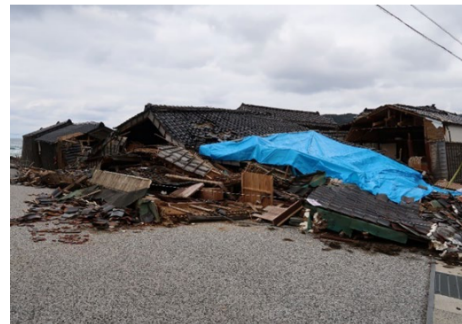
Figure 6: Former Kadomi family house

In this traditional district, the former Kadomi family house's complex constructed in 1871 was severely damaged, shown in Figure 6. The damaged architectural heritage that composed of 5 buildings was designated as the national important cultural property. After the Noto Peninsula Earthquake of 2007 caused damage to those heritage structures, they were

restored with seismic reinforcement, however, the main building collapsed during the Earthquake of 2024. In order to review the effectiveness of the seismic reinforcement performed after Earthquake of 2007, discussion was made by the expert team from earthquake engineering point of view. The outcomes obtained from the discussion at national level was published by Agency for Cultural Affairs.

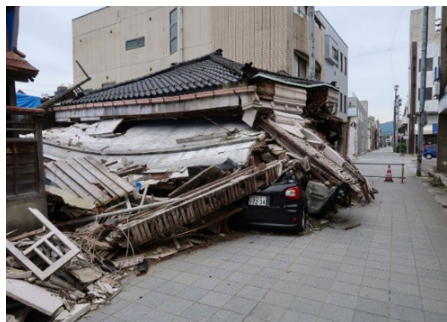
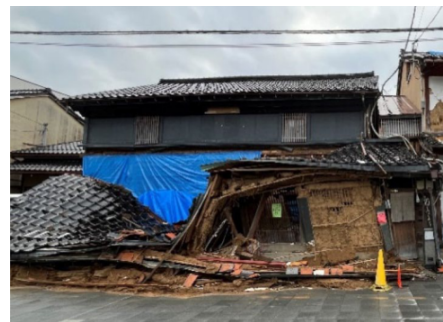
Figure 7: Damaged registered tangible cultural properties along "Ippon Sugi" Street

In Nanao City located 40km from the epicentre, the registered tangible cultural properties were damaged in the historic street called “Ippon Sugi”, shown in Figure 7. The recorded PGA was 0.46G at K-NET in Nanao City.

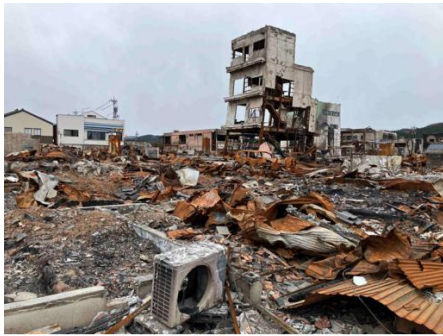
Figure 10: Fire disastrous area of traditional morning market of Wajima

The famous morning market and its surrounding area with traditional townscape in the city centre of Wajima was burned down, shown in Figure 10. In this disastrous area, about 300 buildings (48,000m²) was lost by the fire caused by the Earthquake of 2024. The fire hazard of density built-up area of wooden houses was recognized again.

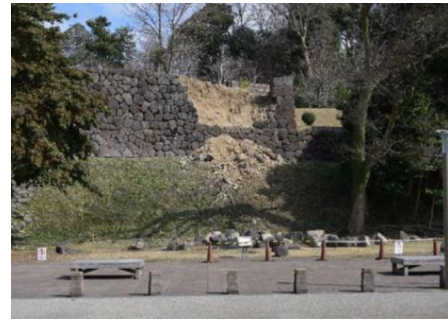
Figure 14: Collapse of stone retaining wall in Kanazawa Castle

Historic retaining stone walls in the Kanazawa Castle partially collapsed, shown in Photo 14. It was reported PGA in Kanazawa City at the epicentral distance of 100km was 0.22G. Following the experience of the Kumamoto Earthquake of 2016, when the stone retaining walls of Kumamoto Castle were severely damaged, the seismic resistance of castles' stone walls has attracted attention, and both research and countermeasures have been carried out in Japan.

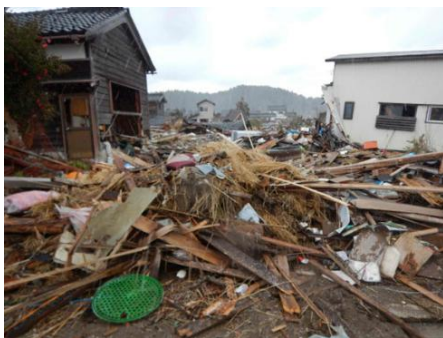
Figure 11: Disaster of residential area hit by tsunami along the coast of Suzu city

The coastal areas of Suzu City suffered extensive damage the tsunami of which height was recorded to be as high as 4.3m. In this disastrous area, a number of traditional wooden houses were severely damaged or lost. Photo 11 shows the disastrous area hit by the tsunami.

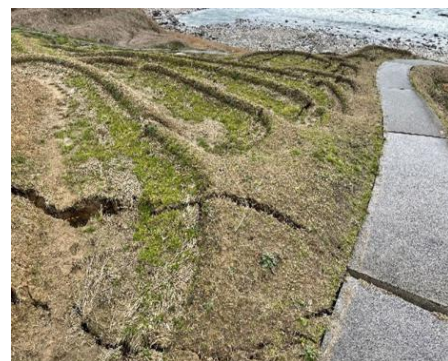
Figure 15: Damage to Shiroyone Denmai-da rice terraces

Several historic sites and places of scenic beauty were damaged. Photo 15 shows the cracks of the ground caused in Shiroyone Senmai-da rice terraces, the national place of scenic beauty in Wajima. The more than 1,000 rice terraces are made in the beginning of 17th century on the slope facing the Sea of Japan. Shown in this photo, the surface soils moved and a number of cracks appeared. At the same time,

the water supply route was cut off. This site is located on a landslide terrain and has a gentle slope.

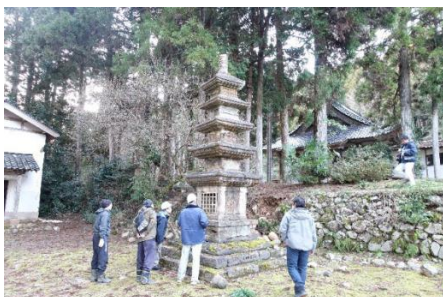
Figure 13: Five-storied Stone Pagoda in Myosenji Temple

Another historical masonry structure to be introduced is the five-storied stone pagoda in Myosenji Temple in Anamizu Town, where the extremely strong ground motions were recorded. This stone pagoda, constructed in 14th century, was designated as a national important cultural property. It was of interest that slight rotational displacement was caused by the Earthquake of 2024, but it survived against the earthquake, shown in Figure 13.

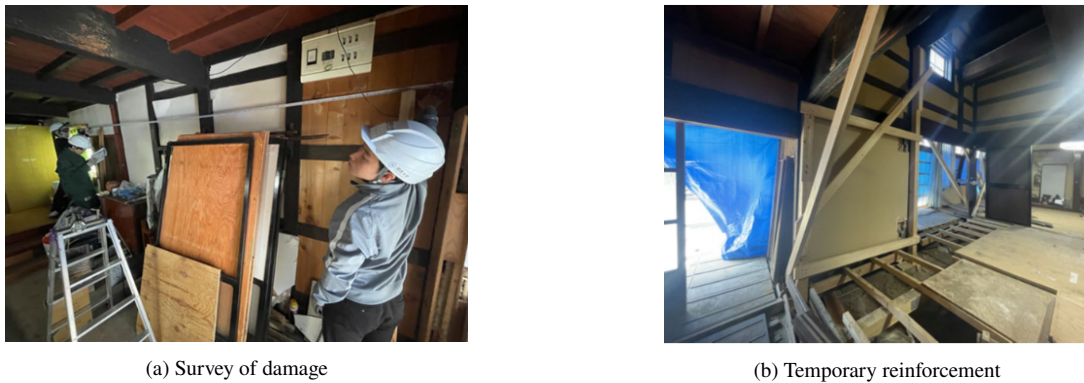
Figure 16: Emergency response work at Wajima Kuroshima Preservation District of Groups of Traditional Buildings

been implemented in various phases in both political and technical measures. Following the experiences of the Great East Japan Earthquake in 2011 and the Kumamoto Earthquake of 2016, those measures have been further improved. Photo 16 examples the emergency response work to rescue the wooden heritage structure damaged by the Noto Peninsula Earthquake of 2024.

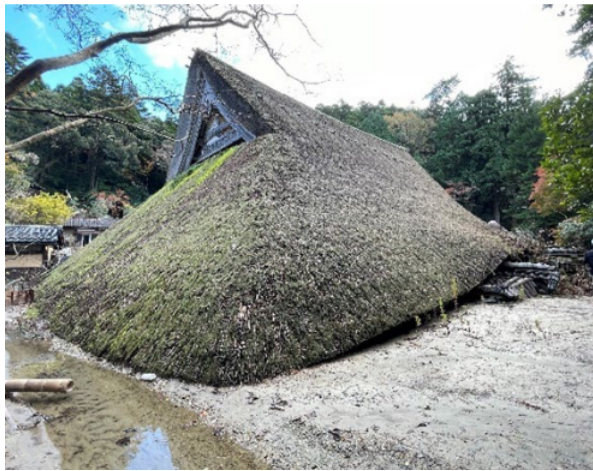
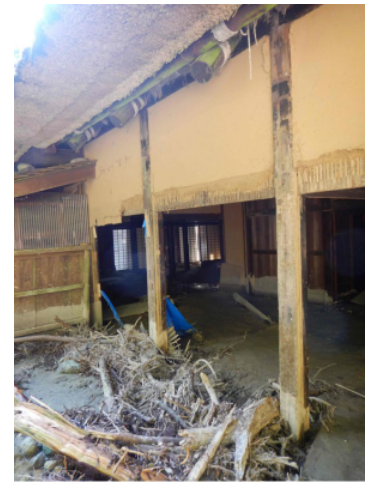
Figure 18: Disastrous situation of damaged cultural properties after extreme rainfall

The adjacent Shimotokikuni family house, also designated as the national important cultural property, did not collapse but was severely damaged. This architectural heritage was also buried by the mudslide during the extremely rainfall in September, shown in Photo 18.

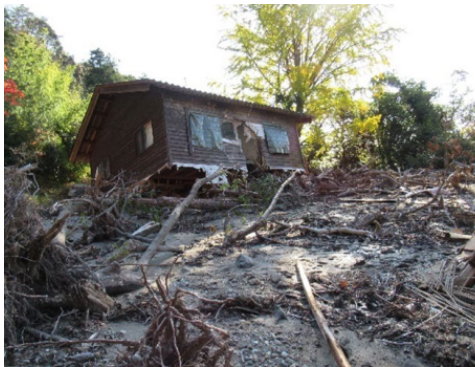
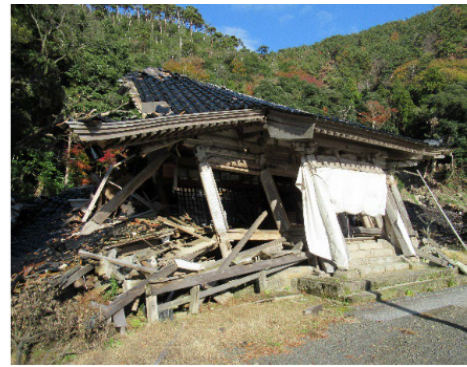
Figure 19: Compound damage to Iwakura-ji temple

The traditional wooden structures of Iwakura-ji Temple located in the mid-slope of the mountain near Kamitokikuni family house were severely damaged by the Earthquake. The main hall of this temple was reconstructed in 1507 after the major fire. However, the extreme rainfall in September caused further damage to traditional buildings including the main hall, and some of the earthquake-damaged buildings were swept away by the terrible mudslides (See Photo19).
