## SHORT COMMUNICATION

## ESTABLISHMENT AND MANAGEMENT OF COVID-19 TESTING MOLECULAR LABORATORY IN MINIMAL RESOURCE SETTING, CHALLENGES AND ISSUES REPORTED FROM BIRGUNJ, NEPAL – AN EXPERIENCE OF PATHOLOGIST

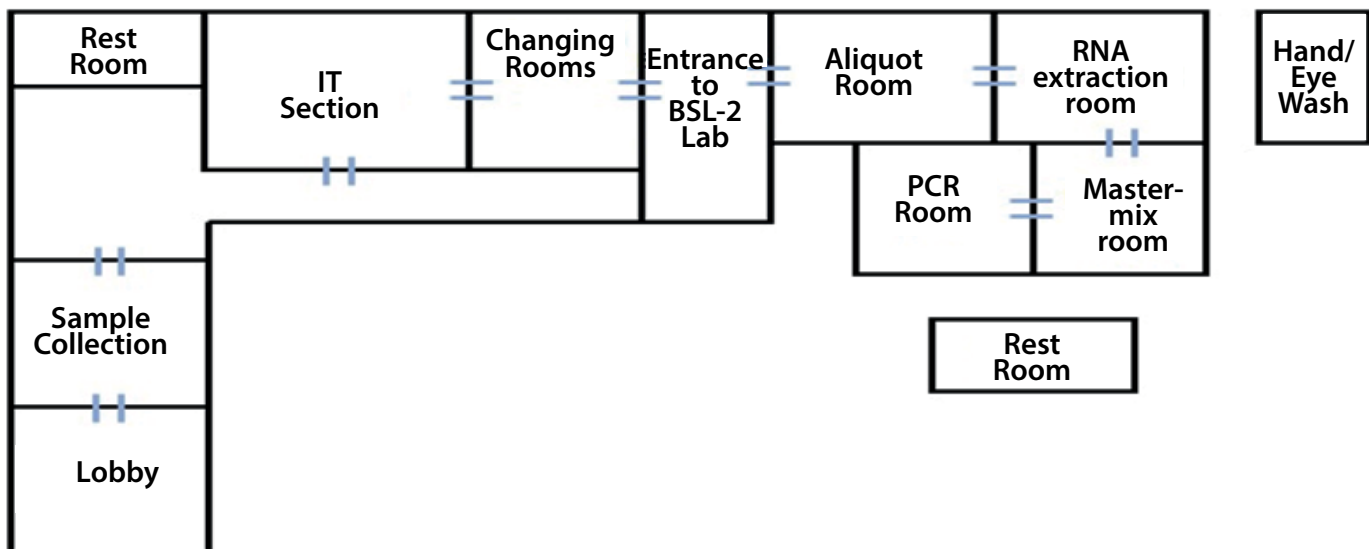
Fig 1: Floor plan of COVID laboratory

COVID-19 molecular laboratory testing has its own set of safety requirements<sup>3</sup>. Due to the limitations in the existing laboratory space for bio-safety level-2 in the hospital, we started a search for a separate space to meet the safety standards and spacious enough for sample storage, processing and disinfection. Consequently, a space containing four separate big rooms inside one open access door; previously used for family planning program at the first floor of the indoor section of the hospital was found suitable. The room was partitioned with aluminium metal frames and windows with adjoining entrance doors into six dedicated rooms for sample reception, aliquot preparation, RNA extraction, master mixing, detection and amplification, and data management. To ensure safety and security, the main entrance corridor was outfitted with an iron gate outside and 2 wooden doors inside. One room was allocated for washroom inside the same space which included hot and cold water facilities. Six rooms were fully setup and painted within two weeks. Eye wash and hand wash basins were placed both inside and outside the laboratory premises. World Health Organization (WHO) documents and experiences from the virology units at the NPHL and provincial laboratories were consulted to design the room's structure and workflow. (Fig 1)

A separate setup for dirty (sample reception and extraction) and clean rooms (master mix) was done. Sample flow was organized in such a way that the dirty rooms did not contaminate the clean rooms (unidirectional workflow).

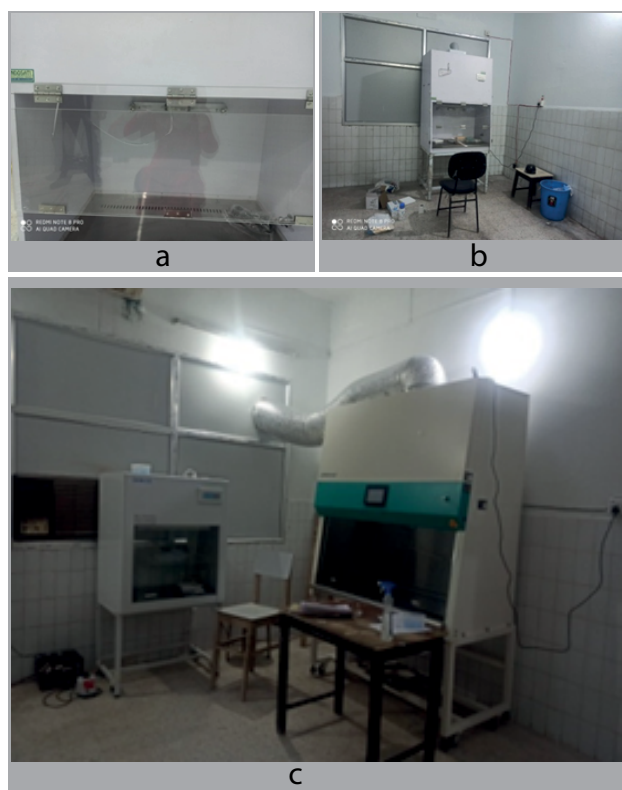
**Fig 3: (a) Broken glass of biosafety cabinet, (b) Malfunctioning filter, (c) New biosafety cabinet.**

During the first trial test, the biosafety cabinet filter was malfunctioning. Biomedical engineer helped to solve the

issues at hand by communicating with their colleagues and the representatives of Nepal Bio-medical Engineer's association. After an intensive period of problem identification by the team, it was concluded that the cabinet needed replacement. It took almost 2 weeks to buy and install another biosafety cabinet. However, the glass window of the cabinet was broken during transportation. The maintenance team helped change the glass window the next day. In parallel, part of the team was mobilizing instruments such as pipettes, tips, vortex, centrifuges, hot water bath, ice-maker, distilled water to start the actual testing. Most of them were bought from the local suppliers.

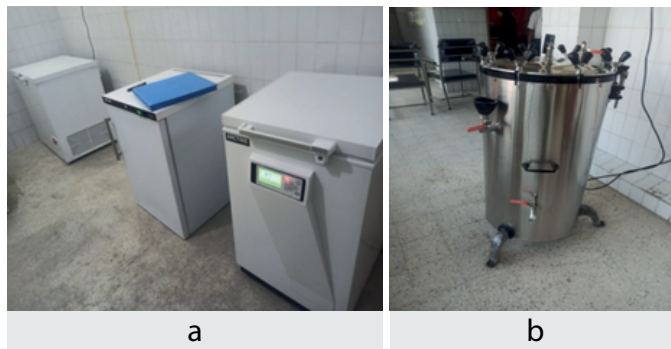
**Fig 4: Consumables supplied by hospital administration (a) Refrigerators, (b) Autoclave machine**

PCR reagents and Personal Protection Equipment (PPE) were made available by the hospital administration, through the aid from the Logistic Management Division, Teku as well as social organizations. (Fig 4)
