CASE REPORT

ACCIDENTAL MIGRATION OF A GUIDE WIRE DURING HAEMODIALYSIS CATHETER INSERTION THROUGH RIGHT INTERNAL JUGULAR VEIN

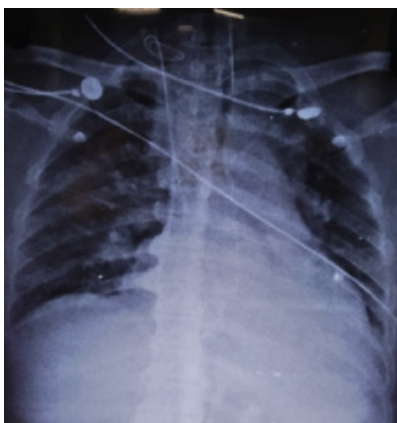
A trainee under the guidance of the register decided to cannulate the right internal jugular vein under the ultrasound. After cleaning and draping, initial cannulation was done with a needle attached to a syringe. Following this, the dilator and the guidewire were introduced. Unfortunately, by inattention, the guidewire was pushed into the right internal jugular vein by the operator. The procedure was immediately stopped and an urgent chest x-ray was done, it showed the guidewire in the right internal jugular vein (Figure 1).

Figure 1: A chest x-ray shows the guidewire in the right internal jugular vein.

The vascular surgeon was not available at our centre so the otolaryngologist decided to remove the wire by open surgery in the operating room. The procedure was performed under general anaesthesia and the surgery lasted for 2 hours. A venotomy revealed migration of the guidewire to the right internal jugular vein and was successfully extracted. A chest X-ray was done after removal of the guidewire which also showed the successful removal of the guidewire (Figure 2).

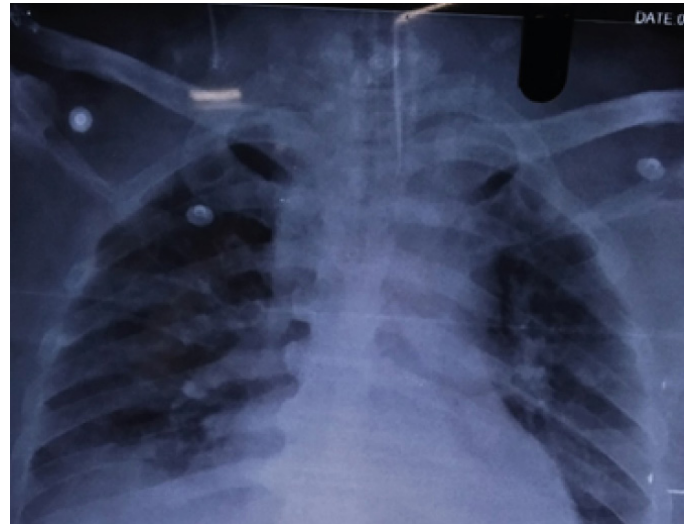
Figure 2: A chest x-ray after removal of the guidewire
