Cause of Failure of Municipal Waste Water Treatment Plant in Narayanghad

Ramesh Khanal

Abstract –

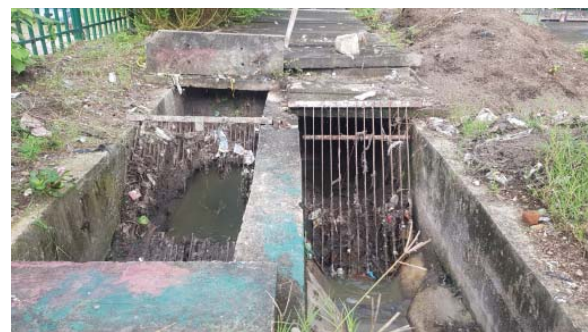
Fig. 3 Bar and screen

There were two screens-coarse and fine. As can be seen in Fig. 3, the finer screen is completely damaged and hence is not able to segregate floating particles and objects.

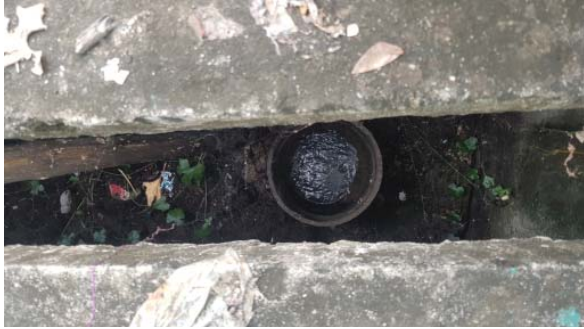
Fig. 4 Grit chamber

Although it was constructed, the grit chamber was not in function. As shown in Fig. 4 the grit chamber was full of debris and the sewage from the bar and screen was made to pass to the Parshall Flume through a pipe. That resulted in the failure to remove inorganic waste from the sewage thereby allowing travel of inorganic matter to further treatment units.

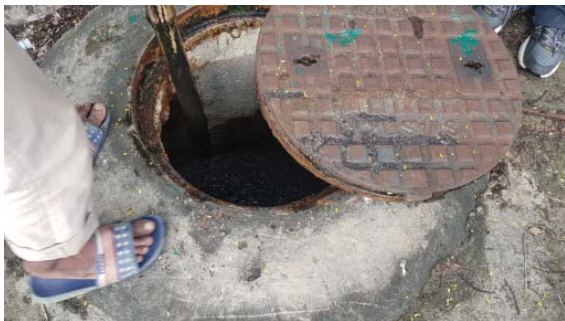
Fig. 5 Checking consistency of sewage in settling tank

As informed, no desludging process had been carried out on the site since the plant's operation. The collection of sludge in the tank was so high that there was no sign of clear effluent deposited on the top part of the tank when observed through manhole (Fig. 5). A long bamboo was immersed to check the consistency of the sewage and it could be felt that the sludge was already thickened and quite high in level. As a result of this there was reduction in effective volume of the septic tank which would reduce the detention time of sewage. Clearly, there will be decreased BOD removal efficiency.

Withering of reed plants in the study was due to the overloading of organic solid matter originating from the unmaintained settling tank and anaerobic reactor. The rehabilitation of the system includes the removal of accumulated solids from all the components. Removing solids from the wetland cell is difficult but can be done by changing the filter medium.

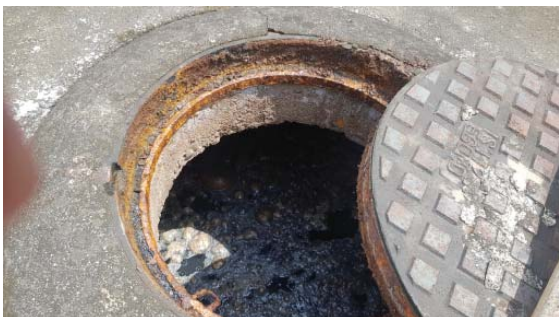
Fig. 6 Anaerobic reactor as seen through manhole

The consequence of lack in desludging at the septic tank is seen in the anaerobic reactor. Sewage in this reactor unit was not clear as shown in Fig. 6.

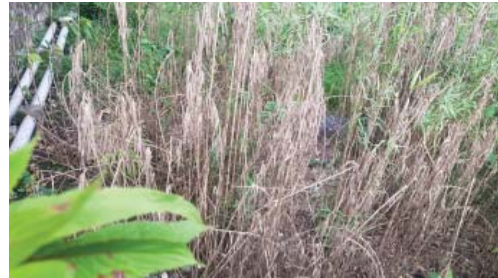
Out of the two parallel units of horizontal flow constructed wetlands, wetland 1 was on the verge of total dysfunction. Certain sections of the bed were overgrown by foreign plants and the remaining reed plants were withering. There was deposition of thick sludge on top of the filter bed. As shown in Fig. 7, the influent feeding perforated pipe from the anaerobic filter to the reed bed was completely dry and hence the reed bed was being deprived of effluents.

Fig. 7 HFCW -1 (Dry inlet pipe, withered reed plant and deposition of sludge)

The major problem initially noticed was the withering of reed plants in the wetlands. One of the possible reasons for this could be the clogging of the filter medium since a thick layer of sludge deposition was observed during the site visit. Clogging is the most critical operational issue of HF wetlands [1]. A series of problems were observed that triggered clogging. As the effluent coming to the wetland component has not fully met its hydraulic retention time (HRT) in the ABR unit, there is a possibility of high concentration of pollution. This directly affects the rhizome growth as nitrifying bacteria are sensitive to toxicity. Further, the reduced permeability will cause ponding of waste water and bypassing of untreated waste water as effluent [7]. One of the factors that lead to the clogging

of CW is inefficient upstream treatment process [8]. Similar effect was also observed in this study. As informed by the staff, desludging of settling tank and anaerobic reactor had not been carried out at all since the plant's operation. So, it was observed that the primary treatment units were full of sludge and, as a result, sludge was flowing down to the wetlands.

Withering of reed plants due to clogging can be the result of oxygen deficiency at the roots of reed plant due to formation of algae [9]. Moreover, hydrogen sulphides produced due to anaerobic decomposition of organic waste depletes the dissolved oxygen in water and thus cuts of the level of oxygen transported to the root zone [10].
