## Toppling and wedge failures in Malekhu River area, Malekhu, Central Nepal Lesser Himalaya

\*Naresh Kazi Tamrakar, Jaya Laxmi Singh, Krishna Kumar Bista and Prayag Maharjan

### ABSTRACT

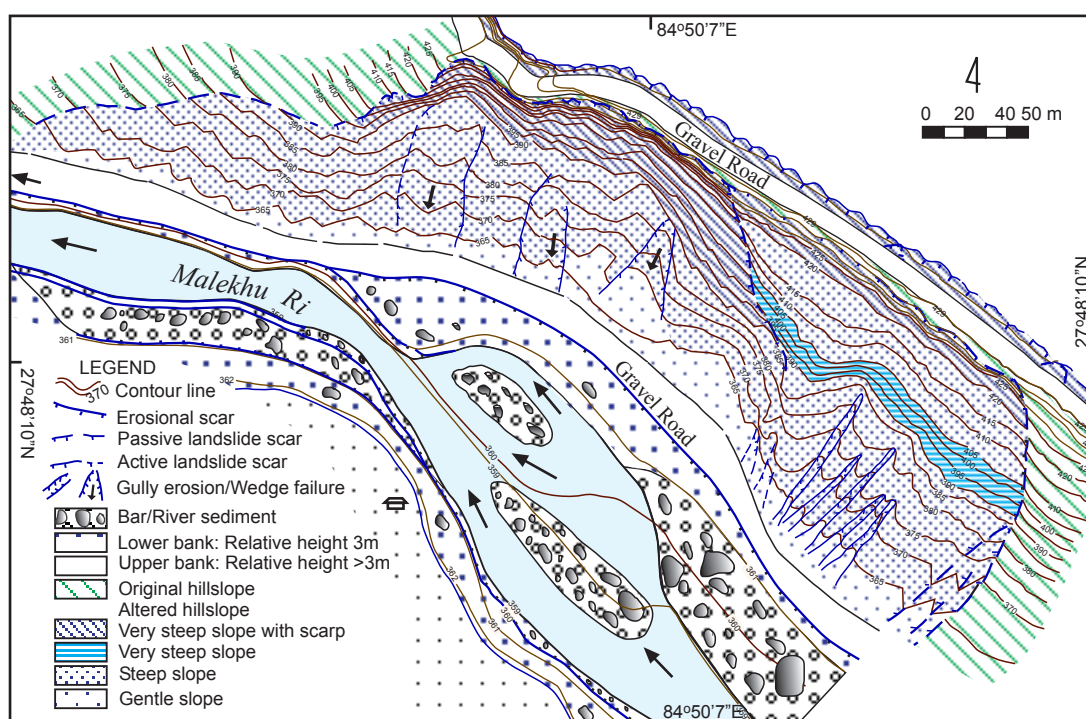
Apart from the hillslope, the river bank slopes are important elements (Fig. 4). These contain an upper bank slope with relative height > 3 m and the lower bank slope with relative height < 3 m. These slopes contain mainly alluvial sediments ranging in size from boulder to clay. The channel element consists of river point bar and mid channel bars containing huge boulders to sand.

Fig. 4 Geomorphology of the landslide area.
