# Effect of Sand Erosion on Turbine Components: A Case Study of Kali Gandaki “A” Hydroelectric Project (144 MW), Nepal

Balendra Chhetry and Kumar Rana

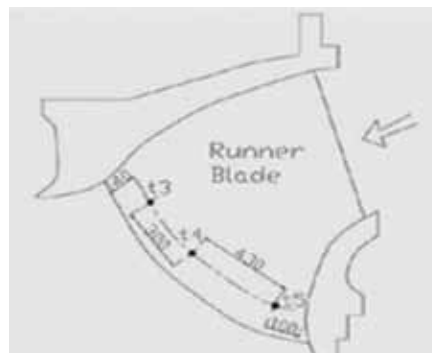
Table 4: Comparison of clearance and runner thickness values of unit 1.

The overhauling of the same unit was carried out after 3 years of operation in 2006 after 14,264 running hours with energy generation of 513.78 GWh. It was observed that the damage of turbine components without HVOF coating were more severe than HVOF coated turbine components due to sand erosion.

Comparison has been made to observe the effect of sand erosion on turbine components by taking the reference measuring data during overhauling of the year 2003 and 2006 of Unit 1. The Table 4 shows the compared values of guide vane clearance and runner out let thickness. The outlet thicknesses of the all 13 runner blades were measured in three positions i.e. near to crown (t<sub>3</sub>), middle (t<sub>4</sub>) and near to band (t<sub>5</sub>) and average value of them were considered. Similarly average value of side clearance guide vanes with lower and upper facing plates were considered for observation.

During the overhauling on year 2006, turbine components were replaced with HVOF coated facing plates, bushes for guide vanes and runner with non-coated guide vanes and wearing ring.

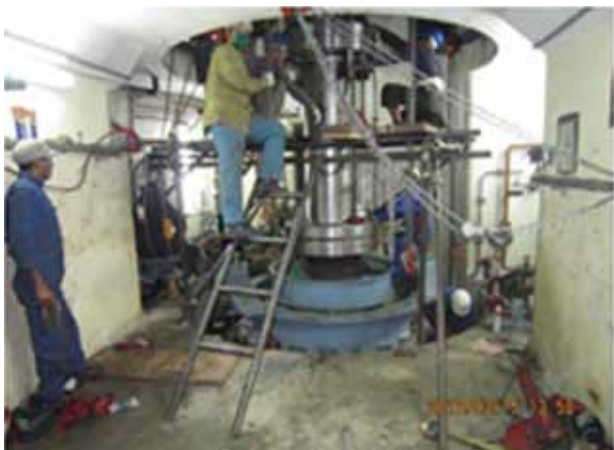
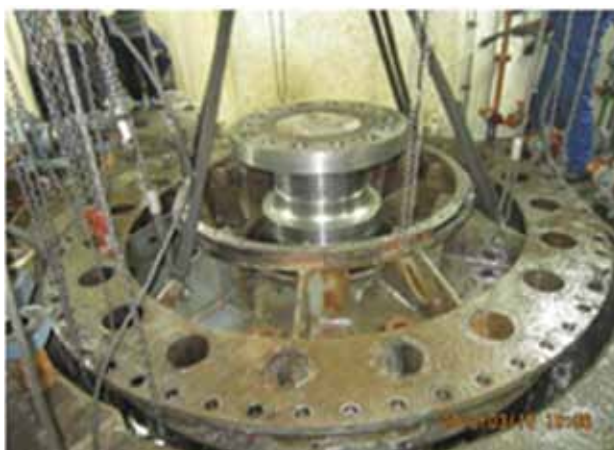
during overhauling of the Unit 2 in year 2013 is shown in Photo 6.

Photo 6: Photos of removing the intermediate shaft and head cover from turbine pit side
