STRUCTURAL ENGINEERING/PERSPECTIVE DAMAGE PATTERN OF TEMPLES OF KATHMANDU VALLEY AFTER GORKHA EARTHQUAKE 2015

Rajan Suwal

Institute of Engineering, Pulchowk Campus, Tribhuvan University, Nepal

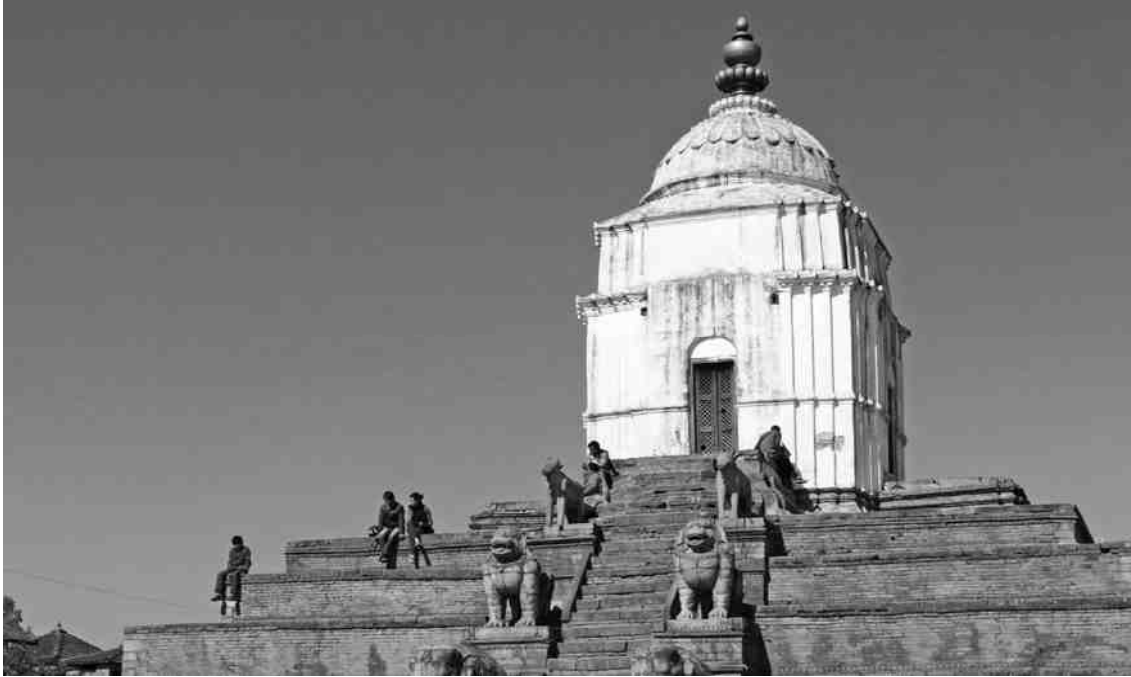
Figure 4: Fasi Dega Temple before Gorkha Earthquake 2015

Fasi Dega temple was constructed up to five steps raised platform in Bhaktapur Durbar Square before the Gorkha earthquake, 2015 (shown in Figure 4). One story temple has square in plan and openings from all sides. The structure of this temple was fully collapsed up to raised plinth level in the Gorkha earthquake, 2015 (shown in Figure 5). The temple was rebuilt as brick masonry with mud mortar after it collapsed in Nepal-Bihar earthquake, 1934.

Even though this structure was only around for 75 years, it was again fully collapsed indicating there must be either structural system failure or material quality failure. Structural integrity of masonry wall seems weak. In addition to that, five tired soft plinth steps might have amplified the earthquake effect for the structure.

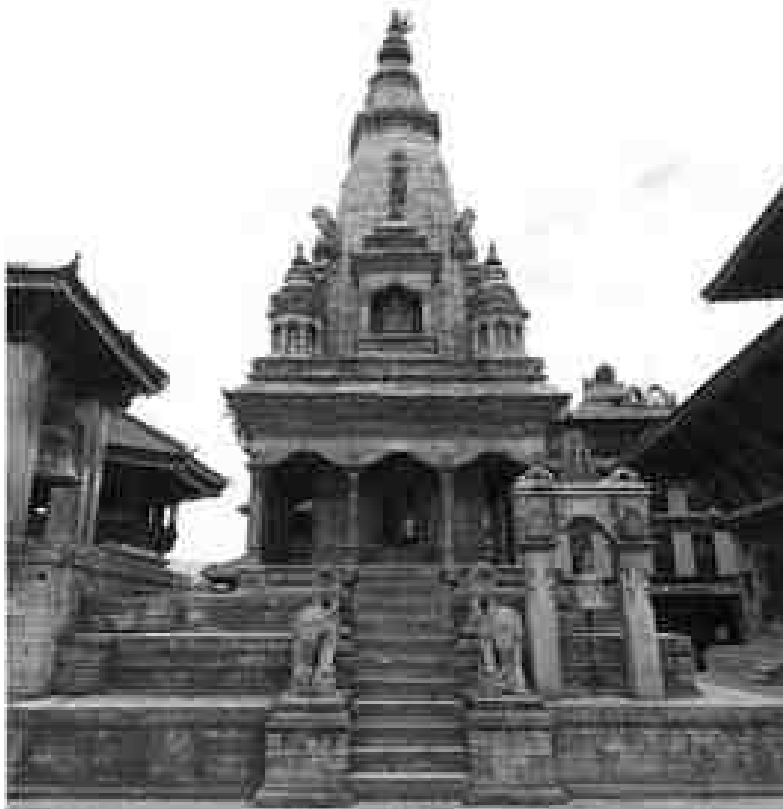
Figure 7: Vatsala Durga Temple, Bhaktapur Durbar Square
(Source: researchgate.net)

Vatsala Durga Temple was constructed on the four tiered elevated plinth in sikhara style. It was made of dressed stone masonry. Temple plan is almost in square shape and having door opening from front side. Main load-bearing of temple is mid core stone structure with stone pillars around, which is seen in Figure 7. Total collapse of this temple after earthquake is shown in Figure 8.

Measuring height to width of core wall ratio of temple from the judgment of picture, it can be said that temple is slender for stone masonry structure. Interlock of stone masonry might not be provided. From the damaged picture of Figure 8 shows that inner part of temple was filled with mud and stone bats without any integration with outer stone masonry walls. There might be already micro-cracks between mortar and stone block in different previous earthquakes, staying without good bond. Due to this weak bond between stones with mortar, it lead to complete collapse.
