Impact of July 2004 high-intensity rain on Hilepani–Jayaramghat–Diktel Environment-Friendly Road in East Nepal

Megh Raj Dhital

*Central Department of Geology, Tribhuvan University,
Kathmandu, Nepal*

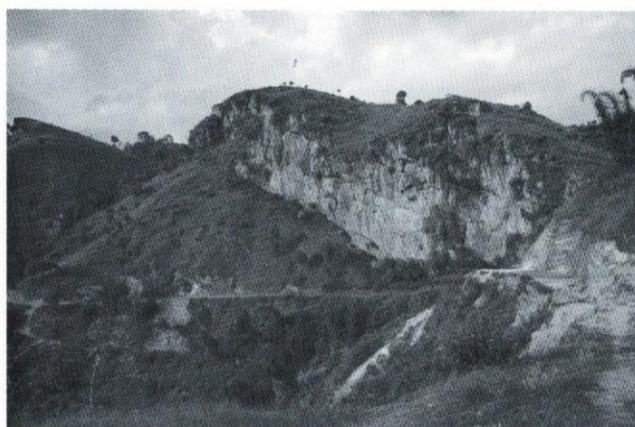
Fig. 10: A thick dolomite band exposed west of Boje, between Khokseli and Chyasmitar. View to N. Photo by Cris Grant.

At DJ36 (H = 1240 m), the stream from Boje forms a high (about 40 m) waterfall on dark grey dolomite (Fig. 10). The contact between the dolomite and underlying thin, light yellow to white quartzite (about 50 m thick) is near a gully. To the east, many dip slopes made up of grey dolomite are seen. On the left bank, at the road level, the dolomite is intensely folded.
