# Landslides and debris flows of 19-21 July 1993 in the Agra Khola watershed of Central Nepal

P. B. Thapa and M. R. Dhital

Central Department of Geology, Tribhuvan University, Kirtipur, Kathmandu, Nepal

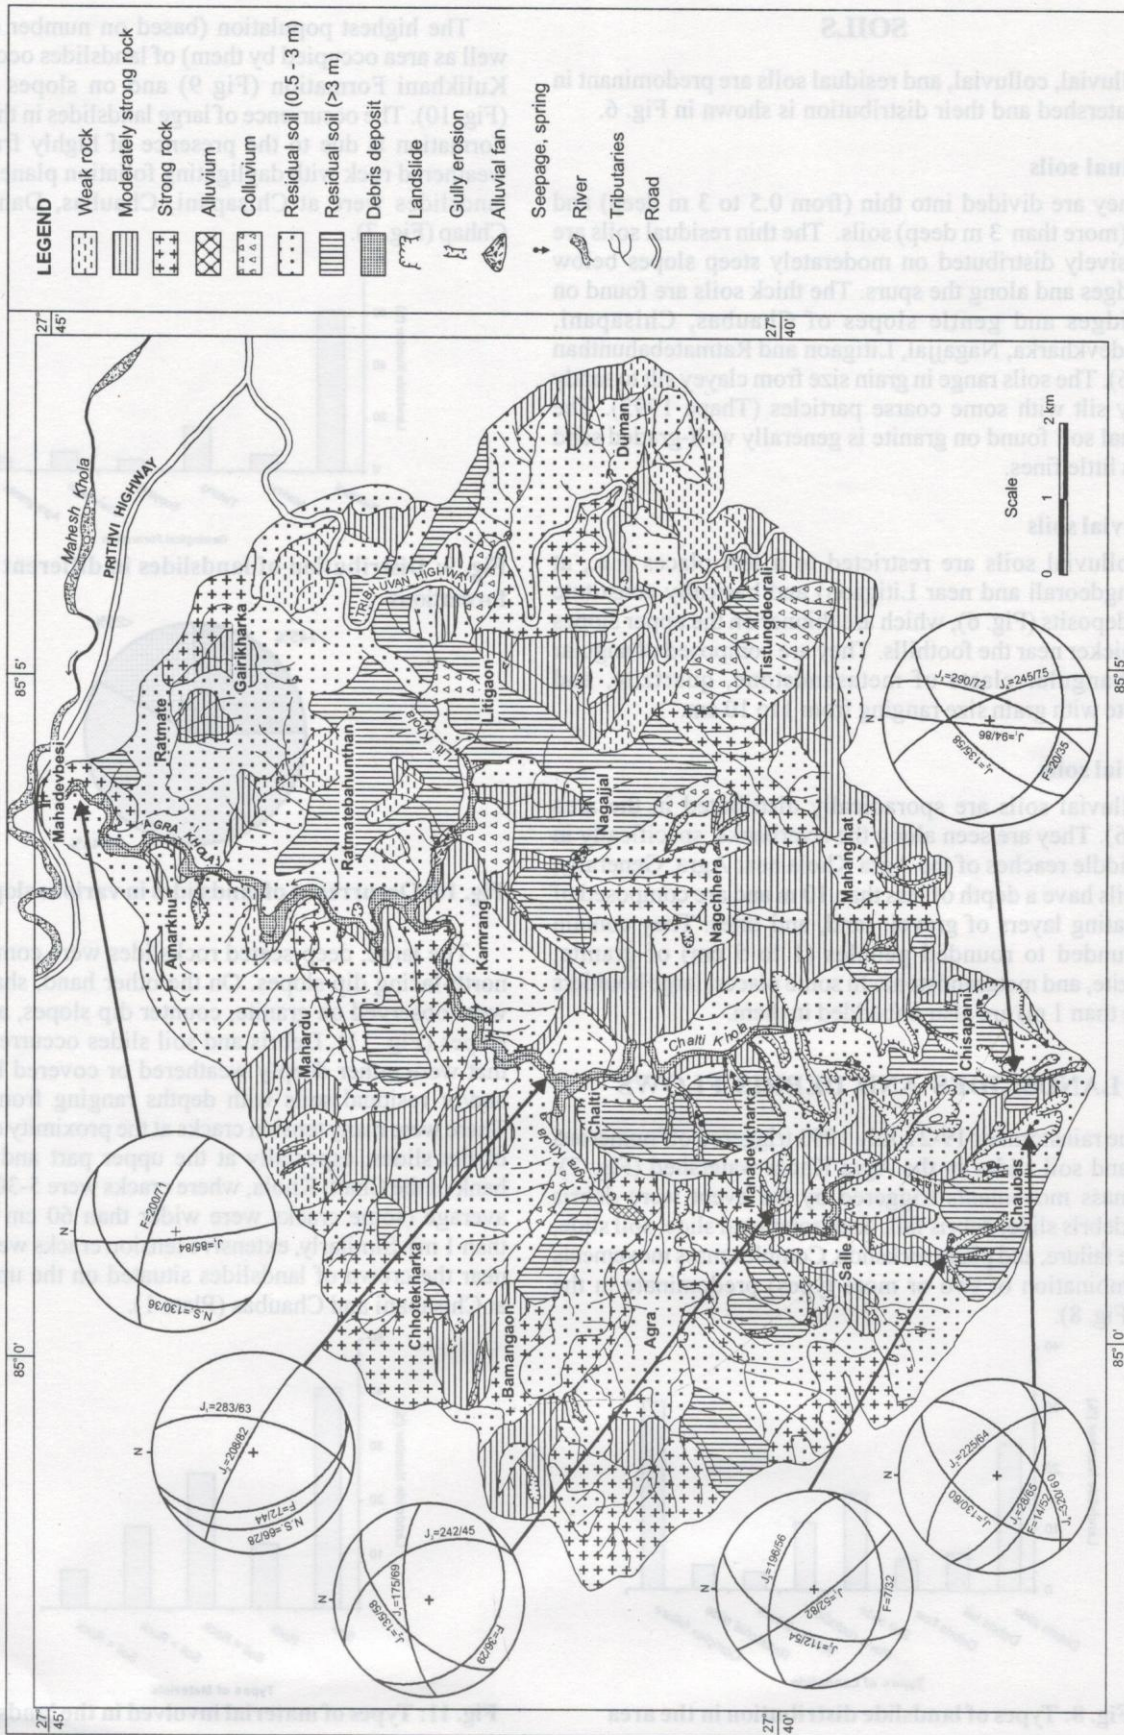
Fig. 6: Engineering geological map of the Agra Khola watershed, Central Nepal, Lesser Himalaya

On the basis of above parameters, the rock mass in the watershed was classified into strong, moderately strong, and weak categories (Fig. 6). In the vicinity of Mahadevbesi, Chhotekharka, Bamangaon, and Nagchhera, the rocks are strong, whereas at Mahanghat, Nagchhera, Mahardu, and Bamangaon, they are moderately strong, and at Chisapani and Tistungdeorali as well as in many other locations, the rocks are weak (Fig. 6).

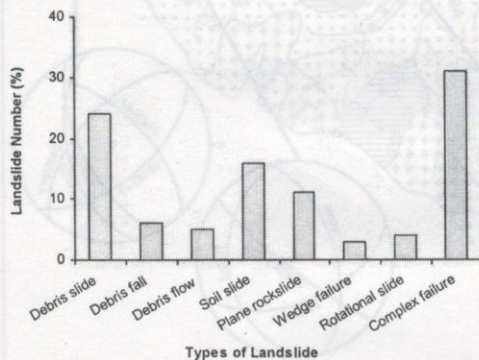
Fig. 8: Types of landslide distribution in the area

The rainstorm of 19-21 July 1993 triggered off numerous rock and soil slides in the Agra Khola watershed (Fig. 7). The mass movements triggered by the event were debris flow, debris slide, debris fall, deep rotational slide, soil slide, wedge failure, and plane rockslide. Complex mass movements (a combination of two or more types) predominate in the area (Fig. 8).

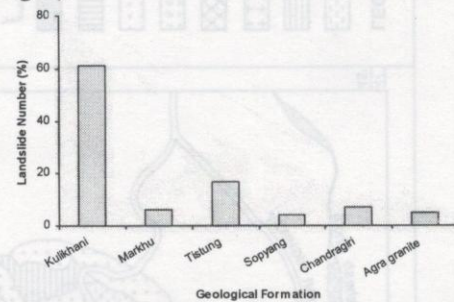
Fig. 9: Distribution of landslides in different geological formations

The highest population (based on number of slides as well as area occupied by them) of landslides occurred in the Kulikhani Formation (Fig 9) and on slopes of 25°-45° (Fig. 10). The occurrence of large landslides in the Kulikhani Formation is due to the presence of highly fractured and weathered rock with daylighting foliation plane. The major landslides were at Chisapani, Chaubas, Dandabas, and Chhap (Fig. 7).

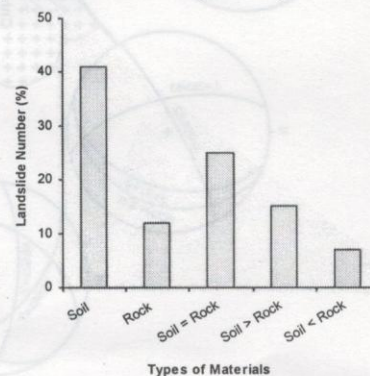
Fig. 11: Types of material involved in the landslides

The large, deep-seated rockslides were common on the north-facing dip slopes. On the other hand, shallow slides were observed on granite, counter dip slopes, and thin soil slopes (Fig. 11). Debris and soil slides occurred on slopes that were either deeply weathered or covered by colluvial and/or residual soils with depths ranging from 1 to 6 m. There were many tension cracks at the proximity of the crown of the slides, especially at the upper part and on the left bank of the Chalti Khola, where cracks were 5-30 cm deep in average (some cracks were wider than 60 cm and deeper than 1 m). Similarly, extensive tension cracks were observed near the crown of landslides situated on the upper portion at Chisapani and Chaubas (Plate 1).

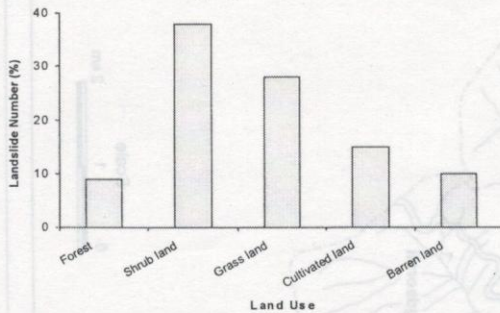
Fig. 12: Land use pattern in landslides

Some landslides occurred in deforested areas and others occurred in forested areas making it difficult to conclude that deforestation caused the sliding although there was a tendency to occur more slides in agricultural areas, shrub lands, and barren lands (Fig. 12).
