Problems of river degradation in the Kathmandu Valley

R. P. Pradhananga

ABSTRACT

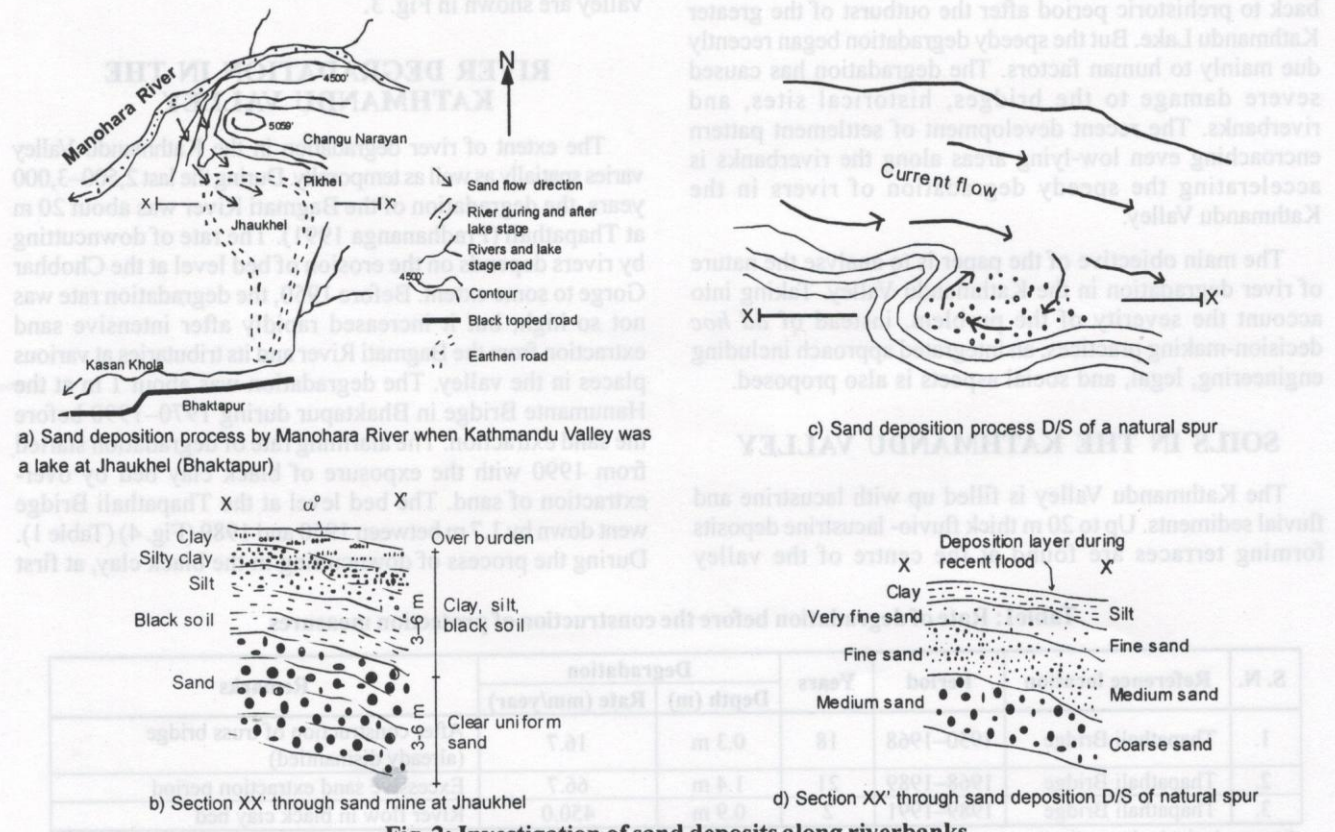
underlain by thick lacustrine black clay (called *Kalimati* in Nepali). The southern part of the valley is made up of fluvial deposits of clay, silt, sand, and gravel. In the Chapagaon, Sainbu, Bungamati, Lagankhel, Jawalakhel, Sanepa, and the Chobhar Gorge areas, alluvial clayey gravel with boulders is found, especially around the Nakhu Khola. It was deposited prior to the outburst of the greater Kathmandu Lake. In Jhaukhel (Phikhel), at the leeward southern side of the Changu Hills, sandy beds were deposited by the Manohara River (Fig. 2). Soils observed in various locations in the valley are shown in Fig. 3.

Fig. 2: Investigation of sand deposits along riverbanks

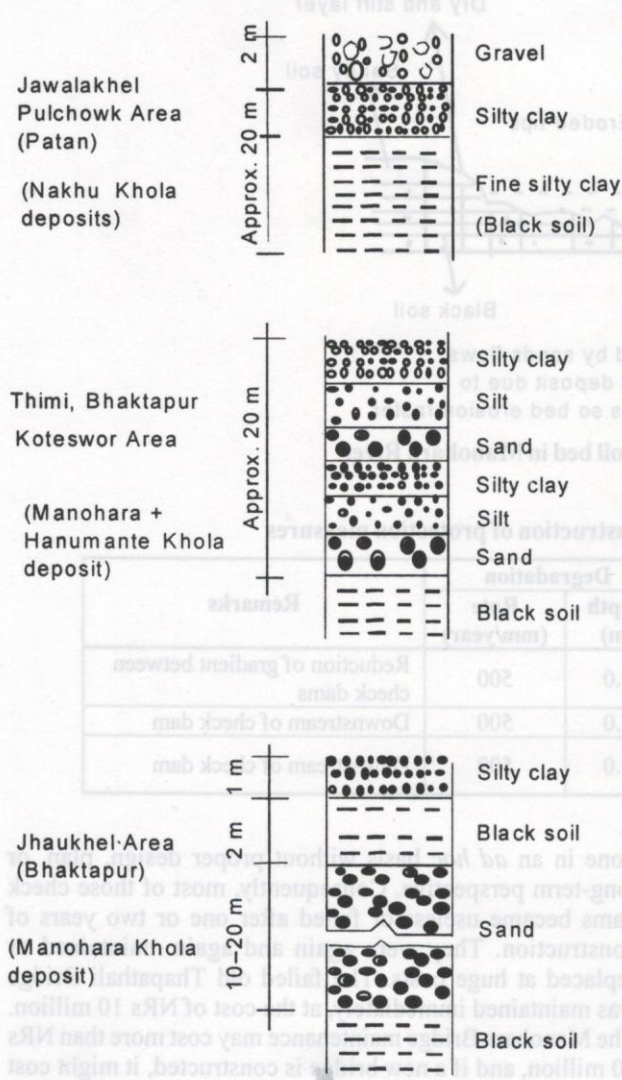
Fig. 3: Soil section at various location in Kathmandu Valley
