## Recumbent fold and deformed cut slope in the landslide-prone region of the Niigata Prefecture, Central Japan

Tamotsu Nozaki<sup>1</sup>, Katsumi Ookubo<sup>2</sup>, and Toshio Yamamoto<sup>3</sup>

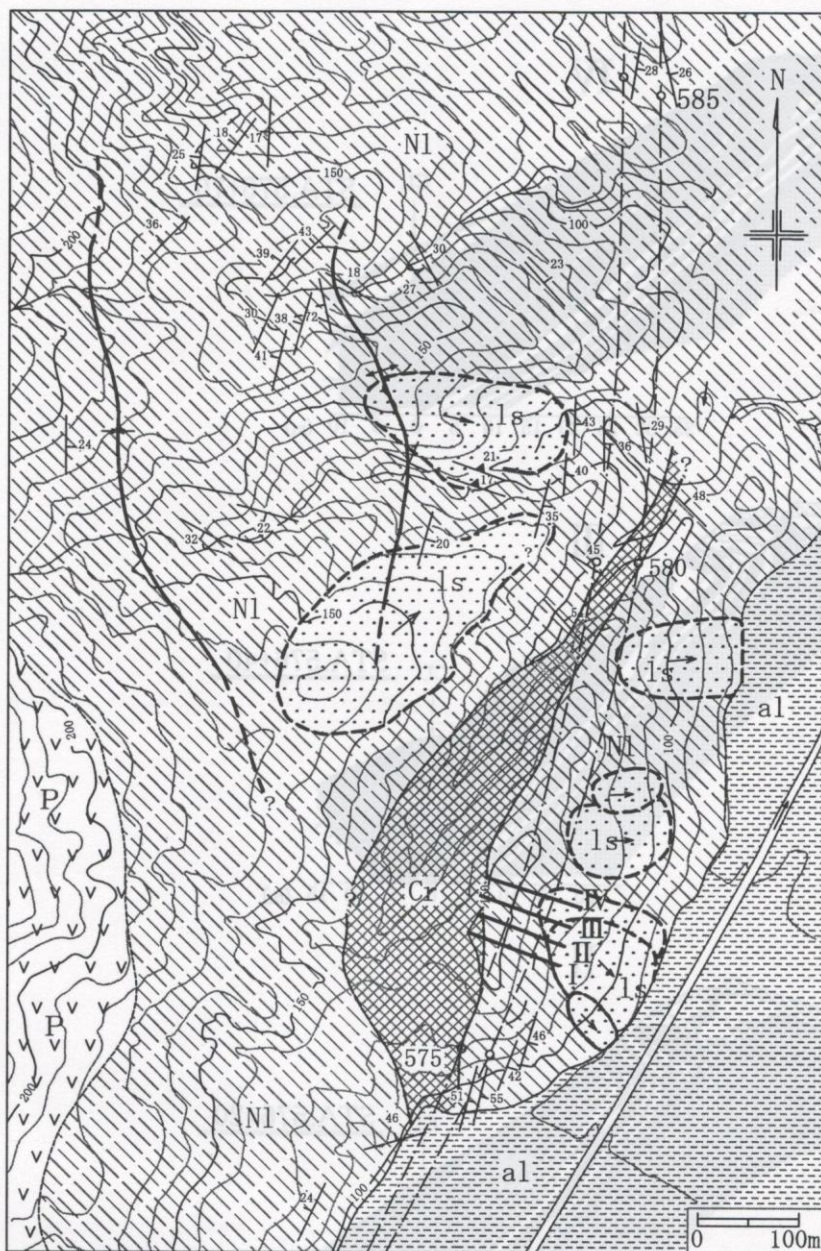
Fig. 5: Schematic section showing the geological structure of the study area

The crush zone underlies the interbedded sequence of sandstone and mudstone (Fig. 5). One of the boreholes (H10-5) was drilled to about 20 m below the alluvial plain. However, it did not reach the bottom of the crush zone. The examination of cores revealed that the entire section was intensely shattered and sheared. Although the materials were the same as the overlying sandstone and mudstone, the original sedimentary structures were obliterated. The thickness of the crush zone is at least 70 m, and it is neither oxidised nor weathered except for the top 2–3 m.

The interbedded sequence consists mainly of sandstone and mudstone and there are hardly any conglomerate beds. The beds strike N10–20°E and dip 35–50° due E (to the plain). Towards the south, the beds are steeper. The sequence overlying the crush zone is highly jointed and friable. It exhibits numerous slickensides parallel to the bedding plane.
