### Study of Common Construction Practices and Structural Defects in RC Buildings in Darchula District Far-Western Nepal

**Birendra Kumar Bohara**

#### Abstract

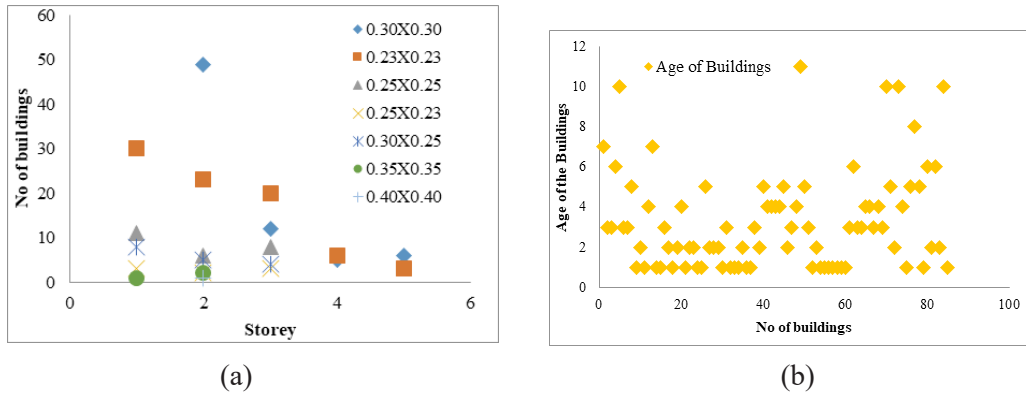
**Figure 3**

Mandatory rules of thumb (MRT) where NBC 201, 202 and 205 provide the ready-to-use provision such as dimension, detailing of the beam, column, and size of the room and it has commonly used in owner-built houses in Nepal. To construct an earthquake resisting buildings NBC recommended some improvements after Gorkha earthquake (2015) in code and minimized the size of columns should be 300mm x 300mm (minimum rebar of 4-12mm diameter bar and 4-16mm dia) for up to three storey’s with a column to columns span should be less than 4.5m. While observing the column size with their storey of 238 buildings different types of column sizes were noticed which is as shown in Figure 3(a). Only 43% of buildings are constructed with 300mmX300mm size columns and almost 48% of buildings have a column size of less than 300mmX300mm. It is also observed (see Figure 3(a)) that nearly 18% of buildings are greater than 2-storey buildings where smaller (less than 300mm) columns are used. This shows that people have no sufficient knowledge of building laws and the building owner constructed their building without getting permission from the municipality. While understanding the people’s views on it, people feel lengthy and costly (taxes, engineer cost) to get permission for the construction of buildings. Figure 3(b) shows the age of buildings and the data shows that most the buildings are constructed recently (almost 6 years) but people do not follow NBC properly.

(a) The relation between the size of columns with storey number (b) Age of buildings

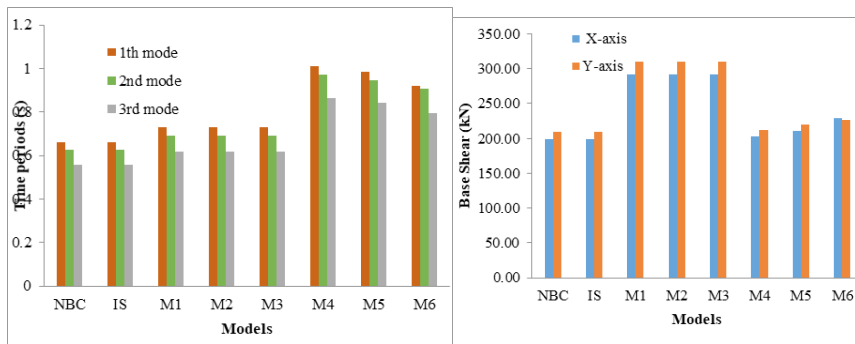
**Figure 14**

Figure 14(a) shows the model NBC and IS have similar natural periods and also value is minimum as compared to the other models. It is observed that when the size of the column and reinforcements of the columns decreases, the fundamental time period increases, it is because the stiffness of the columns increases as the size of the column decreases as shown in Figure 15. Model M4 (230x230 and 0.86% rebar) shows the almost maximum natural period which is 1.012 s.

In the results, it is observed that models NBC and IS have the same values of shear force (see in Figure 14(b)). Even though the column size of the models IS, NBC and M1 to M3 have the same 300x300mm, the base shear value is more in the M1 to M3 models which are 292.43kN, it is because it is assumed that models M1, M2 and M3 are the OMRF (see in Figure 14(b)). However, the well-designed model IS and NBC has been assumed SMRF. It is noticed that as decreasing the size and percentage of reinforcements in columns, the storey stiffness of the structure increases as shown in Figure 15.

(a) Time periods of the building models (b) Base shear (KN) of the building models

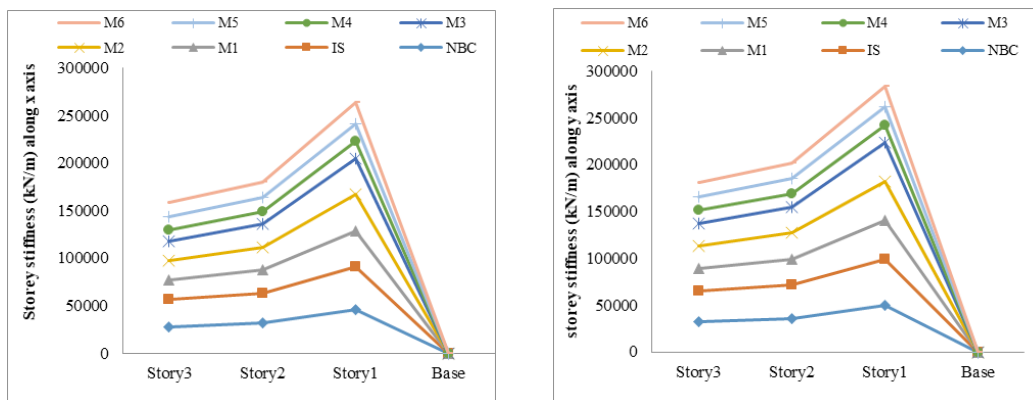
**Figure 15**

Storey stiffness of each model

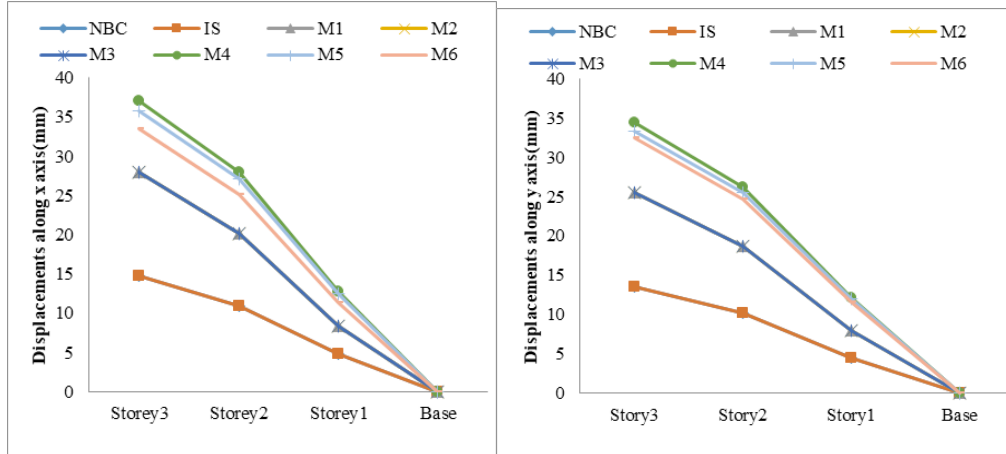
**Figure 16**

It is noticed that minimum displacements are observed in models NBC and IS which is almost 14.7mm and maximum displacement is observed in model M4 which is 37mm as shown in Figure 16. Almost 40% increments in displacements have observed while column size and reinforcements were decreased in M4 models. The Indian standard (IS 1893. Part 1, 2016) suggested that the inter-story drift should be limited to 0.004. Figure 17 shows the maximum inter-story drift of each model in both the x and y directions. It is noticed that only models NBC and IS (nearly the same value) have minimum inter-story drift however the

*Storey displacements of each model*

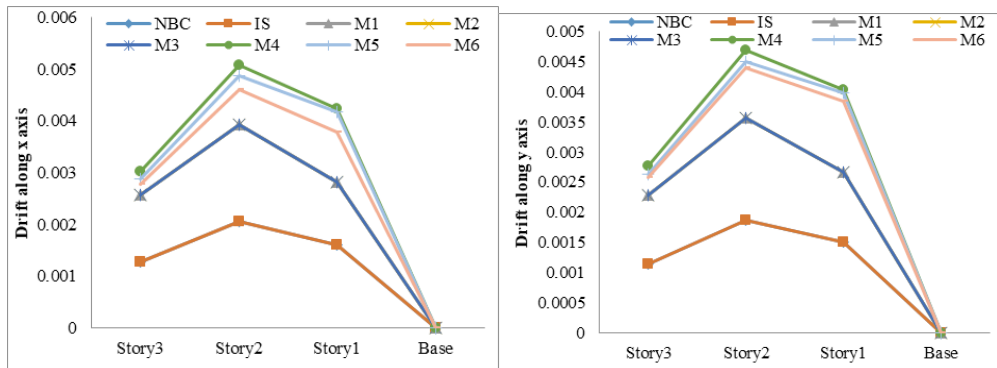
**Figure 17**

*Inter-storey drift of each model*

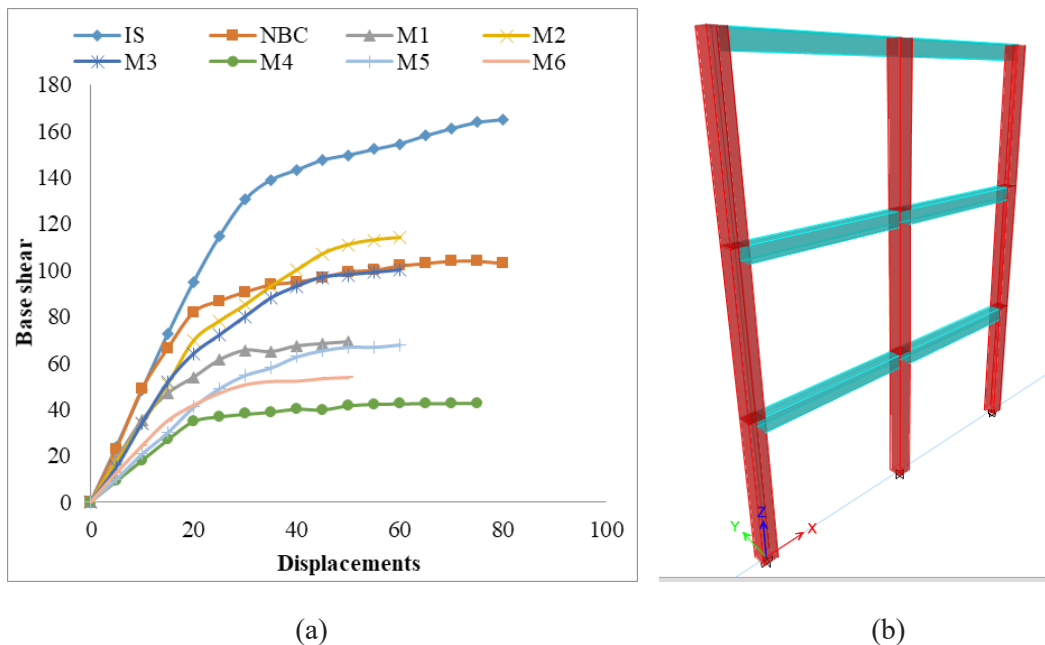
**Figure 18**

When the lateral force is increased and displacements are noticed in every increment of lateral load also known as pushover analysis the capacity curve is obtained as shown in Figure 18(a) and Figure 18(b) shows the 2D frame. It is obtained that models which are designed by using the Indian standard (IS model) show a high capacity value as compared to the NBC models. These two models (IS and NBC) are identical in all senses only the percentage of reinforcements was more as shown in Table 2. It is also noticed that model M4 has minimum capacity. While observing the curve it has been obtained that model NBC, M1, M2, and M3 have similar types of capacity curves. The curve results that only IS models have sufficient capacity and are more ductile.

(a) The capacity curve of each model (b) 2 dimension models for pushover analysis

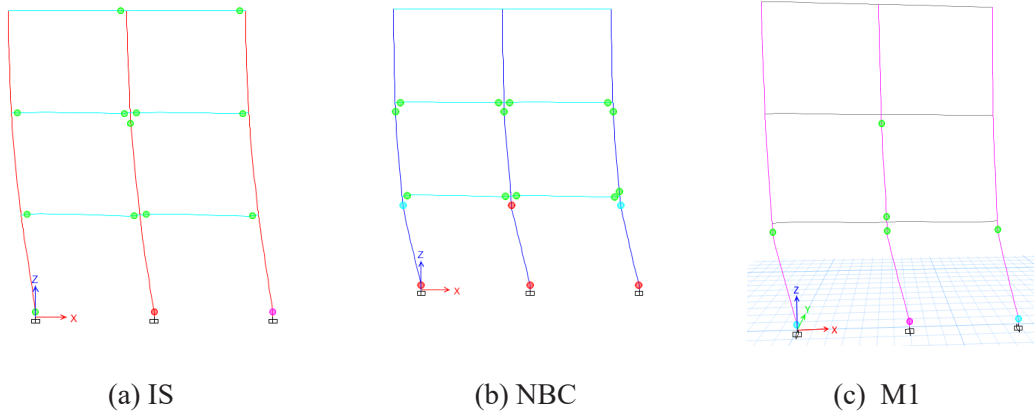
**Figure 19**

While observing the failure pattern of the structure it has been observed that models M1 to M6 have poor performance as shown in Figure 19. While noticing the formation of the hinge in the beam, and columns, some models show the weak column strong beam, which is just opposite to the design philosophy of strong column weak beam.

*Collapse mechanisms for selected models*
