## Seismic Vulnerability Assessment of Plan Irregularity Reinforced Concrete Framed Building

The study presents the seismic vulnerability assessment of plan irregular reinforced concrete framed building. At PEC, there are a total of 5 blocks among which Block-B, established in 2000 AD was selected for detailed assessment due to its structural irregularities. The assessment started with visual inspection using FEMA guidelines, which revealed undersized members, poor concrete quality, irregular plan layout, torsional irregularity, and visible deterioration. Non-destructive tests (Ultrasonic Pulse Velocity and Rebound Hammer) confirmed good internal concrete integrity but weak surface strength. To understand the building's seismic performance more clearly, a structural model was developed in ETABS v22.5 following NBC 105:2020. The analysis showed that 130 members failed seismic checks, including torsional irregularities, storey drift, and displacement limits. Based on these findings, a hybrid retrofitting plan was proposed combining concrete jacketing for columns and beams, steel jacketing for selected beams, and the addition of reinforced concrete shear walls. Post-retrofitting anal

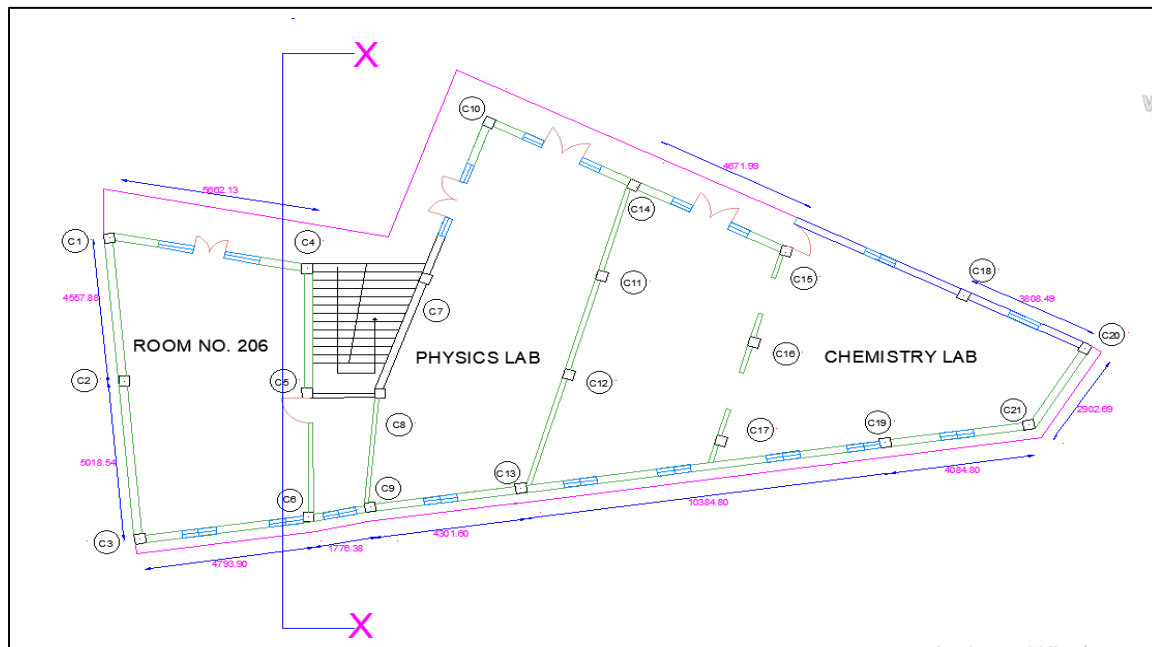
**Figure 1:** Architectural drawing of first floor

The Diploma Building (Block B) of the Pokhara Engineering College (PEC) is a six storey reinforced concrete (RC) frame structure with hollow block infill walls built in 2000 AD. Since the structure was built before the implementation modern seismic codes, it has serious plan

irregularities in the form of re-entrant corners and an asymmetric column layout which would induce torsional effects and stress concentrations during earthquakes. Over time, material deterioration reduces the structure's capacity to resist lateral loads, raising the risk of severe damage if an earthquake occurs.

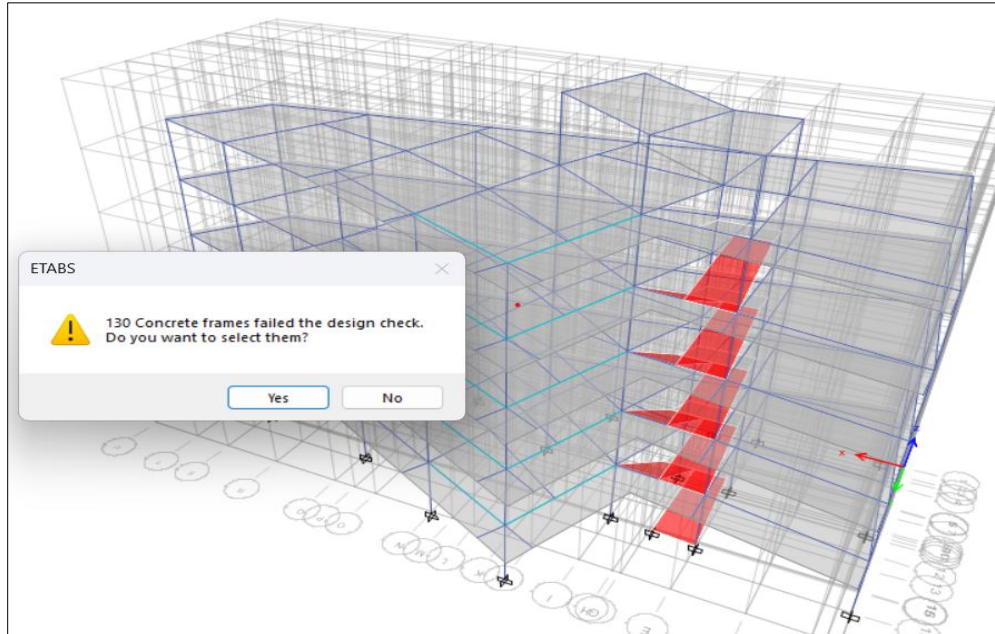
**Figure 2:** Verifying if all members passed the design check

Since the DCR in the top storey is less than 1, this storey is safe but the DCR of lower 5 storey is greater than 1. So, these storeys are overstressed and maybe liable to failure during an earthquake.
